<b>Aircraft Type and Registration:</b>	Yak-52, G-YAMS	
<b>No &amp; Type of Engines:</b>	1 Ivchenko Vedeneyev M-14P piston engine	
<b>Year of Manufacture:</b>	1984	
<b>Date &amp; Time (UTC):</b>	27 December 2004 at 1510 hrs	
<b>Location:</b>	Hill Crest Farm, Canewdon, Essex	
<b>Type of Flight:</b>	Private	
<b>Persons on Board:</b>	Crew - 1	Passengers - None
<b>Injuries:</b>	Crew - 1	Passengers - N/A
<b>Nature of Damage:</b>	Damage to wings, fuselage, landing gear and propeller	
<b>Commander's Licence:</b>	UK Private Pilot's Licence	
<b>Commander's Age:</b>	51 years	
<b>Commander's Flying Experience:</b>	316 hours (of which 26 were on type) Last 90 days - 8 hours Last 28 days - 1 hour	
<b>Information Source:</b>	Aircraft Accident Report Form submitted by the pilot and examination of the aircraft by the AAIB

### Synopsis

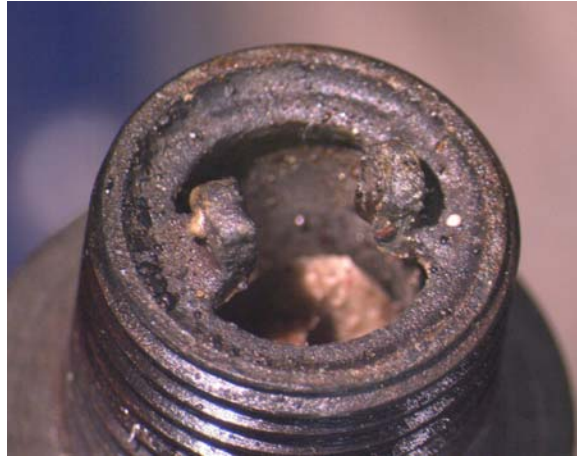
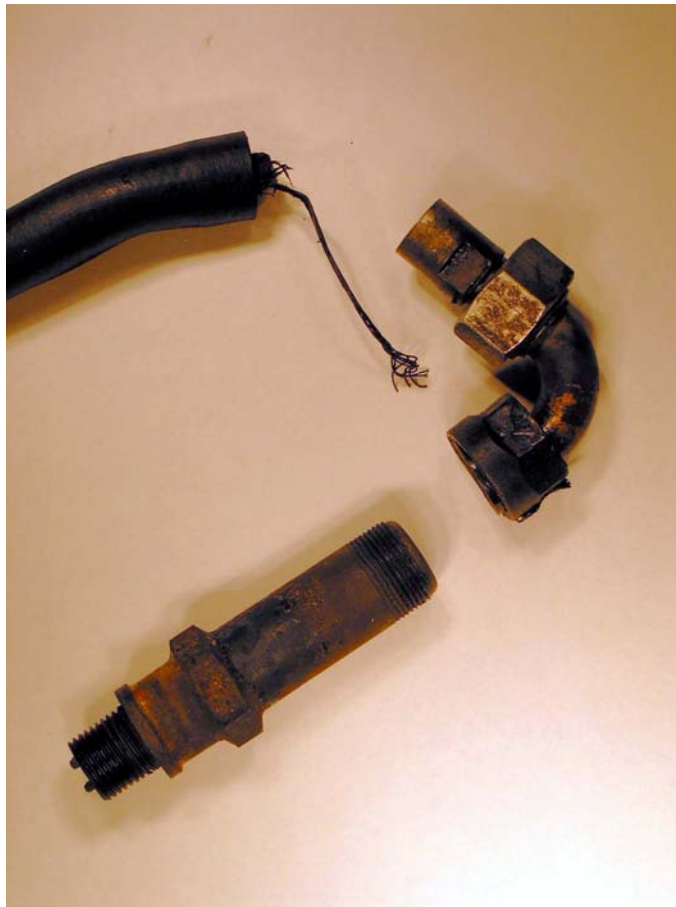
**Figure 1**

The engine was then examined in detail. This revealed the high tension (HT) lead for the No 5 cylinder rear spark plug had been 'blown out' of the elbow fitting to the plug. Subsequent removal and inspection of the plug showed that the ceramic insulating core of the plug had been damaged and the inner electrode was missing. There were also signs of significant local heating of the elbow fitting, Figure 1. The remaining spark plugs fitted to the engine were all in a satisfactory condition. The damaged spark plug was identified with the markings SD-49SMM and was a product of the original plug manufacturer, in Russia, for this engine type. It had been fitted to G-YAMS for approximately 60 flying hours; the spark plugs were last inspected during a routine 50 hr inspection, 11 flying hours prior to the accident.

The rough running of this engine could be directly attributed to the failure of the No 5 cylinder rear spark plug. The inner insulating core had 'blown out', resulting in the hot gases from the cylinder escaping through the plug and blowing out the HT lead connection. The hot gases had then caused localised heating of the spark plug elbow fitting. As a result of the failure, the compression on cylinder No 5 was compromised, resulting in the engine running roughly, but with the remaining eight cylinders operating normally.

Details of the failed rear spark plug from cylinder No 5

Some Yak owners have converted their engines to take spark plugs manufactured in the USA, but these are approximately double the cost of the original Russian plugs and require an adapter to be fitted to the engine cylinder. The life of the USA manufactured plugs is no different to those of the Russian manufacture at 200 hours, but they have not been known to suffer from blow out of their cores.
