## ACCIDENT

<b>Aircraft Type and Registration:</b>	Pegasus Quasar TC, G-MWSH	
<b>No &amp; Type of Engines:</b>	1 Rotax 503-2V piston engine	
<b>Year of Manufacture:</b>	1991	
<b>Date &amp; Time (UTC):</b>	6 April 2007 at 1710 hrs	
<b>Location:</b>	Shifnal microlight site, near Telford, Shropshire	
<b>Type of Flight:</b>	Private	
<b>Persons on Board:</b>	Crew - 1	Passengers - None
<b>Injuries:</b>	Crew - 1 (Fatal)	Passengers - N/A
<b>Nature of Damage:</b>	Substantial	
<b>Commander's Licence:</b>	Private Pilot's Licence (Microlight)	
<b>Commander's Age:</b>	58 years	
<b>Commander's Flying Experience:</b>	315 hours (of which 1 hour was on type) Last 90 days - 8 hours Last 28 days - 3 hours	
<b>Information Source:</b>	AAIB Field Investigation

## Synopsis

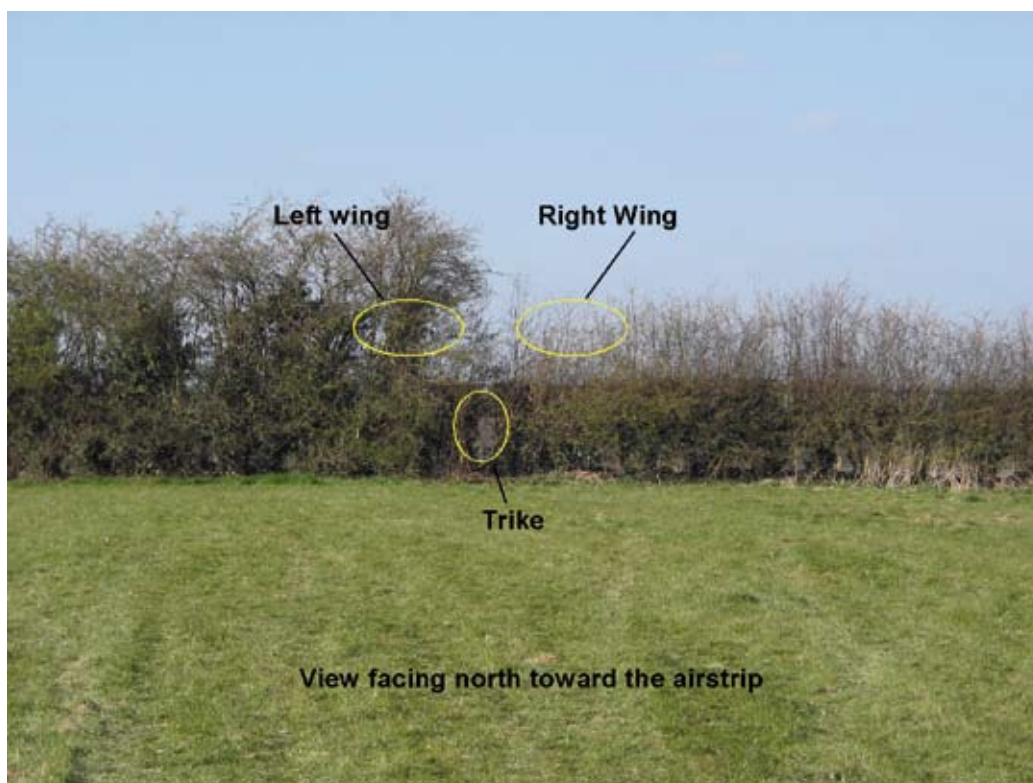
**Figure 1**

The aircraft had struck a hawthorn hedge and trees located 65 m from the threshold of Runway 36. The hedge, which ran perpendicular to the runway, varied in height along its length. Embedded within the hedge, mainly to the west of the approach path, were several trees that exceeded the height of the hedge (see Figure 1). The lack of any ground marks prior to the hedge indicated that the aircraft had not contacted the ground before striking it.

Hedge and tree damage after the recovery of the aircraft

Damage to the hedge and trees were consistent with the aircraft impacting it in a wings level attitude with the trike about 1 m above the ground. It was not possible to establish the exact pitch attitude at impact.

The leading edge of the left wing had initially struck a tree that had grown to a height above the hedge; the right wing did not strike anything significant except for small branches extending upwards from the hedge. The trike had continued to move forward and into the hedge, under its own engine power. The tree had restricted the wing from moving further forward, causing the trike to rotate about the hang point, before pulling forward against the wing structure, fracturing the wing keel in two places. Additionally, as the A-frame was still attached to the wing, as the trike moved forward in relation to the wing, the pilot became trapped between the lower bar of the A-frame and the trike's seat back. When the trike's rear wheels came into contact with the hedge the trike was brought to a halt.

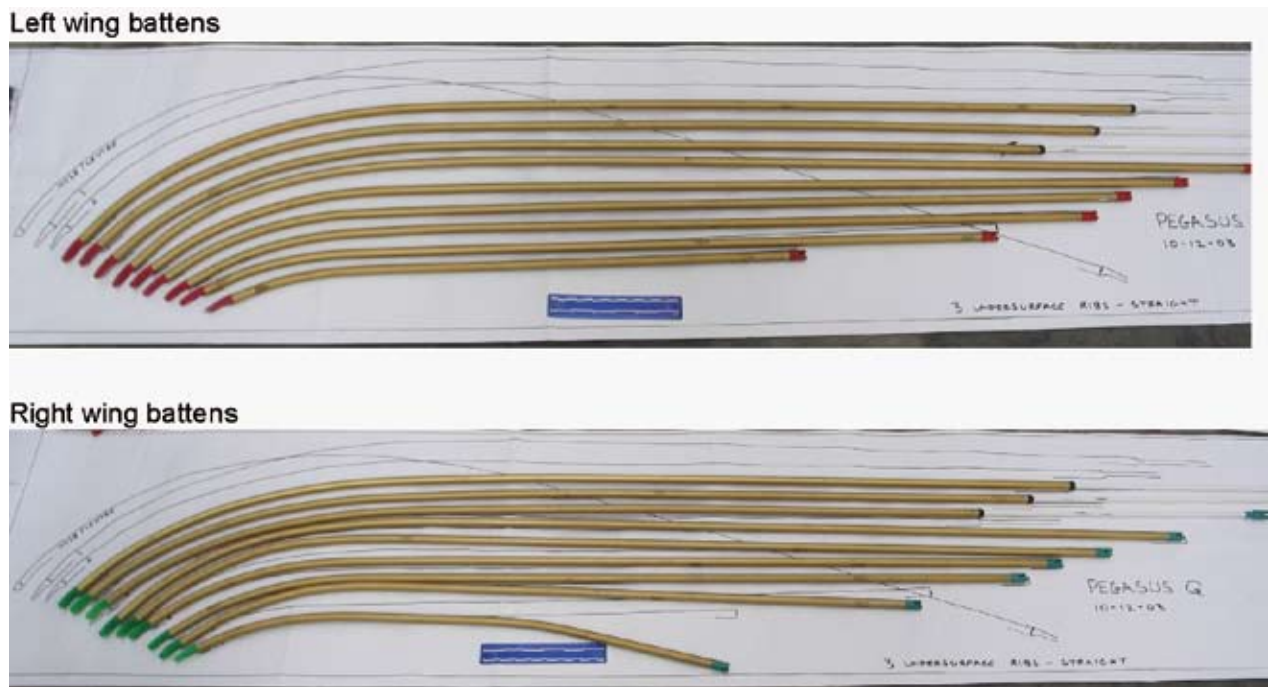
**Figure 2**

A check of the batten profiles for the wings revealed that the correct battens had been used during the rigging of the wing. However, a comparison of the batten profile against the profile drawings supplied by the aircraft manufacturer revealed that although the left wing battens matched the profile drawing, the right wing battens were significantly different. The outer batten, number 11, had been damaged during the attempts to recover the pilot, however batten numbers 6,7,8,9 and 10 had significant over-camber when compared to the drawing. Batten number 10 showed the greatest deviation, with an additional 46 mm to the camber, (see Figure 2).

As a result of the discovery of the altered batten profiles on the aircraft, a series of test flights was carried out on a similar aircraft by the manufacturer. The battens were set to the same profile as found on G-MWSH and the handling characteristics were assessed. The flight test showed that the aircraft had a tendency to turn to the left and required 1 to 2 kg of right roll effort on the bar to fly in a constant direction, although the test pilot assessed the effect as 'not severe'. Other flight characteristics were not significantly affected and the test pilot noted that the aircraft would have been acceptable for a Permit to Fly (PTF) revalidation except for the tendency to turn left. The manufacturer also advised that although the bungees should have been secured by a double loop, a

Wing batten profiles as found following the accident flight

The unusual batten profiles, found after the accident, should also not have affected the aircraft's handling such that it was unmanageable by an experienced pilot. The air tests carried out by the manufacturer showed that the aircraft was flyable in the configuration in which it was rigged. However, less than ideal or unusual handling characteristics could have contributed to a difficulty for a pilot who was not in current practice on a flex-wing aircraft.

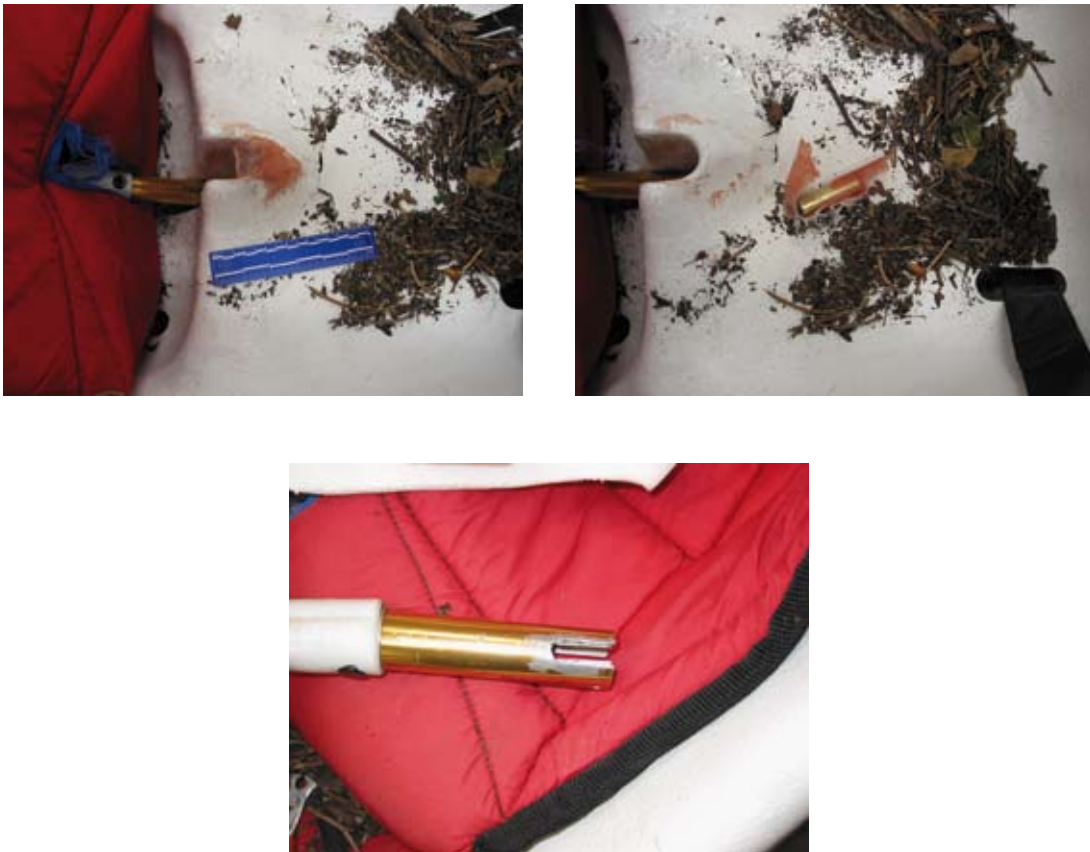
**Figure 3**

The fatal injuries suffered by the pilot were consistent with crushing between the A-frame and the pilot's seat back. Examination of the seat revealed that repairs and modifications had taken place around the pilot's seat back. The seat back and post had been modified with the addition of an inner sleeve of metal within the seat post. There was also evidence that the seat back had been removed and refitted to the seat post. The fibreglass seat had been subjected to repairs in the past due to cracking. However, additional packing had been added within the recess in which the seat post would sit. The packing consisted of a crushed metal bar secured in place by fibre-glass, using a pink coloured resin, (see Figure 3).

The only record of a repair to the seat was in May 2005. The owner at the time, who also carried out the repair, does not recall ever fitting a metal packer into the recess of the seat. Similarly the BMAA inspector that carried out the PTF renewal in June 2006 also does not recall seeing the seat back packer.

Seat back repair

reacted against the packing in the seat recess. A dent to the plastic outer sheath of the seat post was consistent with a large rearward force being applied. The seat also exhibited cracking to the sides of the seat and behind the recess, again indicative of a large rearward force on the seat post.

There is no requirement for the pilot's seat back to collapse when a rearward force is applied, however had the seat back given way in this accident then the injuries may not have been fatal
