## RAF 2000 GTX, G-BXMG

| <b>AAIB Bulletin No: 11/2003</b> | <b>Ref: EW/C2003/02/07</b> | <b>Category: 1.4</b> |
| <b>Aircraft Type and Registration:</b> | RAF 2000 GTX, G-BXMG | |

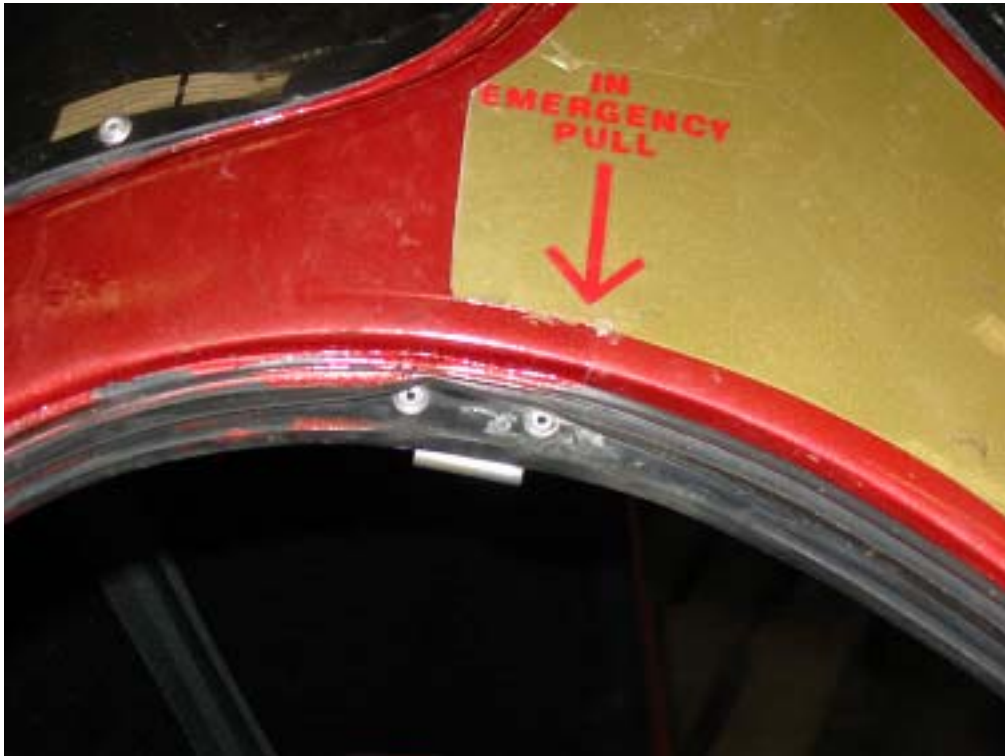
The intention was that in the event of an emergency landing, the occupants would unlatch the uppermost door latch on each door during their descent. This would allow a gap to occur between the door and the door frame in this position, enabling someone outside the aircraft to prise open the door should the occupants become trapped or incapacitated. The external placard instructing where to pull to gain access in an emergency was placed beside the uppermost internal latch as shown below:

Informal enquiries by the AAIB suggest that this procedure is not fully understood by operators. Moreover, on two aircraft inspected the internal placard was either missing or illegible. More importantly, the procedure would be of no use in the event of an unforeseen accident such as this where the occupants would have no time to open the internal latch prior to the impact occurring. In such cases the latch would remain fastened and the external instruction to a rescuer would focus their efforts on one of the points of most resistance when trying to force the door open. This would achieve the direct opposite of the original intention behind the requirement for the placards.

The CAA requirement to fit placards to the RAF 2000 gyroplane in order to facilitate rescue of the occupants may have the opposite effect to that intended if the occupants have been unable to undo the top door latch. Consequently, the present external placards should be removed, repositioned or perhaps amended to show the positions of the internal latches, thereby allowing a rescuer better to judge the most effective position for prising open a latched door.

It is recommended to the Civil Aviation Authority that the Authority's requirement for 'IN EMERGENCY PULL' external placards adjacent to the top latches of the exit doors of RAF 2000 gyroplanes on the UK register should be reviewed.
