AAIB Bulletin No: 12/93

Ref: EW/G93/10/03

Aircraft Type and Registration: Airbus A320-211, G-BUSJ

Nature of Damage: The outer skin from the starboard overwing exit escape slide door panel detached

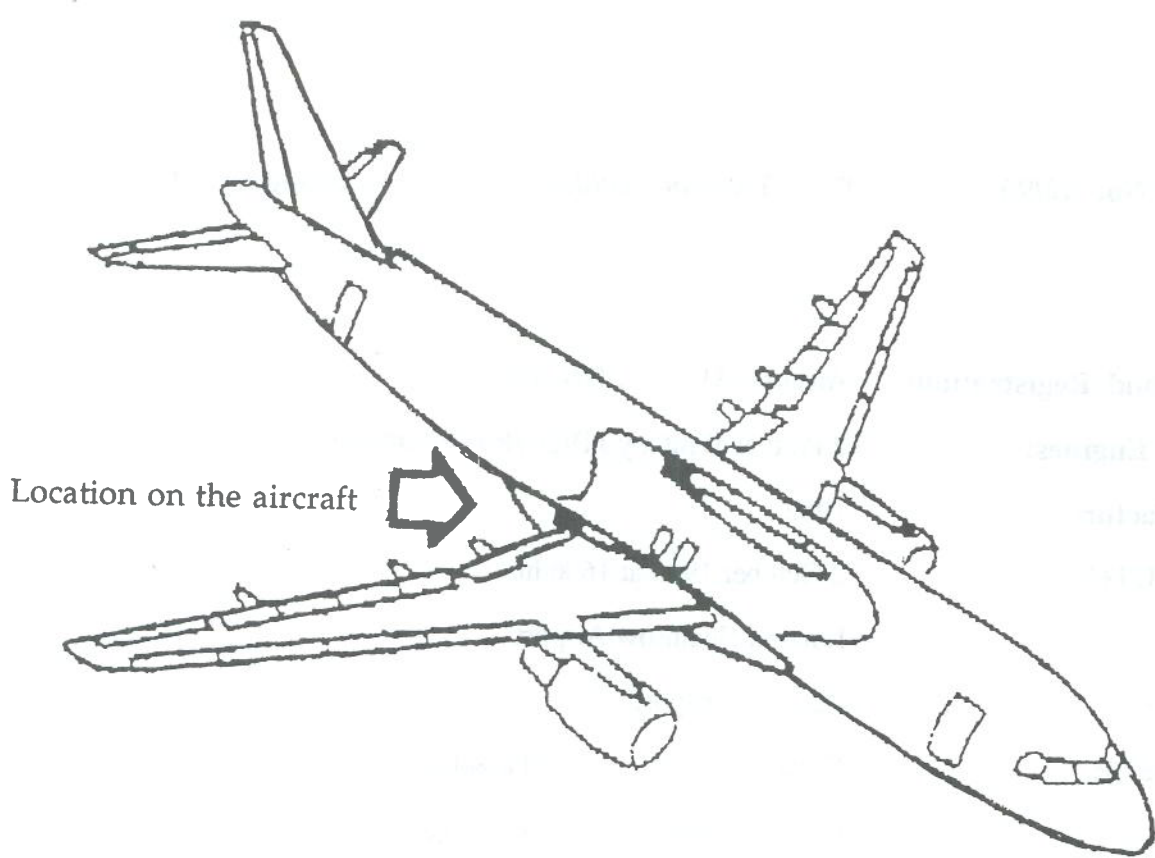
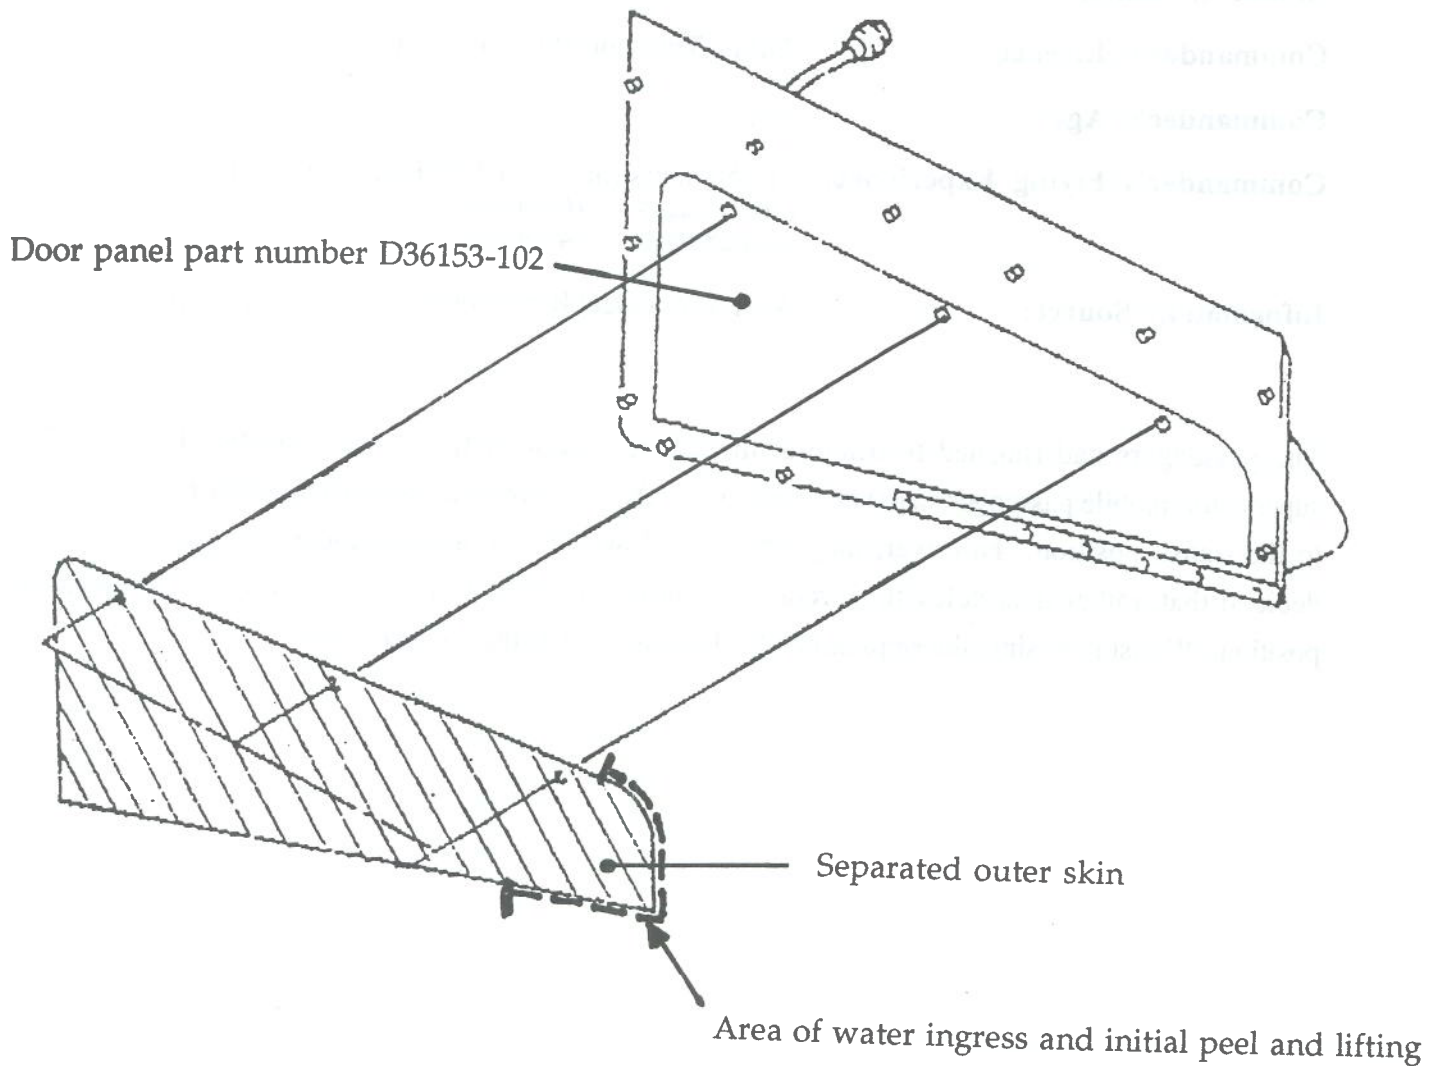
After arrival at Copenhagen a ground engineer found that the outer skin from the right overwing exit escape slide door panel was missing (see figure). The skin had detached en route and was not recovered.

The door panel, part number D36153-102, was removed from the aircraft and subjected to metallurgical examination. It was concluded that the detachment of the outer skin from the door panel was the result of progressive ingress of water into the outer skin/frame interface and that this process was assisted by 'ice-jacking' at sub-zero temperatures in flight. Skin separation appeared to have taken place by continuous peeling which probably resulted from lifting of the detached edge of the skin by aerodynamic forces around the area identified on the figure. The operator has stated that a number of these panels have delaminated, but this is the first where the outer skin has become detached.

Figure Starboard overwing exit escape slide door panel

93-64 In order to prevent separation of the outer skins of overwing exit escape slide door panels on Airbus A320 aircraft the CAA, DGAC and the aircraft manufacturer should introduce a regular

inspection requirement to detect delamination of outer skins from associated door panels, part numbers D36153-101 and D36153-102. (Issued 23 November 1993)

93-65 The manufacturer of the Airbus A320 aircraft should examine the construction of the overwing exit escape slide door panels, part numbers D36153-101 and D36153-102, with a view to preventing water ingress between the outer skins and the door panel frames. (Issued 23 November 1993)
