**SERIOUS INCIDENT**

<b>Aircraft Type and Registration:</b>	Aeroprakt A22L Foxbat, G-CEWR	
<b>No &amp; Type of Engines:</b>	1 Rotax 912 ULS piston engine	
<b>Year of Manufacture:</b>	2008	
<b>Date &amp; Time (UTC):</b>	5 November 2011 at 1300 hrs	
<b>Location:</b>	Otherton Airfield, Staffordshire	
<b>Type of Flight:</b>	Private	
<b>Persons on Board:</b>	Crew - 1	Passengers - 1
<b>Injuries:</b>	Crew - None	Passengers - None
<b>Nature of Damage:</b>	Damage to elevator and rudder anti-balance tab control horn	
<b>Commander's Licence:</b>	Private Pilot's Licence	
<b>Commander's Age:</b>	53 years	
<b>Commander's Flying Experience:</b>	713 hours (of which 497 were on type) Last 90 days - 11 hours Last 28 days - 4 hours	
<b>Information Source:</b>	Aircraft Accident Report Form submitted by the pilot and further enquiries by the AAIB

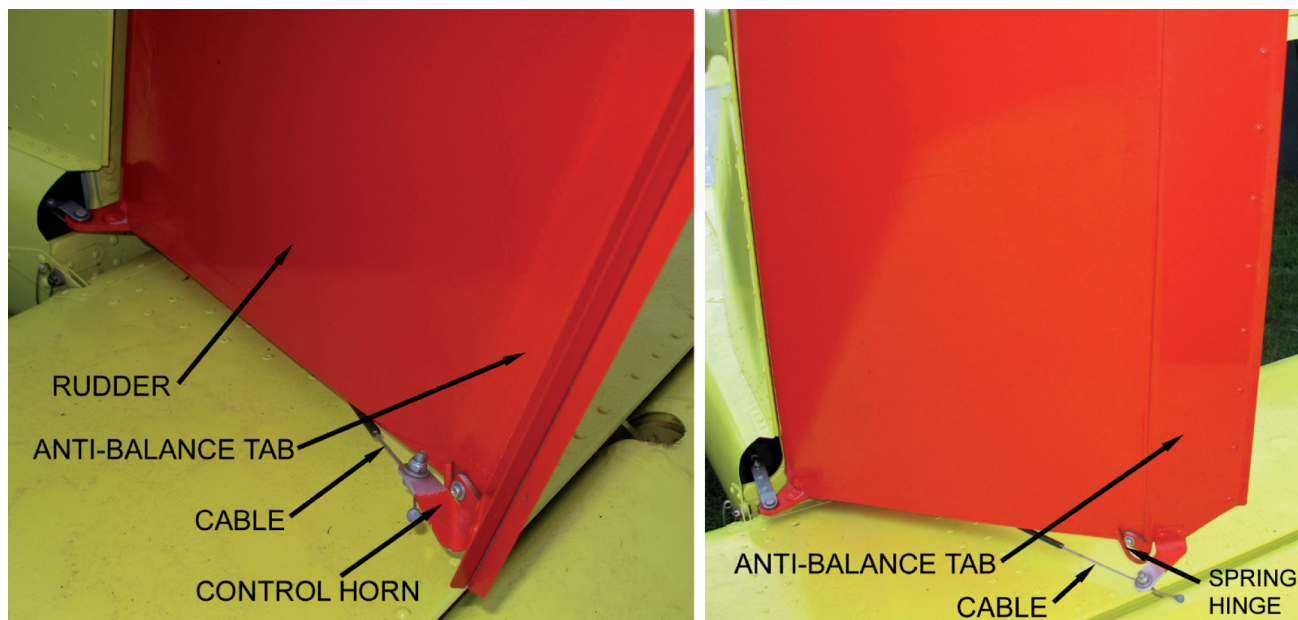
**Figure 2**

Rudder of a similar Foxbat A22L;  
full left rudder deflection and full left anti-balance tab deflection (left image);  
full right rudder deflection and full right anti-balance tab deflection (right image)

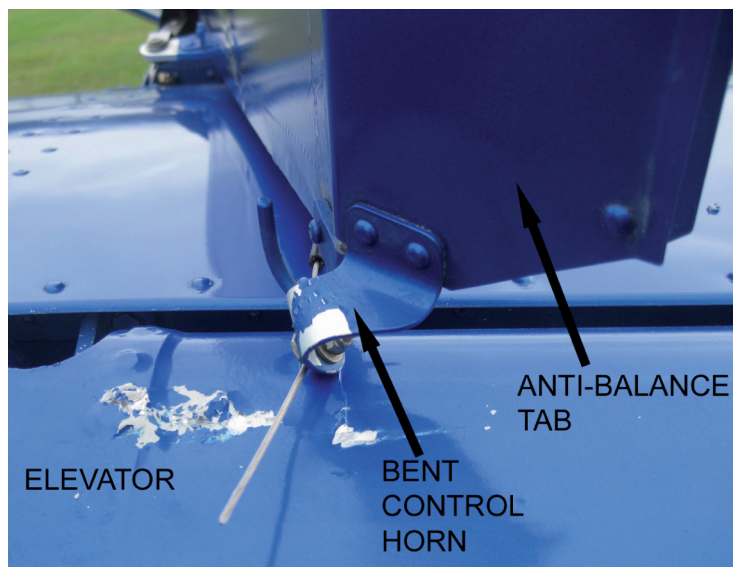
**Figure 3**

G-CEWR was examined by an engineer from the Light Aircraft Association (LAA). He discovered that the control horn, which connects the cable to the tab, had bent downwards and had impinged on the elevator, leading to damage to the elevator's upper surface and restricting movement of the rudder (Figure 3). He also

discovered that the anti-balance tab's spring hinge had seized, which meant that there was no spring return force and therefore the tab could flap freely from left to right. After the spring hinge was cleaned and lubricated the spring force returned and the tab operated correctly during rudder movement. The control horn was then

The LAA concluded that the vibration experienced by the pilot had been a type of rudder 'flutter' event which was caused by the seizure of the anti-balance tab's spring hinge. This allowed the tab to flap freely from left to right and set up a resonant frequency. The consequent high loads at the control horn caused it to bend downwards, jamming the rudder against the elevator.

Bent control horn and damaged elevator on G-CEWR  
(photograph courtesy Light Aircraft Association)

replaced and the bolt securing the cable was orientated 'head down' (as in Figure 2) which is how the bolt should have been attached to provide maximum clearance. The aircraft was then test-flown and the rudder anti-balance system worked normally.

In response to this incident the LAA published Airworthiness Information Leaflet (AIL) entitled '*Aeroprakt A22L Foxbat, Pre-Flight Functioning Checks of Rudder Anti-Balance Tab*' (MOD/317/002 dated 22/11/2011). The AIL required that prior to further flight and during every pre-flight inspection a check of the range and freedom of movement of the rudder anti-balance tab was carried out. It stated that this could be accomplished by pressing down on the tailplane (to take the weight off the nosewheel) and moving the rudder fully left and right, while checking that spring pressure was maintained.

entitled '*Aeroprakt A22L Foxbat, Concerns about Rudder Flutter, Temporary Grounding*' (MOD/317/003 dated 16/01/2012) which grounded the aircraft type until a modification could be developed. This AIL affected all Foxbat A22L aircraft fitted with a rudder anti-balance tab, which was a modification fitted to all but one UK-registered aircraft. On 13 March 2012 the LAA published Airworthiness Alert '*Aeroprakt A22L Foxbat, Modification Approval for changes to Rudder Anti-Balance Tab*' (AWA/12/02) which detailed two modification options, and installing either one would remove the flight restriction. The first modification replaces the tab cable with a pushrod and adds doublers to the tab hinge attachment (LAA Modification Approval 13310). The second modification removes the anti-balance tab and replaces it with a rudder centring spring to provide the necessary centring force that was provided by the tab (LAA Modification Approval 13311).
