INCIDENT

Aircraft Type and Registration:	Boeing 737-76N, G-STRH	
No & Type of Engines:	2 CFM56-7B22 turbofan engines	
Year of Manufacture:	2002	
Date & Time (UTC):	7 March 2006 at 0945 hrs	
Location:	Bristol International Airport	
Type of Flight:	Public Transport (Passenger)	
Persons on Board:	Crew - 6	Passengers - 38
Injuries:	Crew - None	Passengers - None
Nature of Damage:	None	
Commander's Licence:	Airline Transport Pilot's Licence	
Commander's Age:	57 years	
Commander's Flying Experience:	15,000 hours (of which 7,500 were on type) Last 90 days - 125 hours Last 28 days - 47 hours

Synopsis

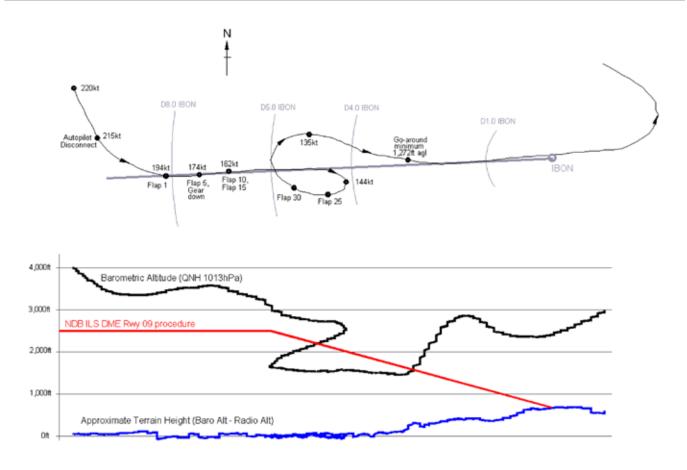
director commands, requested an orbit to lose height. At this time the aircraft was level at 2,800 ft, approximately 500 ft above the glidepath, and 5 nm from the runway threshold. The aircraft was cleared by ATC to fly the orbit and the aircraft commander declined the controller's offer of radar vectors to assist in re-establishing on the ILS. The first officer commenced a right descending turn and then switched off his flight director as it continued to give steering information towards the localiser. During the orbit, the aircraft was subjected to a strong southerly wind and the tower controller, using his radar monitor in the visual control room, could see the aircraft flying through the localiser to the north of the centreline. He transmitted 'YOU ARE GOING TO CLOSE THE FINAL APPROACH TRACK FROM THE NORTH PROBABLY AT LESS THAN A FOUR MILE FINAL, ARE YOU VISUAL WITH THE AIRFIELD?' The commander replied that they were not visual and the tower controller directed them to maintain 1,500 feet until established back on the ILS. At this point the aircraft was level at 1,500 ft; approximately 800 feet below the ILS glidepath (see Figure 1). The tower controller became concerned at the aircraft's slow progress in re-establishing onto the localiser and when the range to the runway threshold reached 3 nm, he instructed the aircraft to go-around. The flight crew realised that they were not going to intercept the localiser before capturing the glidepath and were on the point of initiating a go-around when they were instructed to do so by the tower controller.

The aircraft operator provided the AAIB with data which had been recorded by the Quick Access Recorder (QAR). The data covered the period from the initial approach to Bristol until the eventual landing and was used to derive Figure 1. Due to the late notification of the event the Cockpit Voice Recorder had continued to run and the pertinent recordings had been overwritten.
