No: 3/90

Ref: EW/C1139

**Aircraft Type  
and Registration:**

Agusta-Bell 206B Jet Ranger III, G-JOCO

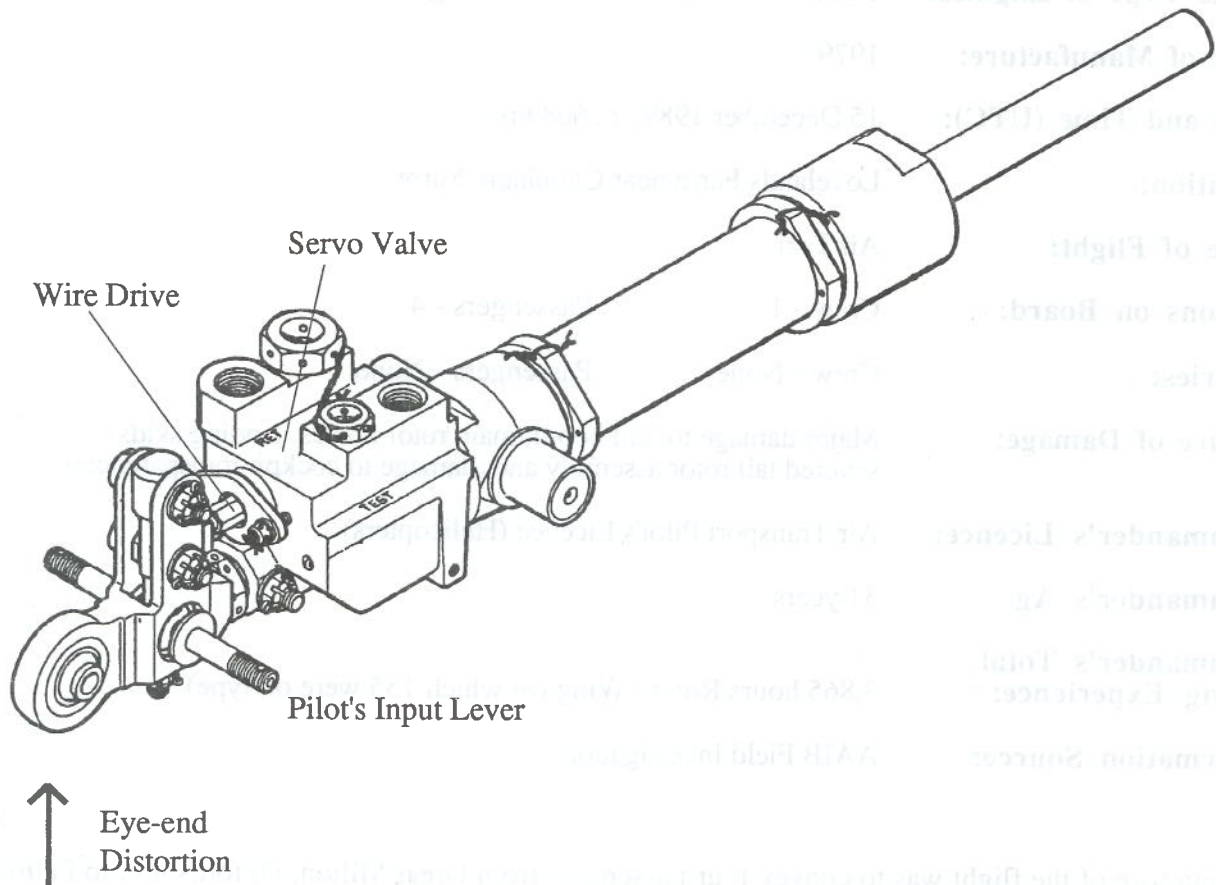
*Hydraulic Flight Control Actuator - Collective Control.* As found, the jack ram had been pulled to the rear by the mast rotating backwards during the crash, ie maximum flat pitch or beyond. The rotation of the mast had raised the rear eyebolt attachment, causing the forward end of the ram and piston to penetrate the cabin roof.

The actuator was mounted in the test jig and the pilot's input lever centralised. When power was applied at 600 psi the ram ran fully forward towards full collective pitch. Inputs to the pilot's lever had no effect.

The actuator runaway was proved to be caused by distortion of the eye-end during the crash; which had displaced the wire drive carrying the spool further into the servo valve and moved the hydraulic neutral by 0.019" - beyond the limits of movement of the pilots input lever. When the valve was re-datumed with a new eye-end it operated correctly.
