INCIDENT

Aircraft Type and Registration:	Dornier 328 100, TF-CSB	
No & Type of Engines:	2 Pratt and Whitney 119B turboprop engines	
Year of Manufacture:	1997	
Date & Time (UTC):	22 June 2006 at 1952 hrs	
Location:	Aberdeen Airport	
Type of Flight:	Commercial Air Transport (Passenger)	
Persons on Board:	Crew - 3	Passengers - 16
Injuries:	Crew - None	Passengers - None
Nature of Damage:	Minor damage to wheels	
Commander's Licence:	Airline Transport Pilot's Licence	
Commander's Age:	62 years	
Commander's Flying Experience:	13,000 hours (of which 300 were on type) Last 90 days - 111 hours Last 28 days - 64 hours	
Information Source:	AAIB Field Investigation

Synopsis

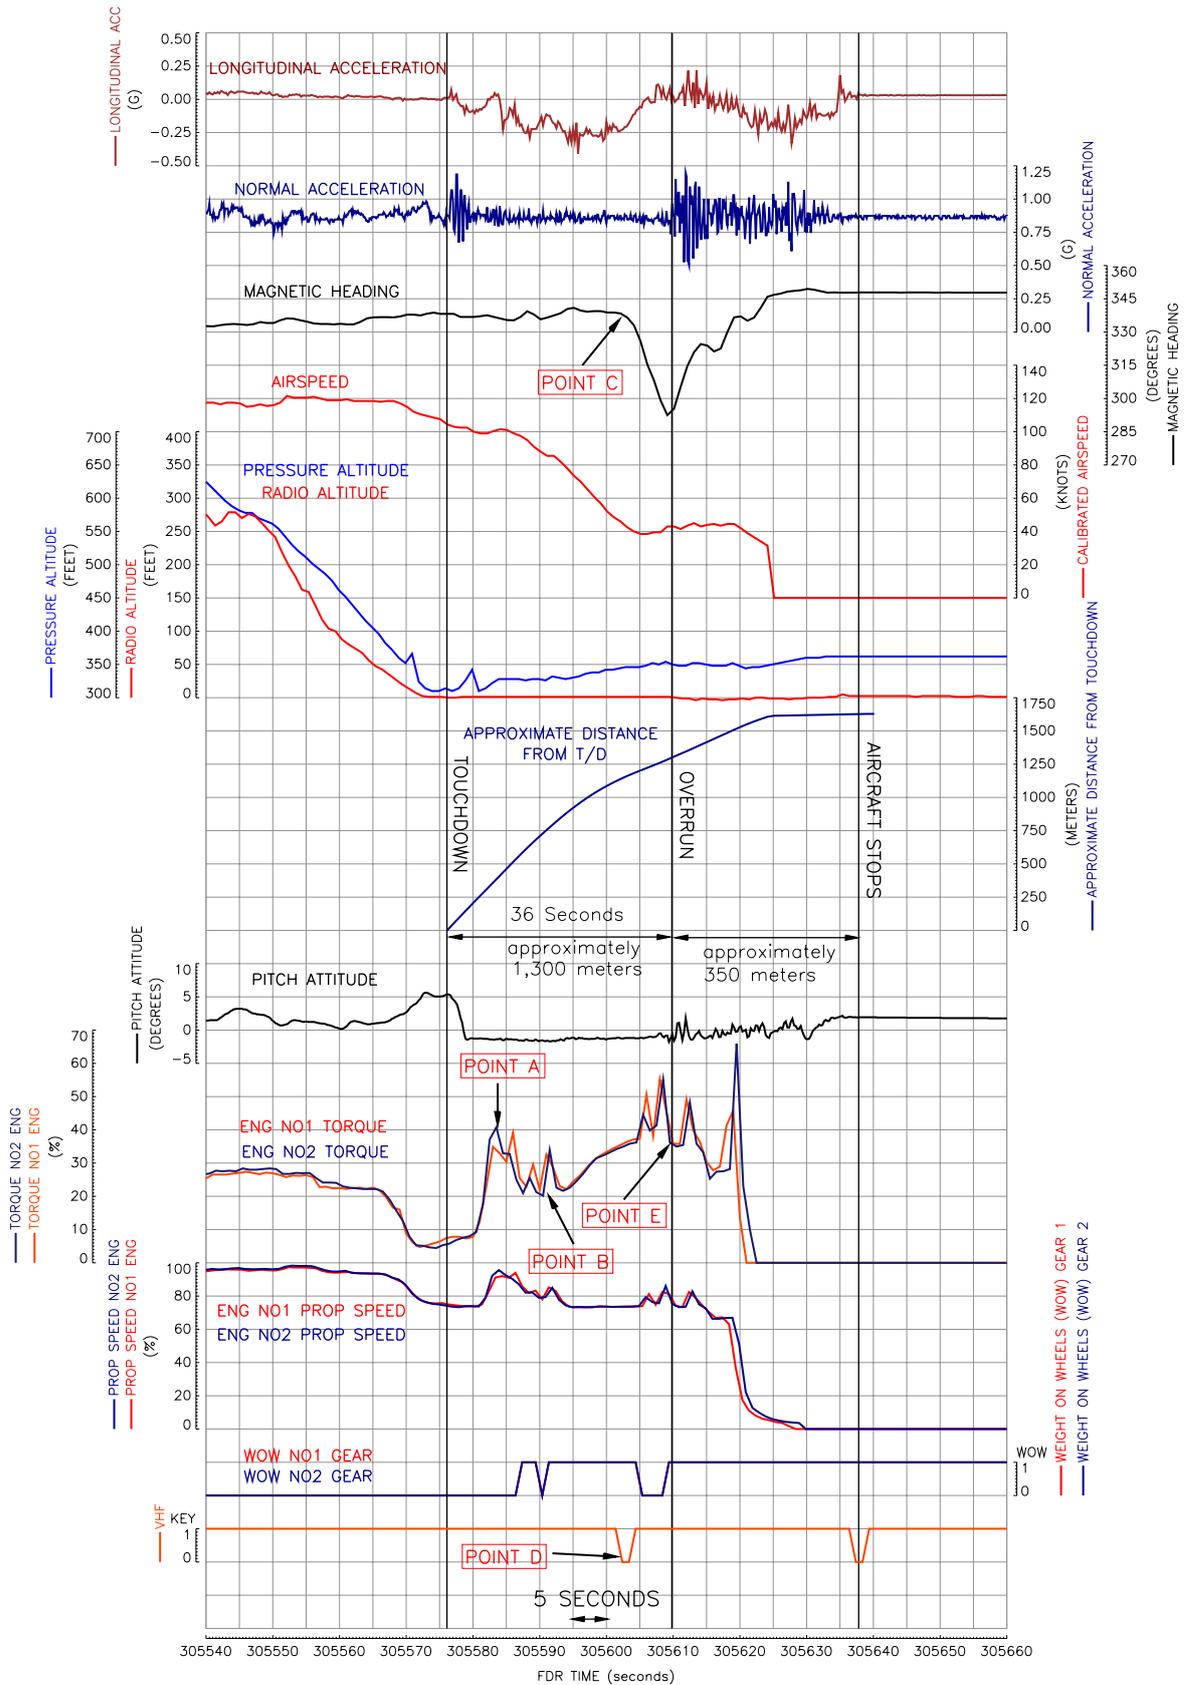
Figure 1 provides the salient parameters of the final approach and landing. As the aircraft passed through 50 ft radio altitude, the power levers were retarded and the aircraft started to flare; airspeed was 119 kt. The aircraft touched down approximately 530 metres from the threshold of Runway 34 (approximately 1,300 metres from the end of the runway), at an airspeed of about 105 kt (a ground speed of 109 kt). Almost immediately the engine torque started to increase (from about 5% to 40%) before rapidly decreasing (Figure 1, point A), at which point the aircraft started to settle on to its wheels and the ground speed started to reduce. The engine torque then rapidly increased and decreased twice in quick succession (Figure 1, point B) and the aircraft momentarily became light on both main gears. During the second engine torque increase the co-pilot said "WE DON'T HAVE BETAS" to which the commander acknowledged "NO"; the aircraft was about 600 metres from the end of the runway and ground speed was about 92 kt.

Salient FDR Parameters

approximately 190 metres from the end of the runway it started to deviate from the runway centre line (Figure 1, point C), turning to the left, almost coincidentally the commander advised the tower “WE GOT A PROBLEM” (Figure 1, point D) ; ground speed was about 40 kt and engine torque was at 37%.

When the aircraft was approximately 150 metres from the end of the runway the engine torque increased and decreased rapidly again (Figure 1, point E), the aircraft became momentarily light on both main gears and started to accelerate slightly. As the aircraft overran the end of the runway ground speed was about 43 kt, and it turned left reaching a heading of 299°. The aircraft then started to turn to the right again and the engine torque increased and decreased twice, in rapid succession, before the commander gave the instruction to shut down the engines; the aircraft was approximately 300 metres beyond the end of the runway at the time. As the engines ran down the aircraft started to decelerate, eventually coming to a stop approximately 350 metres beyond the end of the runway on a heading of 348°. During the landing the ground spoilers had remained stowed.

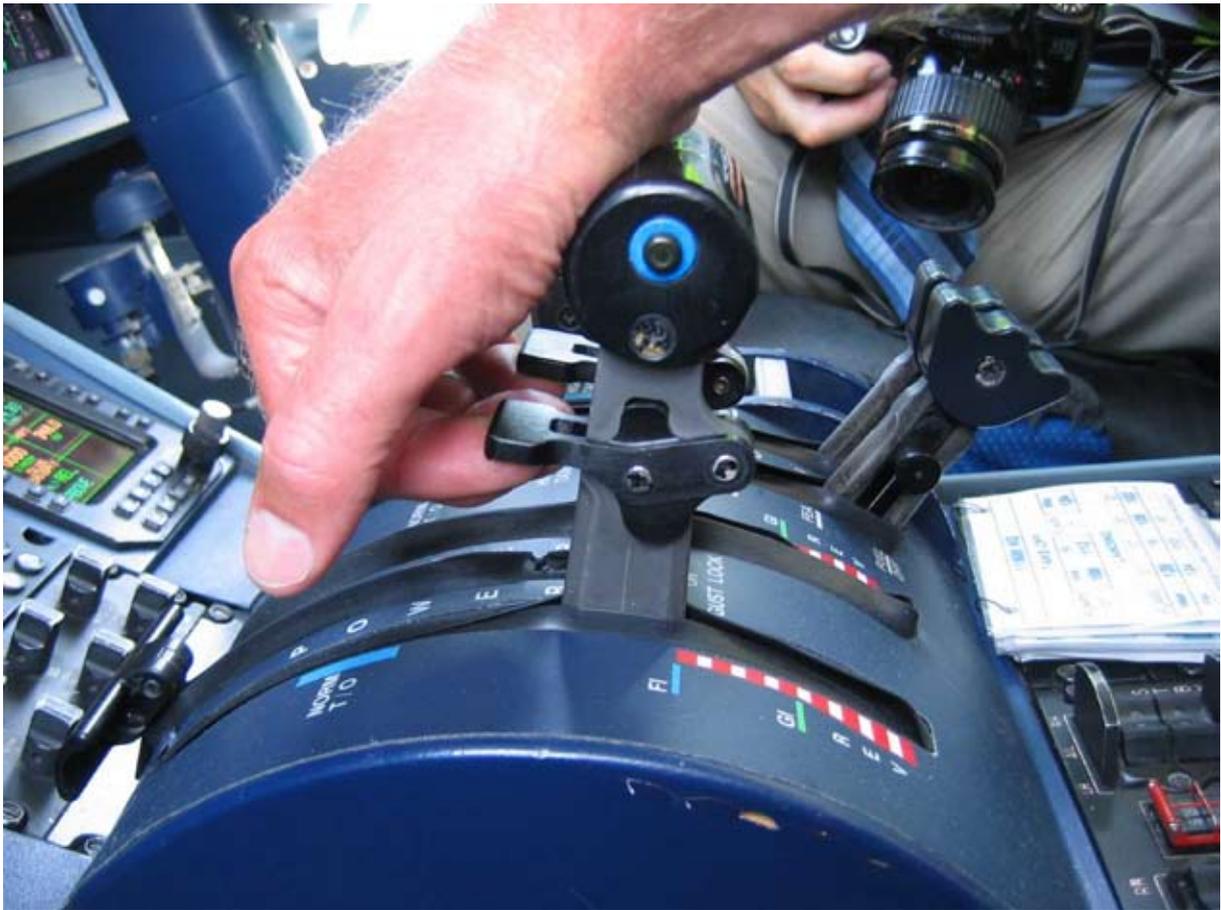
Figure 2

The aircraft’s power levers are fitted with mechanical baulks to prevent inappropriate selections. One baulk prevents selection of settings below flight idle unless certain conditions are met. To select settings below flight idle (after landing or in the event of a rejected takeoff), the pilot must first ensure that the power levers are at the flight idle position, and then pull two latches (one on each power lever) upwards to disengage the locks, before retarding the power levers below flight idle into the beta range. Further rearward movement of the power levers causes selection of increasing amounts of reverse thrust. The latches are operated with the tips of the fingers, whilst the palm of the hand rests on (or grasps) the power lever itself (see Figure 2).

Power levers and latches

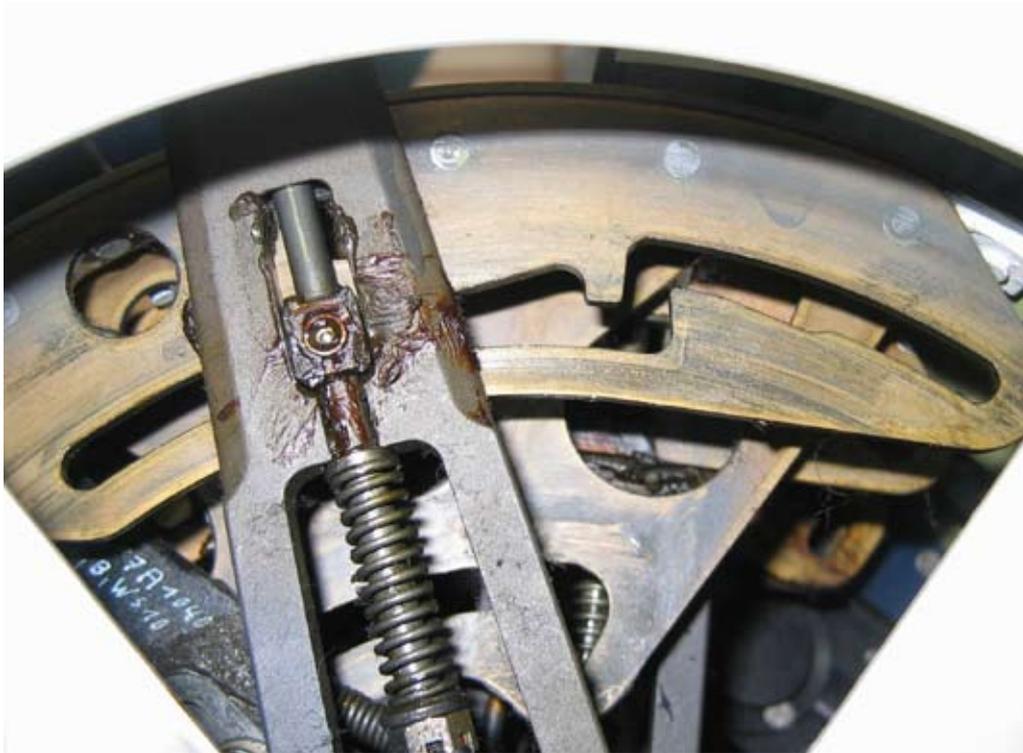
Figure 4

Also be aware, that if the Power Levers are not completely retarded to the Flight Idle stop they may be positioned at Location "X" (see Figures 3 and 4). If this occurs the latches cannot be lifted at all and the Power Levers may jam if rearward pressure is on the latches. If the latches are lifted before Flight Idle, the Power Levers cannot be moved beyond the stop shown in the Power Lever Gate thus preventing the selection of Flight Idle and non-flight regimes.

Internal view of power lever, gate and latch

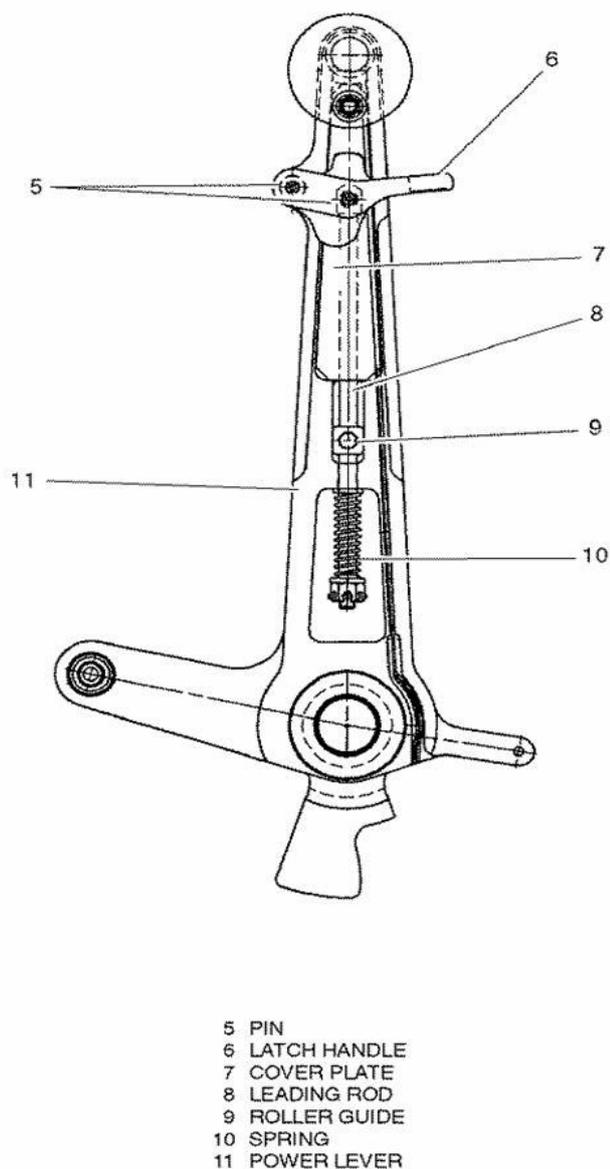
Figure 5

Power lever assembly
