INCIDENT

Aircraft Type and Registration:	Dornier 328 100, TF-CSB	
No & Type of Engines:	2 Pratt and Whitney 119B turboprop engines	
Year of Manufacture:	1997	
Date & Time (UTC):	22 June 2006 at 1952 hrs	
Location:	Aberdeen Airport	
Type of Flight:	Commercial Air Transport (Passenger)	
Persons on Board:	Crew - 3	Passengers - 16
Injuries:	Crew - None	Passengers - None
Nature of Damage:	Minor damage to wheels	
Commander's Licence:	Airline Transport Pilot's Licence	
Commander's Age:	62 years	
Commander's Flying Experience:	13,000 hours (of which 300 were on type) Last 90 days - 111 hours Last 28 days - 64 hours	
Information Source:	AAIB Field Investigation

Synopsis

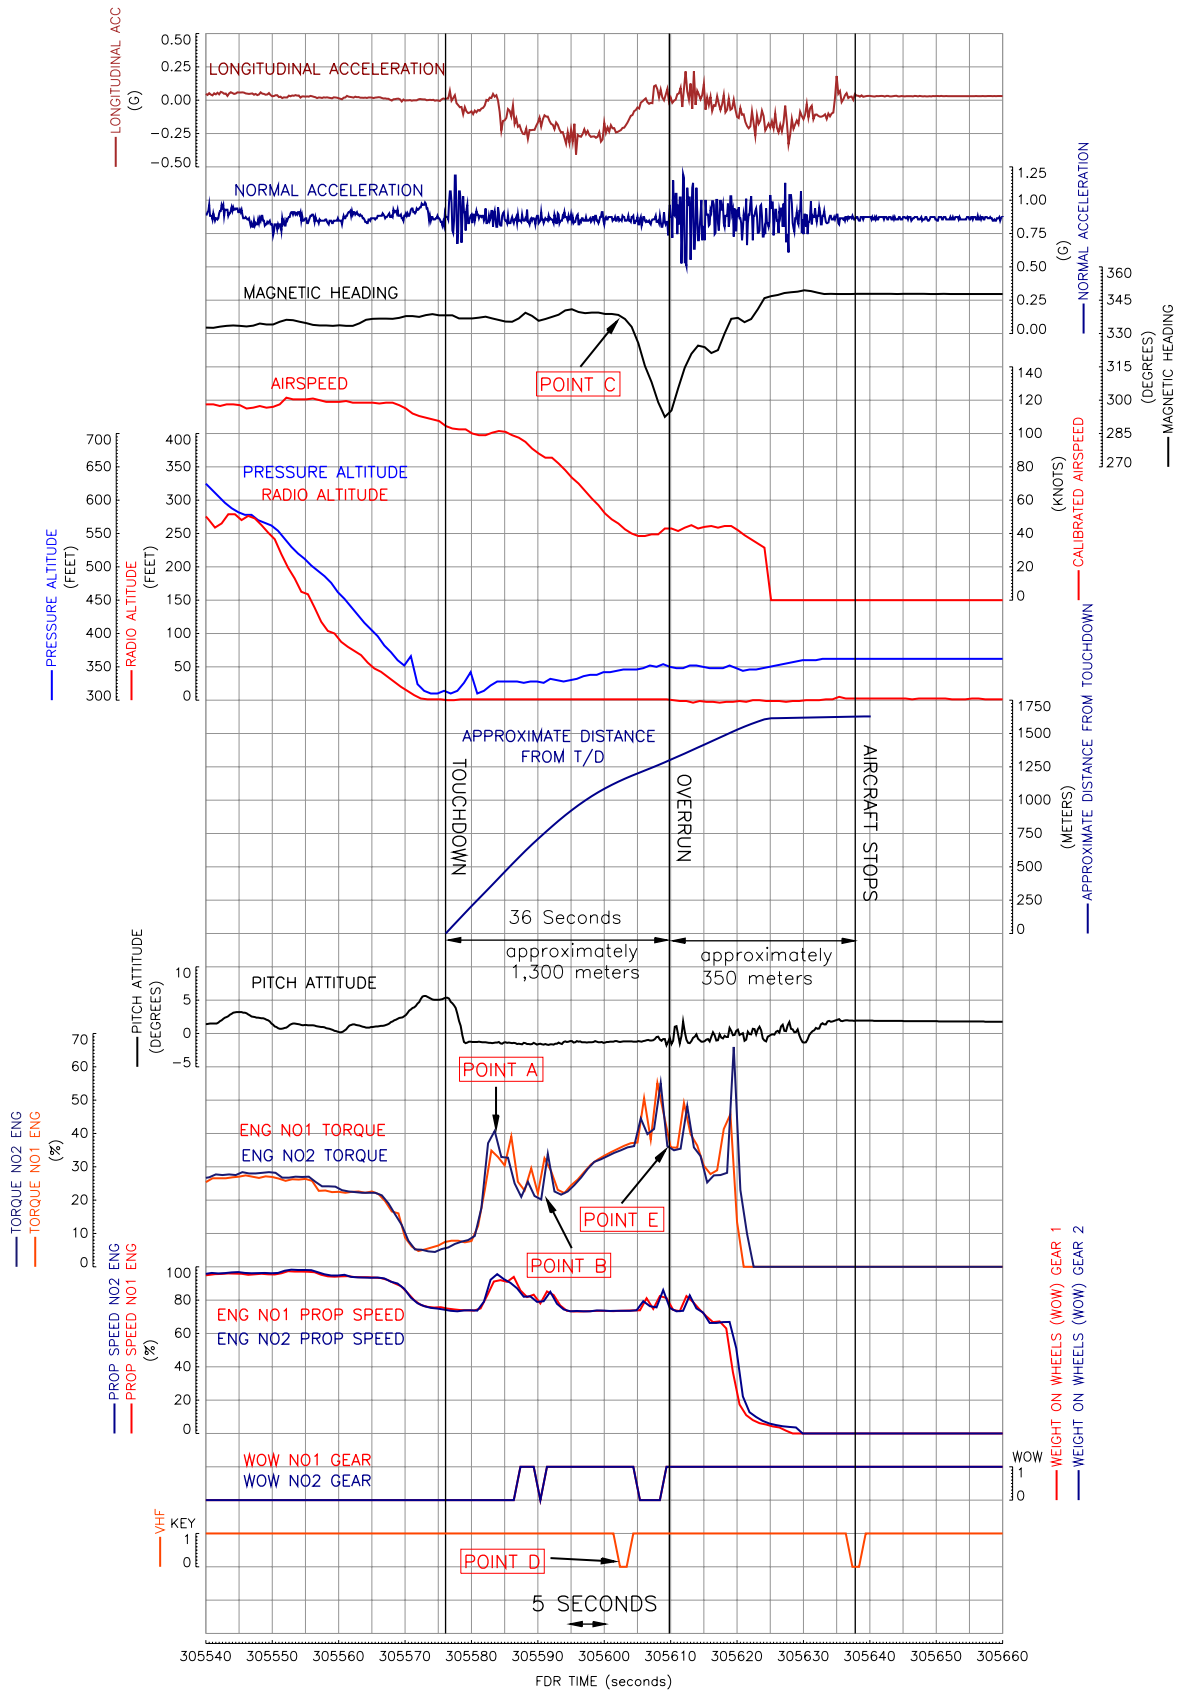
Figure 1 provides the salient parameters of the final approach and landing. As the aircraft passed through 50 ft radio altitude, the power levers were retarded and the aircraft started to flare; airspeed was 119 kt. The aircraft touched down approximately 530 metres from the threshold of Runway 34 (approximately 1,300 metres from the end of the runway), at an airspeed of about 105 kt (a ground speed of 109 kt). Almost immediately the engine torque started to increase (from about 5% to 40%) before rapidly decreasing (Figure 1, point A), at which point the aircraft started to settle on to its wheels and the ground speed started to reduce. The engine torque then rapidly increased and decreased twice in quick succession (Figure 1, point B) and the aircraft momentarily became light on both main gears. During the second engine torque increase the co-pilot said "WE DON'T HAVE BETAS" to which the commander acknowledged "NO"; the aircraft was about 600 metres from the end of the runway and ground speed was about 92 kt.

Salient FDR Parameters

approximately 190 metres from the end of the runway it started to deviate from the runway centre line (Figure 1, point C), turning to the left, almost coincidentally the commander advised the tower “WE GOT A PROBLEM” (Figure 1, point D) ; ground speed was about 40 kt and engine torque was at 37%.

When the aircraft was approximately 150 metres from the end of the runway the engine torque increased and decreased rapidly again (Figure 1, point E), the aircraft became momentarily light on both main gears and started to accelerate slightly. As the aircraft overran the end of the runway ground speed was about 43 kt, and it turned left reaching a heading of 299°. The aircraft then started to turn to the right again and the engine torque increased and decreased twice, in rapid succession, before the commander gave the instruction to shut down the engines; the aircraft was approximately 300 metres beyond the end of the runway at the time. As the engines ran down the aircraft started to decelerate, eventually coming to a stop approximately 350 metres beyond the end of the runway on a heading of 348°. During the landing the ground spoilers had remained stowed.

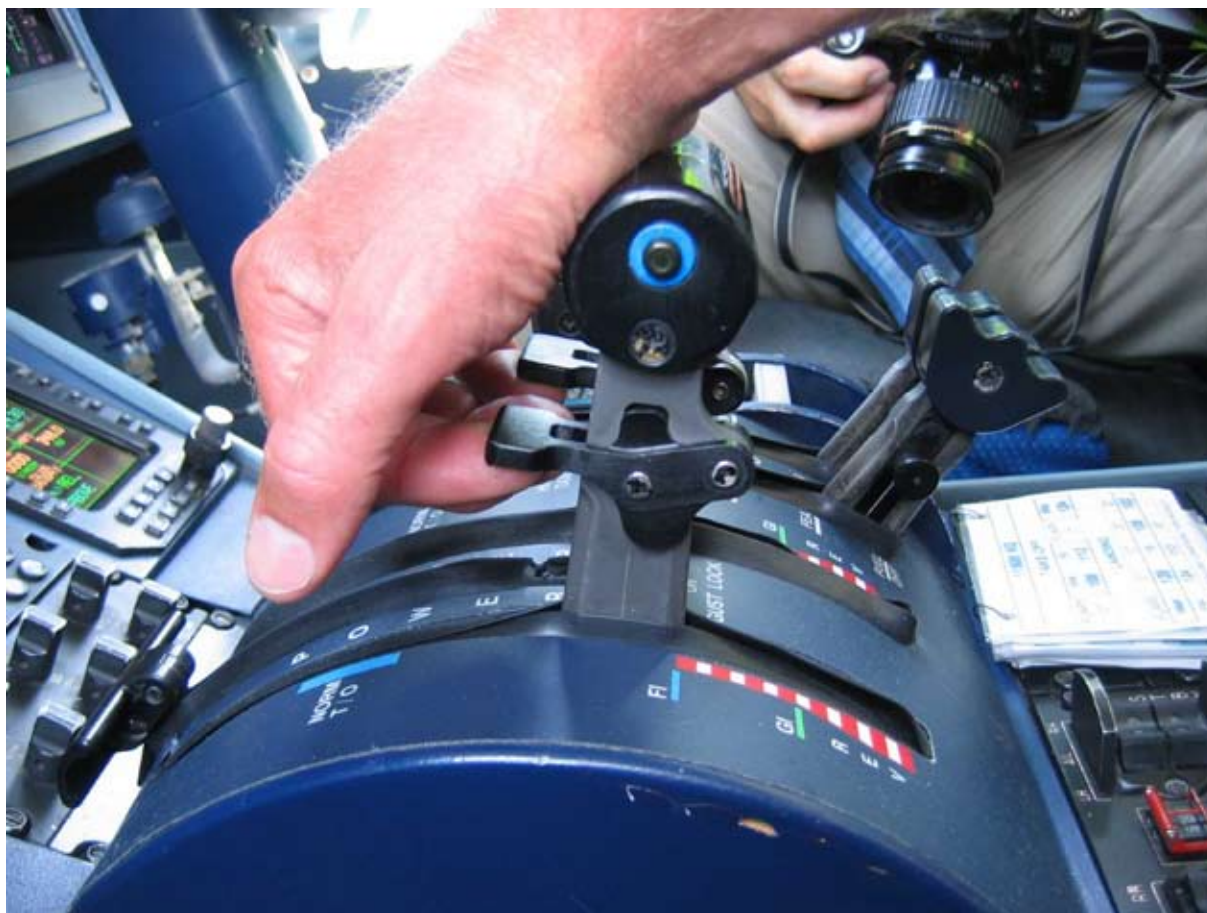
Figure 2

The aircraft’s power levers are fitted with mechanical baulks to prevent inappropriate selections. One baulk prevents selection of settings below flight idle unless certain conditions are met. To select settings below flight idle (after landing or in the event of a rejected takeoff), the pilot must first ensure that the power levers are at the flight idle position, and then pull two latches (one on each power lever) upwards to disengage the locks, before retarding the power levers below flight idle into the beta range. Further rearward movement of the power levers causes selection of increasing amounts of reverse thrust. The latches are operated with the tips of the fingers, whilst the palm of the hand rests on (or grasps) the power lever itself (see Figure 2).

It is vital that the power levers are moved to the flight idle position BEFORE attempting to lift the latches and continue to ground idle. There have been instances of premature lifting of these latches causing the power levers to become jammed. If the power levers are left in flight idle residual torque will exceed 30% and it will be difficult to stop the aircraft without damage. Should this

Power levers and latches

situation arise, the pilot flying should release the latches and push the power levers forward with the flat of his hand. He should then bring the power levers smartly backwards to the flight idle position before attempting to lift the latches and continue to ground idle’.

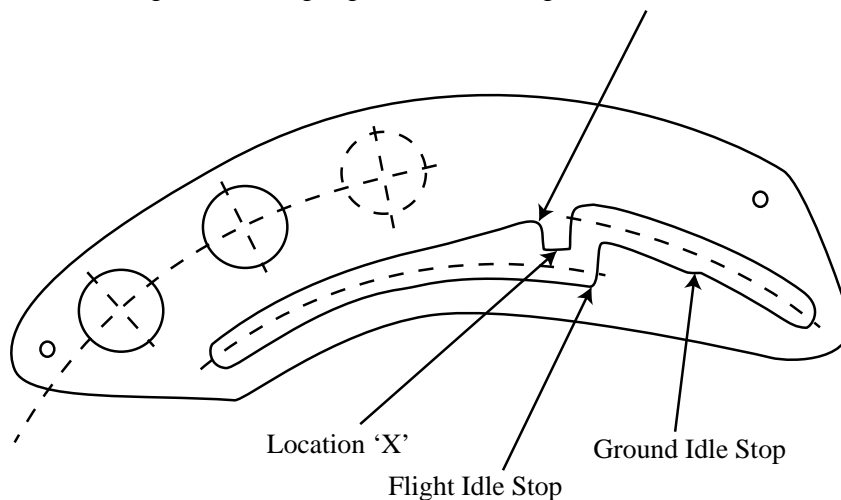
Figure 3
Power Lever Gate

Also be aware, that if the Power Levers are not completely retarded to the Flight Idle stop they may be positioned at Location "X" (see Figures 3 and 4). If this occurs the latches cannot be lifted at all and the Power Levers may jam if rearward pressure is on the latches. If the latches are lifted before Flight Idle, the Power Levers cannot be moved beyond the stop shown in the Power Lever Gate thus preventing the selection of Flight Idle and non-flight regimes.

Stop prevents pilot from inadvertent selection of a position below Flight Idle during flight when retarding Power Lever with latch lifted

- 1. Remove any backpressure on the Power Levers and release the latches completely.*
- 2. Hold the Power Lever only and smartly retard the Lever to Flight Idle.*
- 3. Normal selection to Ground Idle is now possible.*
- 4. If the Power Lever still cannot be moved below the Flight Idle position, the aircraft can be stopped by applying maximum braking while maintaining a wings level attitude.'*

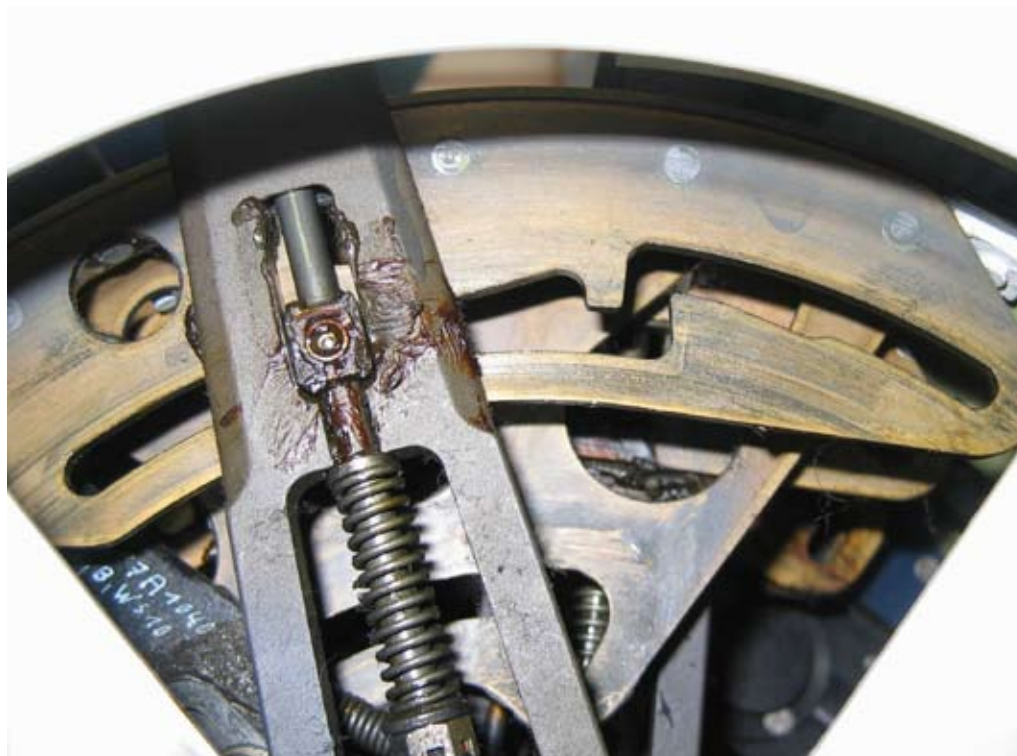
Figure 4

Internal view of power lever, gate and latch

Following the accident in Genoa, two amendments were made to the airplane operating manual, one of which identified that it was possible to move the power levers aft, with the latches lifted, until the latch cams were in 'Location X' (Figure 3). Whilst there is no doubt that this position is achievable, it is also possible that the investigation into that accident did not identify the difficulties found in the course of this investigation, and that the difficulties experienced by pilots centre, not around placing the cams into 'Location X', but around the friction and cable forces. Thus, whilst technically accurate, the second amendment to the airplane flight manual may have been based upon a false assumption of cause. Therefore the following additional Safety Recommendation is made to the Type Certificate holder's National Airworthiness Authority, the Luftfahrt-Bundesamt (LBA), to minimise the likelihood of a further, similar, accident:

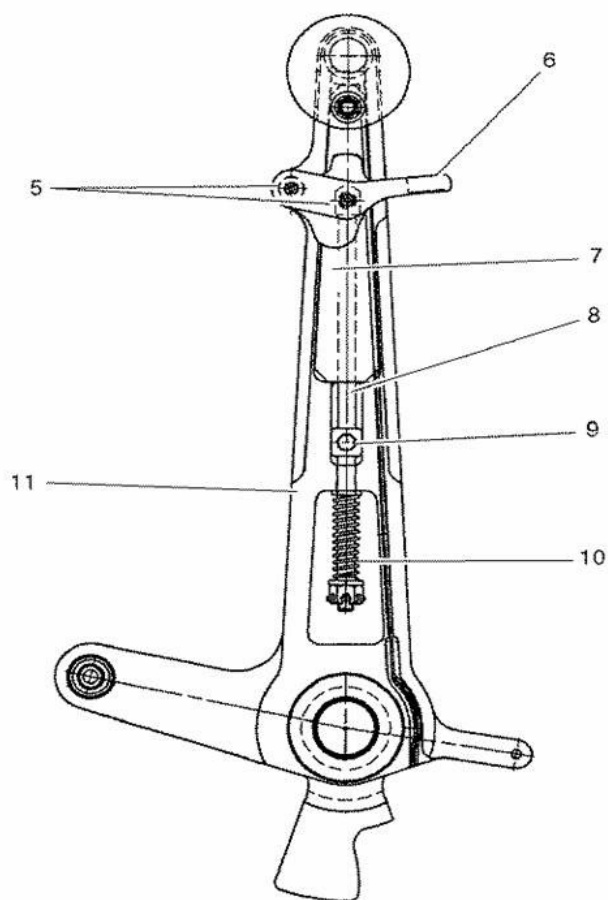
Figure 5

The latch levers are positioned forward of and below

Power lever assembly

the roll handles of the power levers such that they can be grasped by the fingers whilst the palm of the hand rests comfortably on the lever.
