INCIDENT

Aircraft Type and Registration:	Dornier 328 100, TF-CSB	
No & Type of Engines:	2 Pratt and Whitney 119B turboprop engines	
Year of Manufacture:	1997	
Date & Time (UTC):	22 June 2006 at 1952 hrs	
Location:	Aberdeen Airport	
Type of Flight:	Commercial Air Transport (Passenger)	
Persons on Board:	Crew - 3	Passengers - 16
Injuries:	Crew - None	Passengers - None
Nature of Damage:	Minor damage to wheels	
Commander's Licence:	Airline Transport Pilot's Licence	
Commander's Age:	62 years	
Commander's Flying Experience:	13,000 hours (of which 300 were on type) Last 90 days - 111 hours Last 28 days - 64 hours	
Information Source:	AAIB Field Investigation

Synopsis

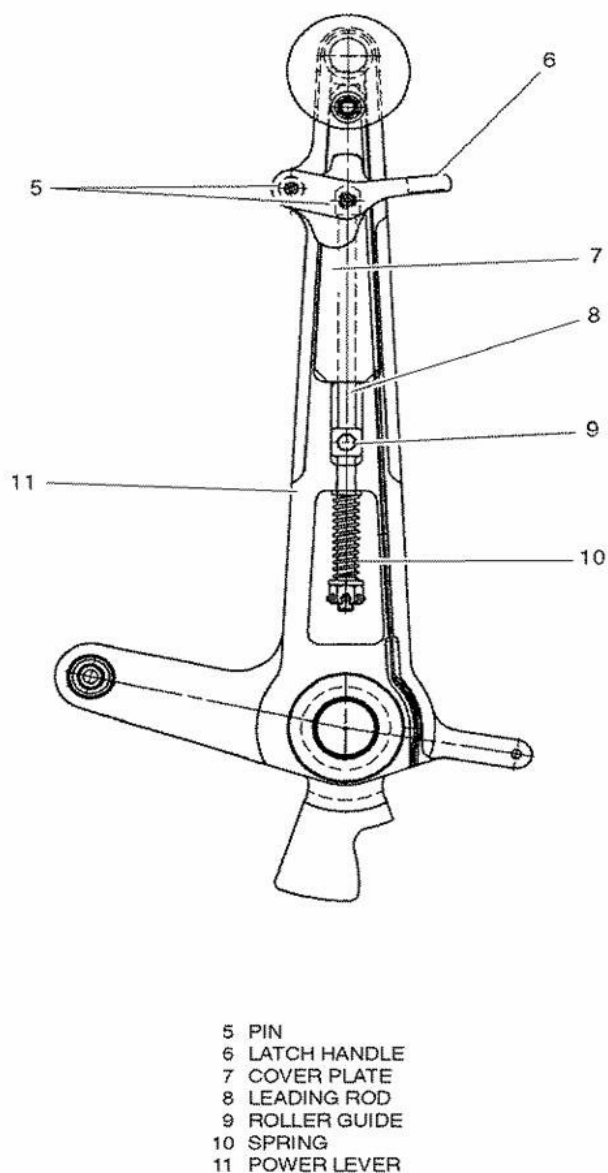
Figure 5

Undesired movement of each power lever from the flight idle position to the ground idle position is prevented by contact between a roller on the lever mechanism and a fixed stop in the console (see Figures 4 and 5). Each roller is mounted on a pin, which in turn is attached to a fitting on a vertical rod mounted within its power lever. Each roller moves aft within a curved track as its power lever is moved backwards, until the flight idle stop is encountered. Raising the latch lever against spring pressure lifts the rod, which raises the roller clear of the flight idle stop. This allows the roller and hence the power lever to move further aft towards the reverse position, the roller travelling in a curved track having greater radius than that of the track within the flight range forward of the flight idle stop position.

The two sections of curved track and the flight idle stop at each power lever location each take the form of a continuous shaped cut-out in one of a pair of titanium alloy plates orientated in a vertical and longitudinal plane. Each roller is manufactured from a bronze alloy and moves within its cut-out forming the curved tracks and the relevant flight idle stop.

Power lever assembly
