## ACCIDENT

<b>Aircraft Type and Registration:</b>	Reims Cessna F172N Skyhawk, G-DENR	
<b>No &amp; type of Engines:</b>	1 Lycoming O-320-H2AD piston engine	
<b>Year of Manufacture:</b>	1979	
<b>Date &amp; Time (UTC):</b>	20 August 2006 at 1140 hrs	
<b>Location:</b>	Lower Widdon Farm, near Ashburton, Devon	
<b>Type of Flight:</b>	Private	
<b>Persons on Board:</b>	Crew - 1	Passengers - 2
<b>Injuries:</b>	Crew - None	Passengers - None
<b>Nature of Damage:</b>	Engine cowling, firewall, wheel struts, left wing tip, wing skins, tailplanes, elevators and cabin interior	
<b>Commander's Licence:</b>	Private Pilot's Licence	
<b>Commander's Age:</b>	45 years	
<b>Commander's Flying Experience:</b>	107 hours (of which 31 were on type) Last 90 days - 12 hours Last 28 days - 0.5 hours	
<b>Information Source:</b>	Aircraft Accident Report Form submitted by the pilot and further enquiries by the AAIB

## Synopsis

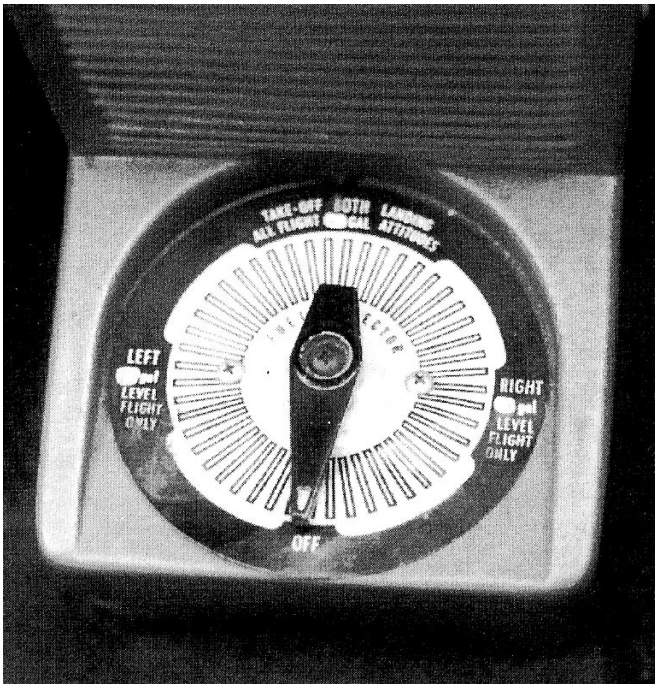
**Figure 1**  
Fuel Selector

the left or right tank or both tanks. To turn the fuel OFF the pointer is turned to face directly aft. There is no safeguard on the OFF position, so care is required when changing the selection. For all normal operations the fuel selector should be placed in the BOTH position. If the tank levels become uneven it is possible to select the higher quantity tank in cruising flight to balance the tank levels.

avoided by under-filling the left tank by two gallons or the left tank can be selected initially after start. Once a small amount of fuel has been used the selector can then be returned to BOTH. The selector should be selected to BOTH for takeoff, climb and landing; this requirement was placarded on the fuel selector in G-DENR as shown in Figure 1 below.

The pilot added that his recollections of his actions before and during the engine failure are imprecise and as such he is not sure what cockpit selections he might have made. He feels that one possibility could be that he misidentified the fuel selector position and turned it from BOTH to OFF. While he does not recall doing this, he accepts it as a possibility.

Given the circumstances, the design of the fuel selector and the pilot's statement, it is conceivable that an inexperienced pilot lacking in currency could make an incorrect selection. As a result, it is possible that the engine failure could be attributed to a selection error,
