ACCIDENT

Aircraft Type and Registration:	P&M Aviation Ltd Flight Design CTSW, G-VINH	
No & Type of Engines:	1 Rotax 912ULS piston engine	
Year of Manufacture:	2006	
Date & Time (UTC):	12 August 2009 at 1550 hrs	
Location:	Caird Park Golf Course, Dundee	
Type of Flight:	Private	
Persons on Board:	Crew - 1	Passengers - None
Injuries:	Crew - 1 (Minor)	Passengers - N/A
Nature of Damage:	Aircraft destroyed	
Commander's Licence:	National Private Pilot's Licence	
Commander's Age:	63 years	
Commander's Flying Experience:	136 hours (of which most were on type) ¹ Last 90 days - 20 hours Last 28 days - 13 hours	
Information Source:	AAIB Field Investigation

The pilot made a forced landing in a tree after the engine stopped near Dundee. The investigation identified flight planning as a contributory factor. One Safety Recommendation is made.

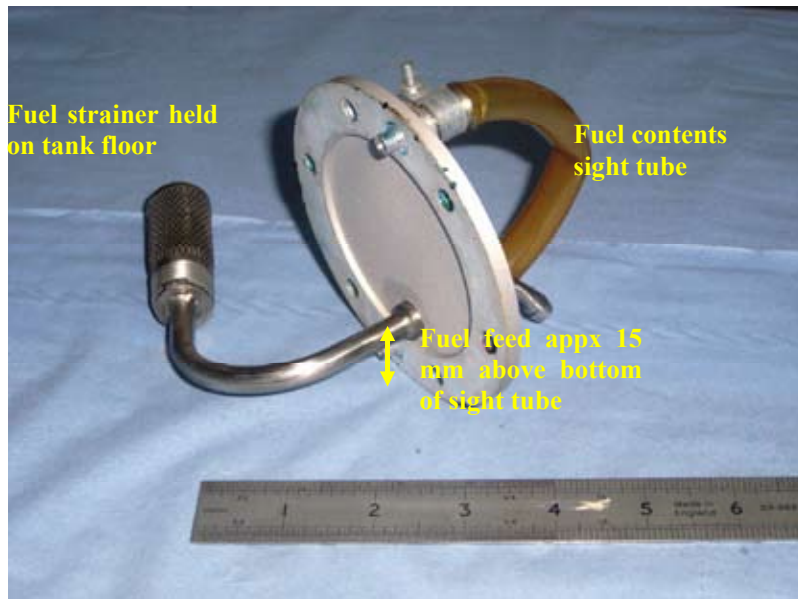
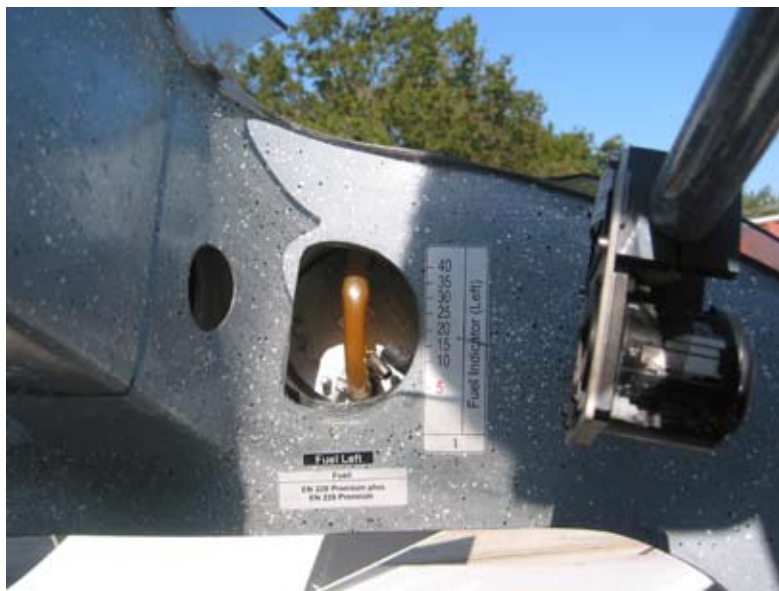
Views of fuel tank off-take, fuel contents sight tube and gauge

almost halfway up the sight tube. The late onset of flow was attributed to the fact that, with reference to Figure 4, the fuel feed tube is positioned approximately 15 mm above the sight tube lower fixture, meaning that the fuel had a small gradient to climb from the inlet strainer assembly in the bottom of the tank. Once a siphon was established, flow could be maintained at lower dihedral angles and continued to the point at which the inlet strainer in the tank became uncovered. At this point slightly more than 0.5 litre remained in the tank.

The pilot reported that, shortly before the engine lost power, he had observed zero fuel indication in the right tank and approximately 5 litres in the left. It is apparent from Figure 4 that the 5 litres represents a low value, and it is noteworthy that it is written in red on the adjacent fuel contents scale. In addition, the location of the sight tube relative to the scale would be prone to parallax error. However, any such error is likely to be insignificant compared with the inherent inaccuracy arising from the tank geometry, the width to length ratio of which could give rise to considerable span-wise movement of fuel in response to lateral accelerations. Thus an accurate reading, or at least one with the least amount of error, would only be achieved with the aircraft in a level attitude and in balanced flight in smooth conditions.

The reported circumstances of the accident indicate that the engine became starved of fuel. The nature of the tank design is not conducive to accurate gauging, with any sustained sideslip or nose-down attitude effectively generating quantities of unusable fuel in excess of the 0.5 litres stated by the aircraft manufacturer. In fact the manufacturer's own tests, conducted with the aircraft on the ground, indicated a significant increase in the unusable fuel quantity when the aircraft attitude changed from the straight and level. The manufacturer additionally noted that it was possible to restart the engine following temporary fuel starvation; however, this might not be a practical procedure for pilots in the course of a normal flight and, moreover, would not comply with BCAR S959, which refers to the **first**

evidence of malfunctioning. The BCAR allows up to 5% of the tank volume to be unusable, which equates to 3.25 litres. This would seem to represent a more realistic figure in actual flying conditions, despite the manufacturer having conducted flight tests in which lower quantities were demonstrated.

It is recommended that Flight Design GmbH, together with P&M Aviation, revise their assessment of the unusable fuel in the CTSW aircraft.

Following this accident, P&M Aviation declared their intention to publish a Service Letter which will explain the effects of aircraft attitude and turbulence on fuel feed at low fuel levels. In addition, it will point out that the minimum quantity that the fuel sight gauge will indicate is 3 litres. Finally, a placard will be required to be fitted to the aircraft advising the pilot that he or she must ensure that at least 1 cm of fuel is visible on both fuel contents sight gauges at all times.
