INCIDENT

| Aircraft Type and Registration: | Jetstream 3202, G-BYRA | |
| Nature of Damage: | Mechanical failure of the right engine propeller reduction gearbox | |
| Information Source: | AAIB Field Investigation | |

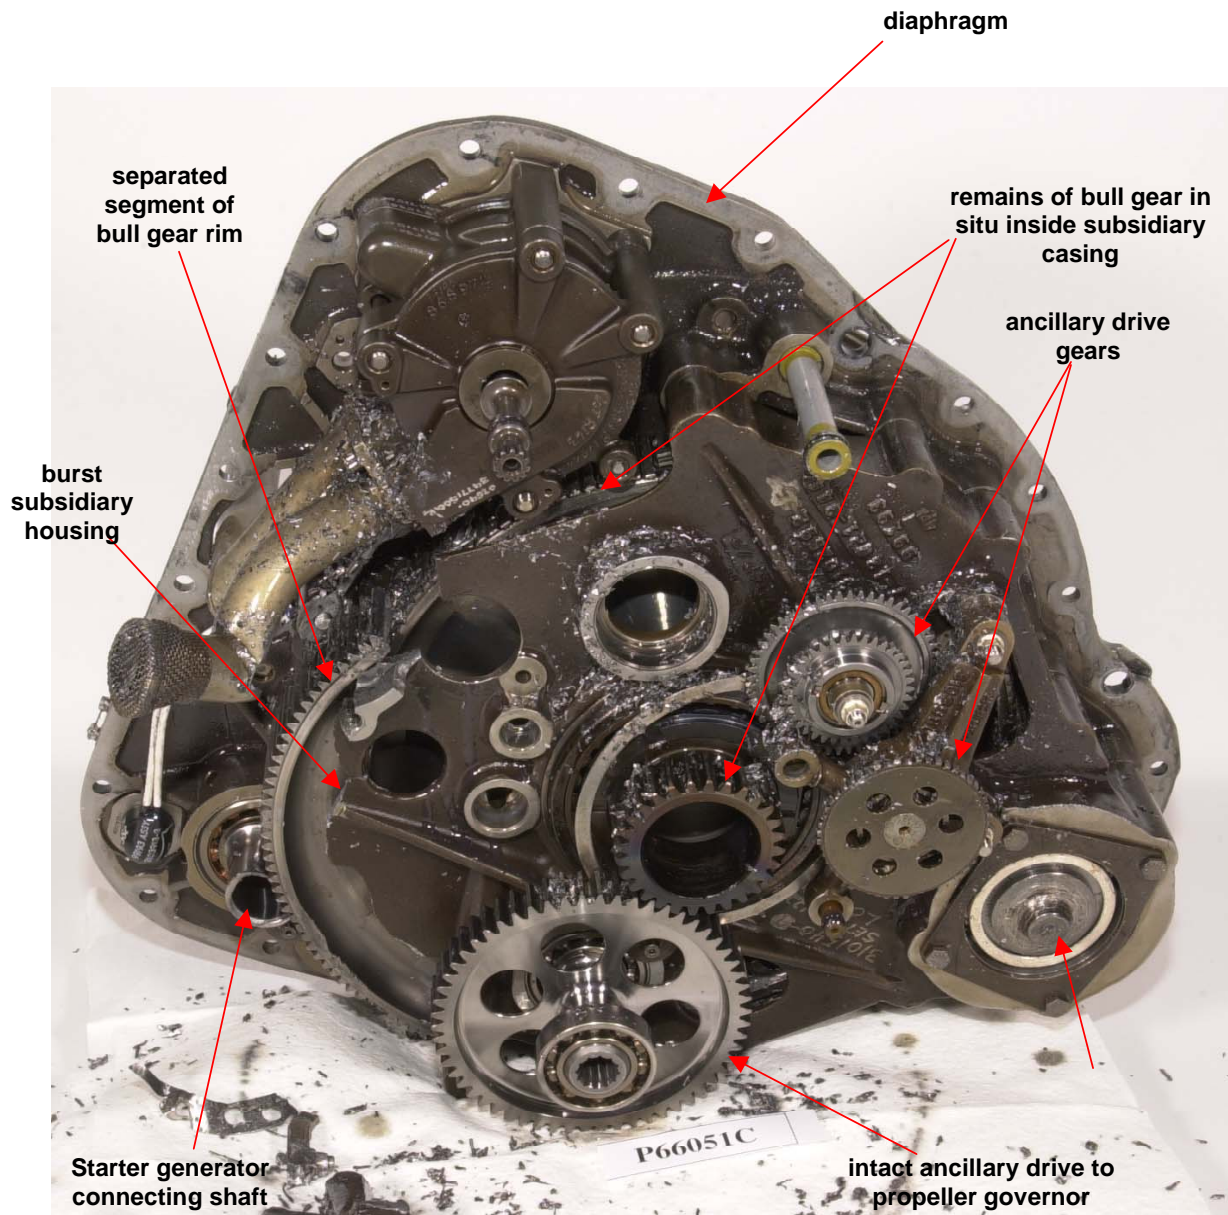
Figure 3:
View onto aft face of diaphragm, with damaged components in situ

When the diaphragm plate was split from the rear section of the gear case, it was evident that a major failure of the first stage gears had occurred, see Figure 3. The debris thus exposed included: broken pieces of gear tooth; crushed remains of various bolts and studs; fragments of the subsidiary housing which enclosed the input gears; and a large quantity of general debris.

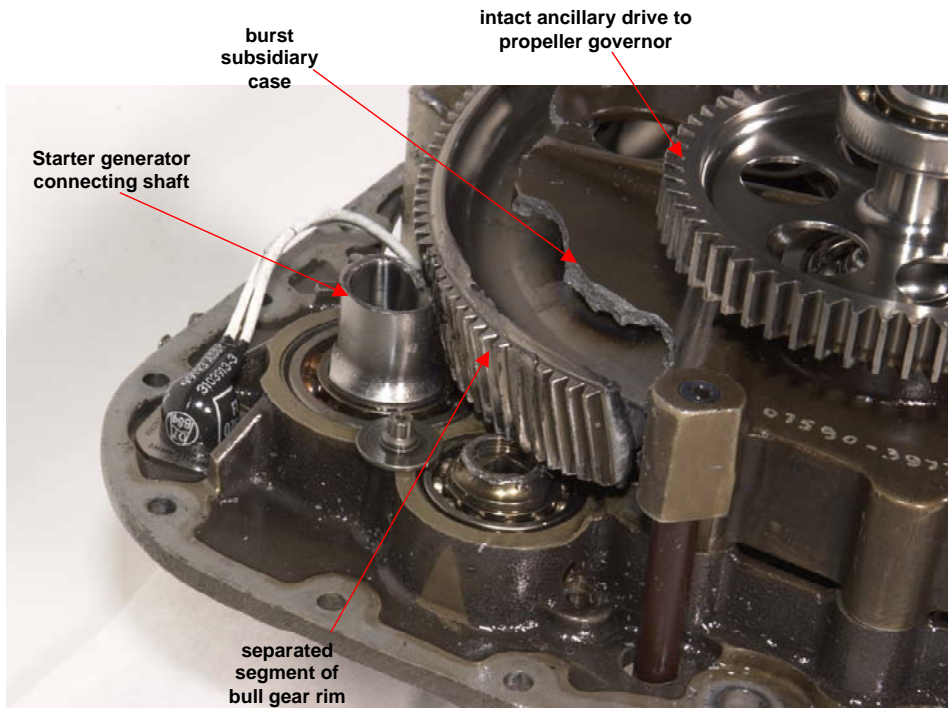
Figure 4:
Detail of separated segment of bull gear

A large segment of the bull gear rim, comprising approximately one third of the gear's circumference, had separated and burst out through the side of the subsidiary housing and had become jammed hard up against the starter generator shaft, fracturing and crushing the hollow shaft, see Figure 4.

Based on a visual assessment alone, it was not possible to determine with confidence whether the separated rim segment, which had burst through the side of the subsidiary housing and become jammed against the starter generator connecting shaft, would have obstructed the remaining part of the bull gear and thus prevented its rotation in the post-failure period.

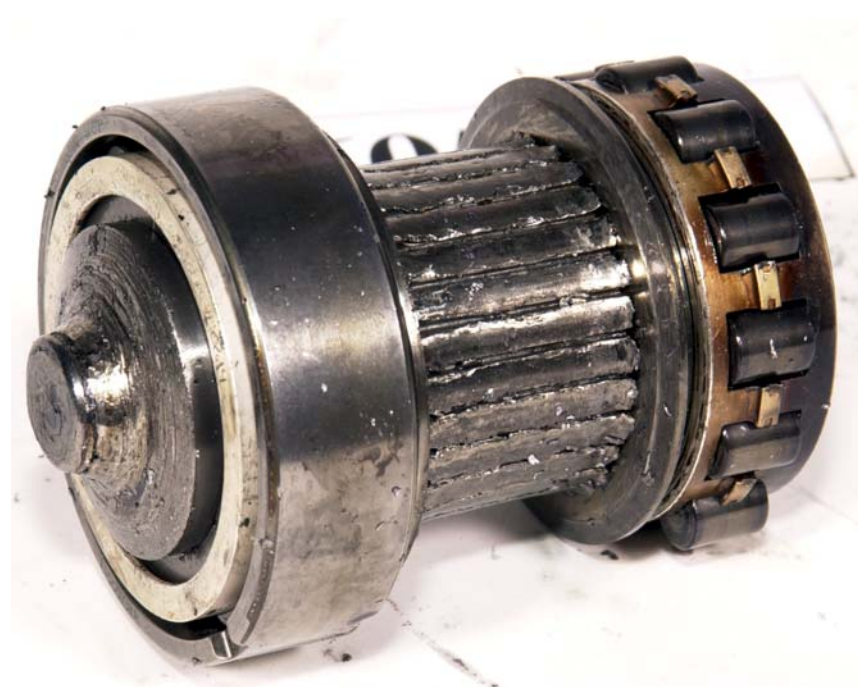
Figure 5
Input (high speed) pinion, showing sheared drive neck

Based on the distribution of secondary damage within the gearbox, it is very unlikely that the engine would have been capable of driving the fractured bull gear. The stripped condition of the high-speed pinion is consistent with its forced re-engagement with the disrupted rim of the bull gear in the instant following separation of the detached section of the rim. This process is likely to have been virtually instantaneous – due to the rapid acceleration of the gas generator shaft in the interval between the shaft becoming unloaded, as the pinion disengaged momentarily from the fractured bull gear, before attempting to re-engage again as it came into contact with the far side of the missing section of rim. Indeed, the distribution of tooth damage on the bull gear indicates that all of the pinion's teeth were effectively wiped off within about half a revolution of the bull gear, and there is little doubt that the pinion coupling sheared at some point during this sequence. From that stage onwards the engine would have been disconnected from the gearbox input and, assuming that the fuel delivery side of the system was still operable, it would have accelerated rapidly until constrained by the overspeed governor. Continued operation of the engine, however, would not have been possible because of collateral damage from the gear failure, which disrupted the drive to the fuel control unit thus rendering the gas producer inoperative. In summary, therefore, it is evident that any post-fracture rotation of the bull gear, and the attendant vibration, must have been the result of it being back-driven by the propeller.

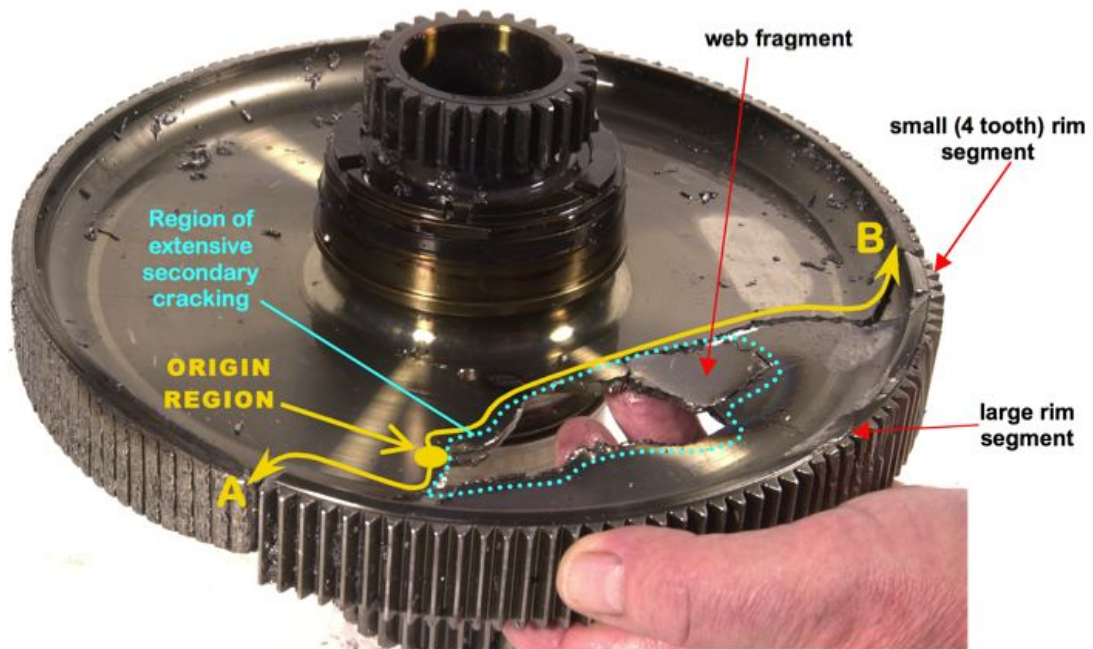
Figure 6
Fractured bull gear, showing principal fracture paths

Close inspection of the fractured pieces of bull gear revealed clear indications of fatigue consistent with propagation from an origin region in the web at approximately 60% radius. Figure 6 shows the fractured bull gear, with the principal separated fragments held in position to illustrate the fracture paths and position of the origin region, from which two primary crack fronts propagated, labelled 'A' and 'B' respectively.

The shorter of the two primary cracks ('A' in Figure 6) propagated radially outwards for a short distance until it met the thicker section of the rim, where it turned and ran circumferentially for a short distance before reverting back to a radial direction and intercepting the free edge of the wheel at the root of a tooth. The much larger primary crack ('B') propagated radially inwards initially, in opposition to crack 'A', then turned briefly in a circumferential direction (also away from crack 'A') before turning back inward again to follow an oblique path towards the centre of the wheel. As it approached the blend radius marking the transition from the web into the hub, the crack was

deflected again and thereafter it followed an oblique path back outwards towards the rim of the wheel, where it intercepted the free edge at the root of a tooth. During the course of its progress, numerous secondary cracks branched off crack 'B' to form a network of fractures in the adjoining web. The consequence of this multiplicity of cracks was the separation and detachment of:

1. The large rim segment comprising approximately $\frac{1}{3}$ of the wheel circumference, with vestigial web attached.
2. The small rim segment comprising four teeth.
3. Numerous fragments of the inner web from within the region of secondary cracking, identified in Figure 6, of which four pieces in total were eventually recovered and positively identified. (Figure 6 shows only the largest of the recovered pieces.)

The fractured bull gear was subjected to detailed metallurgical examination at the manufacturer's materials laboratory. This confirmed the provisional assessment of crack propagation made during the teardown, and established that the fracture origins were on the aft face of the web approximately 3.7 inches from the rotational axis.

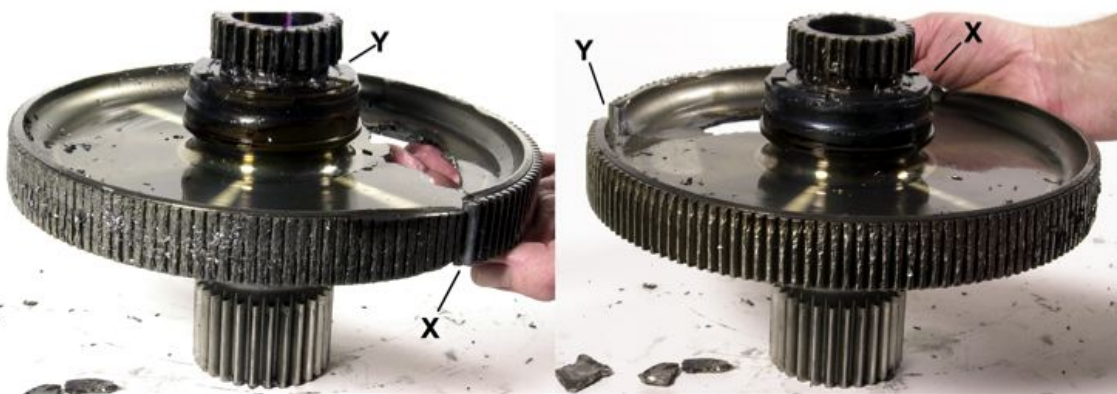
Figure 7
Pattern of post-fracture tooth damage

The condition of the teeth on the main section of the fractured bull gear varied progressively from completely stripped at 'X' in Figure 7 (adjacent to the large segment) through to a substantially undamaged state at 'Y' (adjacent to the small separated rim segment). This pattern of damage, together with the completely stripped condition of the high-speed pinion, was consistent with the main segment of the fractured bull gear attempting to re-mesh with the high-speed pinion following separation of the rim segments.

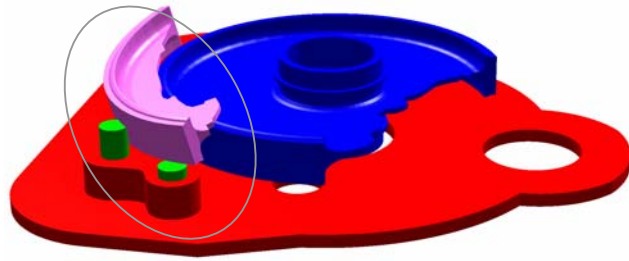
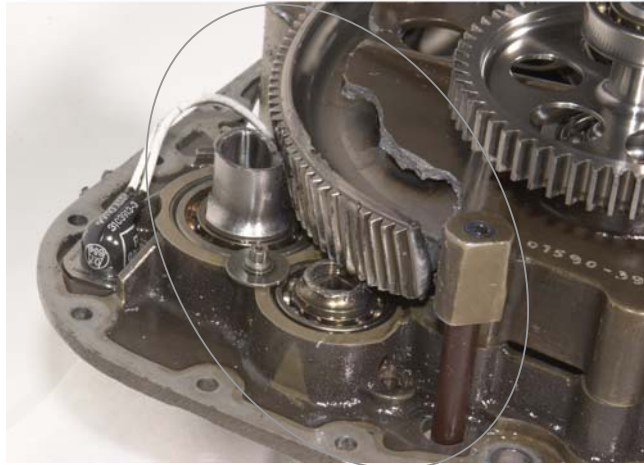
Figure 8:
**CAD model showing relative positions of
separated rim segment and remains of bull gear**

In order to resolve this issue a simple 3-D CAD model was constructed of the detached rim segment, together with the remains of the fractured gear and relevant parts of the adjacent gearbox casing. After setting up the model to match the observed position of the jammed rim segment, (see Figure 8), it was evident that the combination of its radial position, and tilted orientation relative to the surviving part of the gear, was such that it would not have interfered. Consequently, it would have been possible for post failure rotation of the bull gear to have taken place, and thus for it to have been the source of the severe vibration, provided the drive line from the engine, or alternatively from the propeller shaft, had remained intact following gear fracture.
