No: 9/88

Ref: EW/C1074

Aircraft Type and Registration: Aeronca A-65-TAC Champ, G-BIHW

Location: To the side of Runway 21 at Shoreham Airport

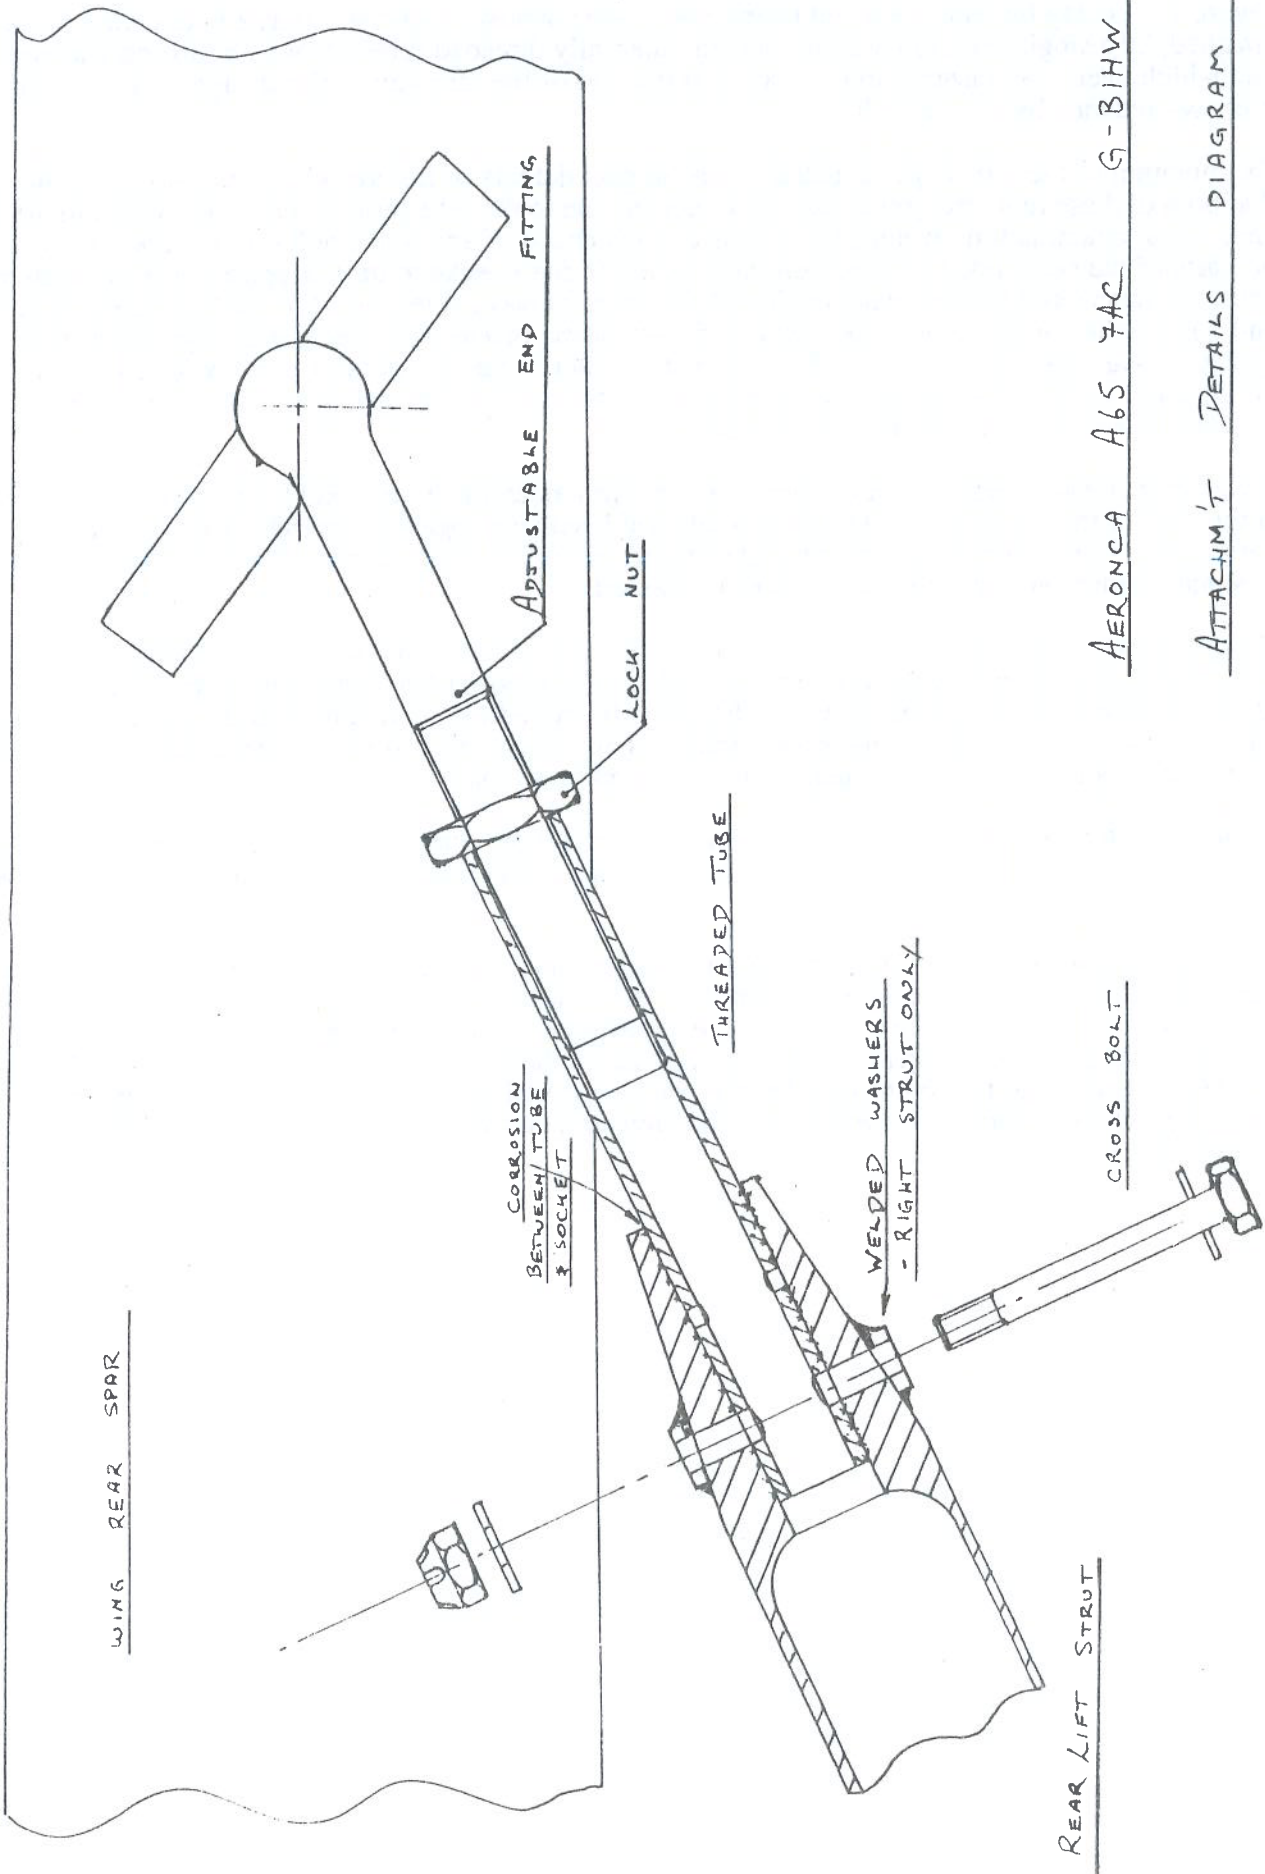
FIGURE 1

Figure 1. As may be seen, each end fitting was made from two parts: an externally threaded rod which attached, by a single bolt, to the spar; and an internally threaded tube into which this rod was screwed and which itself was inserted into a socket at the end of the rear strut. The design was such that this tube was retained by a cross-bolt.

Examination of the wreckage revealed no pre-impact defects or failures within the aircraft, other than that both of these rear strut joints had disconnected due to the tube pulling out of the socket in the strut end. Close examination revealed no evidence of distortion of any of the holes in the tubes or struts and no parts of the cross bolts or their nuts were found in the wreckage trail, despite a specific search. In addition, fresh paint (which matched that of the aircraft) was evident in all of the bolt holes. Figures 2 and 3 show the condition of these joints, with corrosion present over the mating surfaces of both. The corrosion was more severe on the left wing joint. A later inspection of these areas revealed that the joint on the right wing had progressively pulled apart, whilst that on the left wing had initially been forced further into engagement, before pulling apart.

It was thus apparent that neither of these two rear strut attachment bolts had been present in their joints at the time of the accident, and that both joints had been held together through friction, induced by the corrosion. A test carried out, on the substantially intact left wing, demonstrated the expected lack of torsional rigidity with the rear strut joint disconnected.
