No: 4/89

Ref: EW/G88/11/07

Aircraft Type and Registration: Piper PA20, G-BHMO

Location: Ludham Airfield, Norfolk

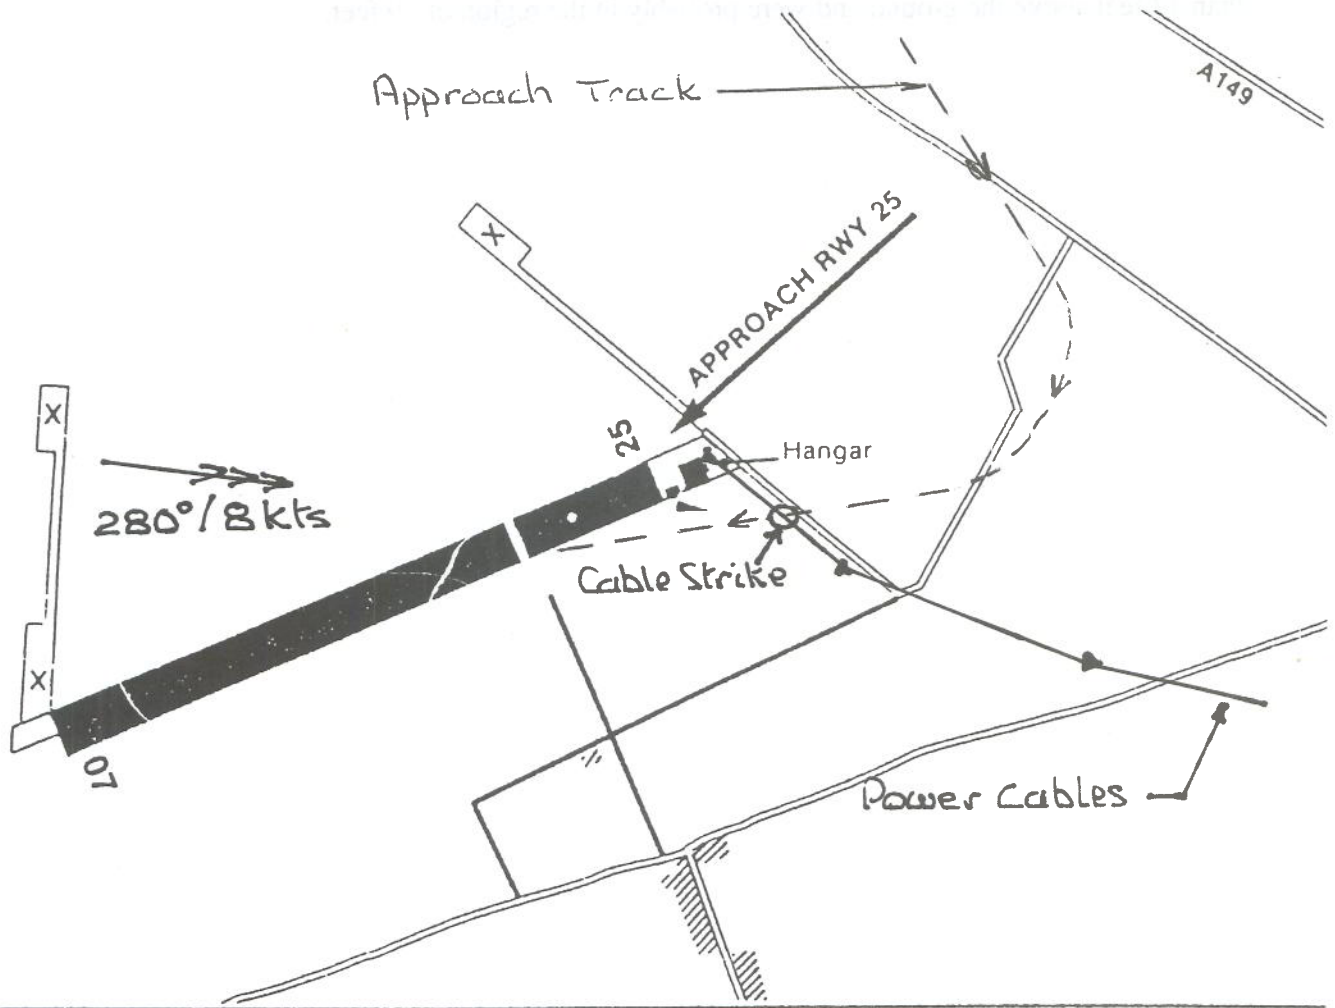
LUDHAM AIRFIELD (based on Pooley's Flight Guide 1988)

After about 10 minutes flying in the local area, G-BHMO returned to the circuit at Ludham. The runway in use was 25 with a wind of 280°/8 kts and a cloudbase of 2000 feet. The pilot reports that it was dusk. Runway 25 has a hangar and club house on its threshold (see diagram) and the preferred approach is from the north east. Because of the prevailing wind however, the pilot elected to approach from a more easterly direction on the advice of the pilot in the lefthand seat. This approach track takes the aircraft over electricity supply cables which terminate close to the hangar.

that the electricity supply cables situated approximately 100m from the intended touchdown point had been severed. The Eastern Electricity Board state that at the point of impact these cables were not less than 17 feet above the ground and were probably in the region of 19 feet.
