ACCIDENT

Aircraft Type and Registration:	ARV Super 2 (ARV1), G-TARV	
No & Type of Engines:	1 Hewland AE75D piston engine	
Category:	1.3	
Year of Manufacture:	2001 (rebuilt)	
Date & Time (UTC):	30 April 2005 at 1135 hrs	
Location:	Naish Farm, Clapton in Gordano, Bristol	
Type of Flight:	Private	
Persons on Board:	Crew - 1	Passengers - None
Injuries:	Crew - 1 (Fatal)	Passengers - N/A
Nature of Damage:	Aircraft destroyed	
Commander's Licence:	Private Pilot's Licence	
Commander's Age:	71 years	
Commander's Flying Experience:	624 hours (of which approximately 33 were on type) Last 90 days - 3 hours Last 28 days - 1 hour	
Information Source:	AAIB Field Investigation

Synopsis

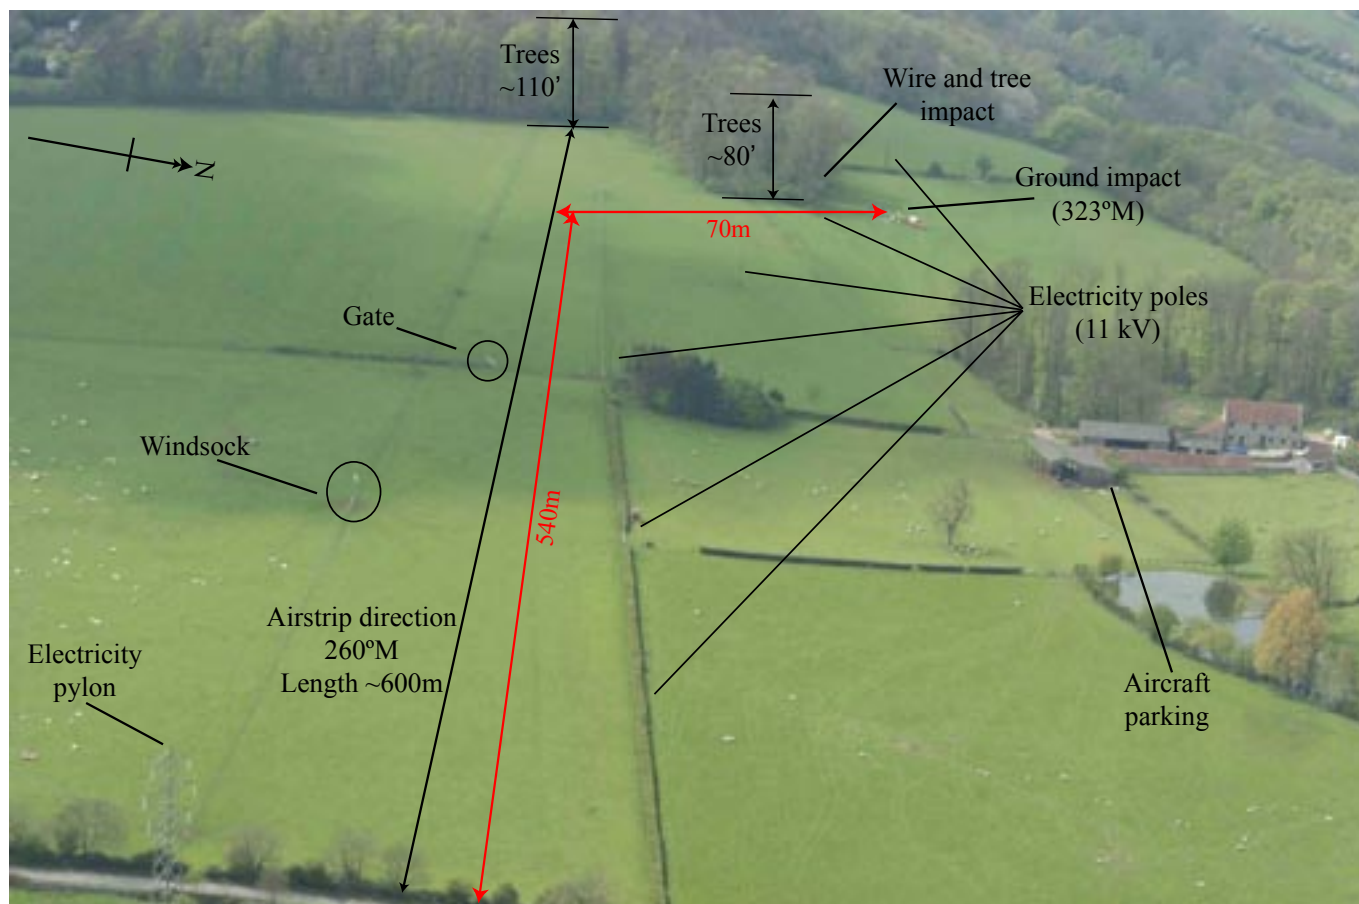
On the morning of the accident, he had decided to fly to Dunkeswell Aerodrome, near Taunton, and then return to his airstrip. Figure 1 shows the airstrip in the take-off direction. The pilot moved sheep from the airstrip, put up his windsock and positioned his aircraft at the eastern end. At about 1130 hrs, an eye witness heard an increase in engine noise and looked towards the airstrip. The eye witness watched the aircraft travel along the airstrip. She had previously watched the aircraft takeoff and had the impression that it was not going as fast as normal. It also appeared to lift-off later than normal and the witness saw the aircraft airborne and banked to the right before losing sight of it. Shortly after, there was a loud bang and the witness started to run towards the site of the crash. On the way, she alerted a neighbour, who telephoned for an ambulance. At the accident, the aircraft was inverted with the pilot still strapped in but motionless. The witness checked the pilot but could not detect any pulse.

The airstrip is orientated 260°/080° and is approximately 600 m long. It is at an altitude of approximately 400 ft amsl and has a level grass surface, which was firm and dry at the time of the accident. The area is normally used for sheep grazing and the grass varied in length from no greater than two inches long in some areas up to four inches long in other areas. To the east, a road with a hedge bounded the end of the airstrip and there were power lines, on pylons, crossing north to south just beyond the airstrip boundary. Further 11 kV power lines, on wooden poles some 27 ft high, were located parallel to the northern edge of the airstrip and these diverged towards the northwest from a point approximately 420 m along the airstrip. At the western edge of the airstrip, there was a line of trees orientated north/ south; these were approximately 110 ft high. Entries in the pilot's log book indicated that G-TARV was the only aircraft that he had operated from the airstrip. He had first flown the aircraft into the airstrip in October 2001. His next recorded flight from the airstrip was in July 2003 and he had subsequently flown out of the airstrip on 15 occasions prior to the accident. There was no evidence that any other aircraft had operated from there. Witnesses commented that the pilot would only takeoff in a westerly direction. Figure 1 shows the layout of the strip in the direction of takeoff on the accident flight.

Airstrip at Naish Farm, 30 April 2005
