R22 engine exhaust valves - history of sticking

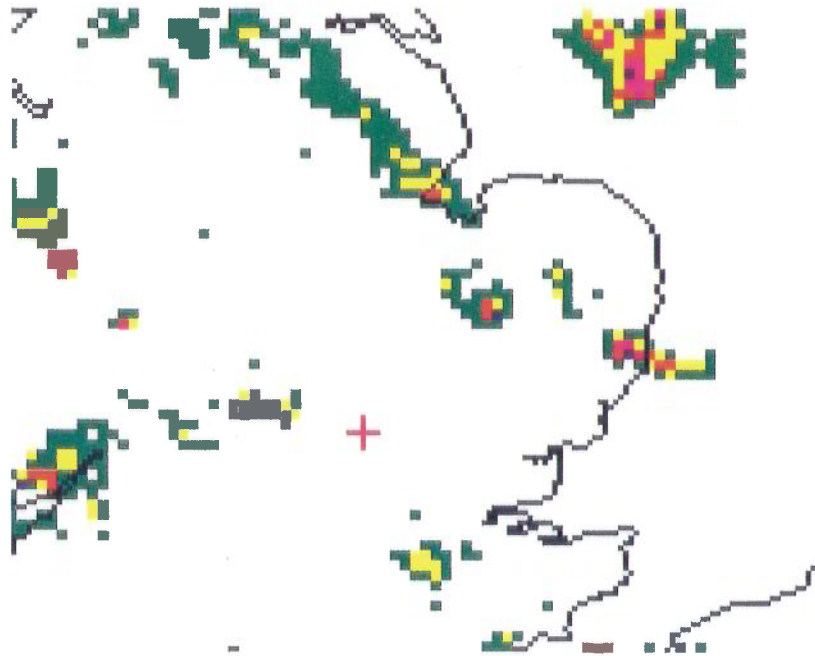
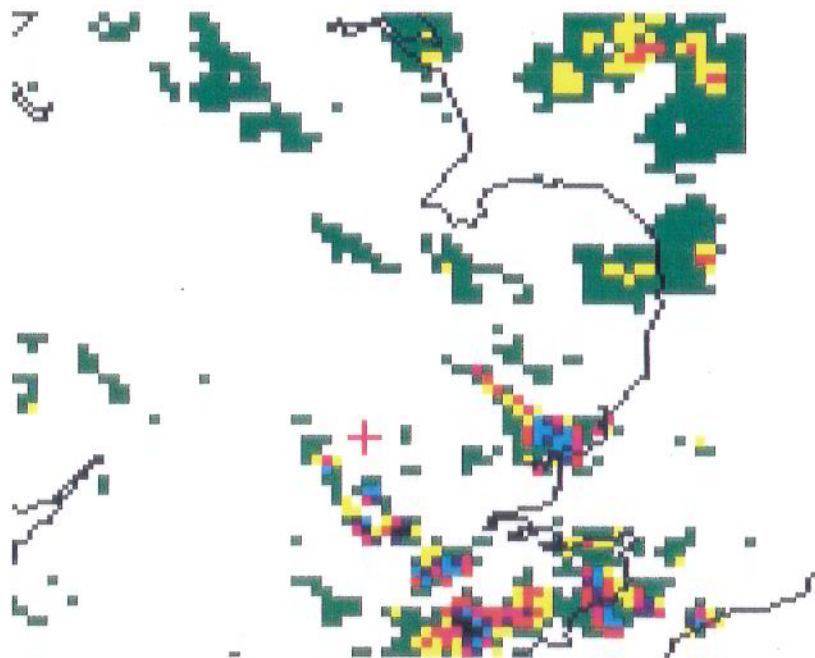
FIGURE 1

Remarks: It would appear from the radar echoes that at the time of the accident there was no rain but there had been some heavy rain/shower or thunderstorm earlier on leaving very moist conditions with poor visibility and low cloud probably covering the highest parts. Further outbreaks of rain, heavy at times with thunder, developed and moved across the area soon after the accident.'

The significant change in weather conditions that occurred in the period from one hour before to one hour after the accident is shown on the radar composite illustrations in Figure 1.

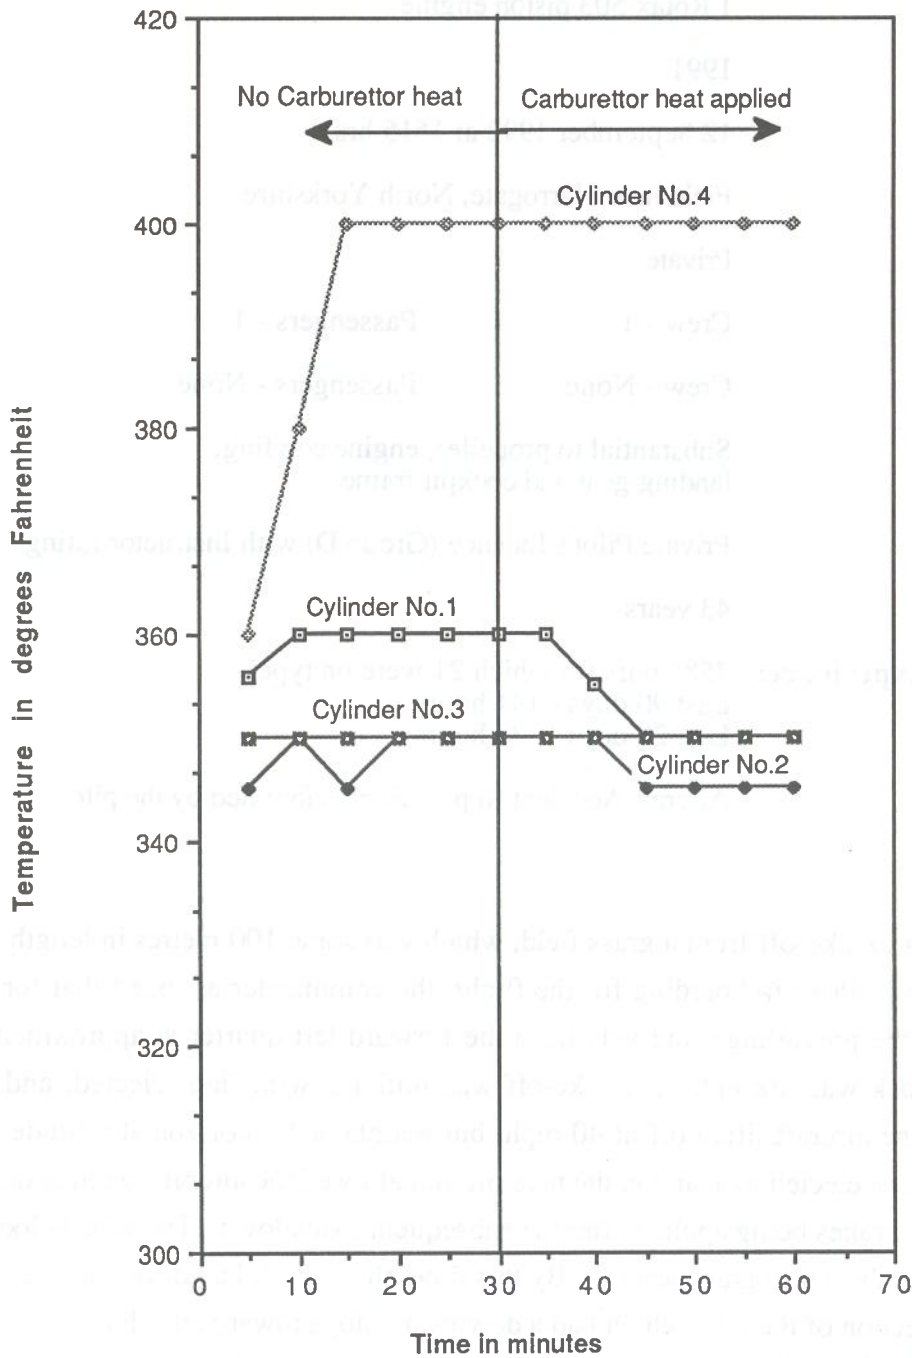
FIGURE No.2 CYLINDER HEAD TEMPERATURES MEASURED DURING CRUISE FLIGHT
IAS 80 knots, manifold pressure 22", OAT 21 C

The technical director of one UK operator had instrumented a R22 Beta engine so that all four cylinder head temperatures could be monitored. A one hour flight was then conducted for 30 minutes with no carburettor heat applied and for 30 minutes with full carburettor heat applied. The cylinder head temperatures noted during the flight were plotted graphically and are shown at Figure 2. It was noted that the application of carburettor heat does not appear to affect cylinder head temperature and that No 4 cylinder head temperature is about 14% higher than the other three cylinder head temperatures.
