Air Accidents Investigation Branch

**Report on the accident to
Grob 115E Tutor, G-BYUT
and
Grob 115E Tutor, G-BYVN
near Porthcawl, South Wales
on 11 February 2009**

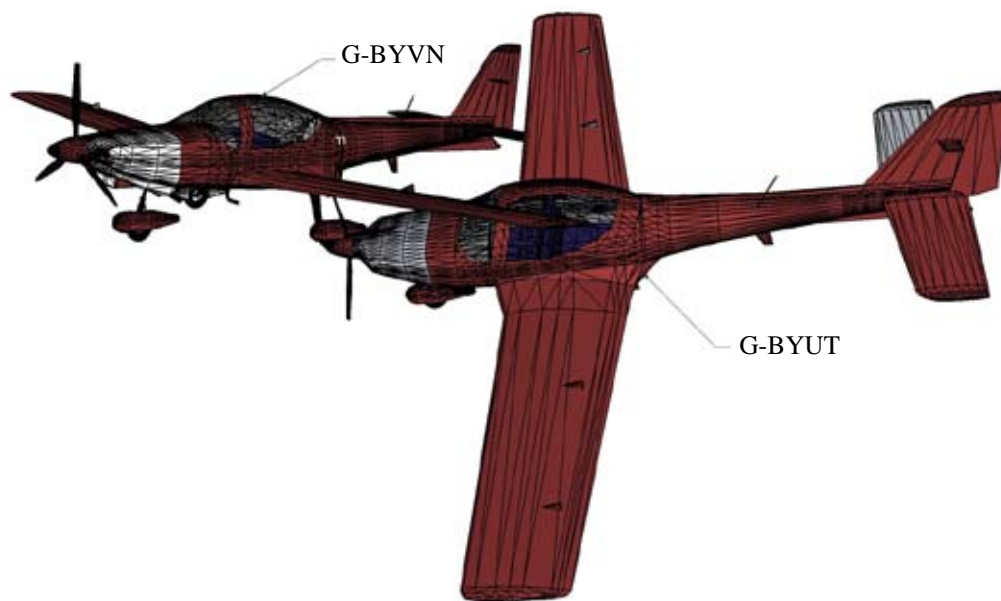
Figure 4

Model of collision orientation

Damage observed to the left landing gear of G-BYVN and evidence from the propeller and nose structure of G-BYUT show that these were the initial points of contact in the collision. It is likely that G-BYUT sustained damage to the windscreen and canopy from the landing gear, though this could also conceivably have been caused by debris released at the point of collision. The right wing of G-BYUT, at approximately mid-span, then struck the tail section of G-BYVN, just behind the cockpit, causing both structures to fragment and detach.

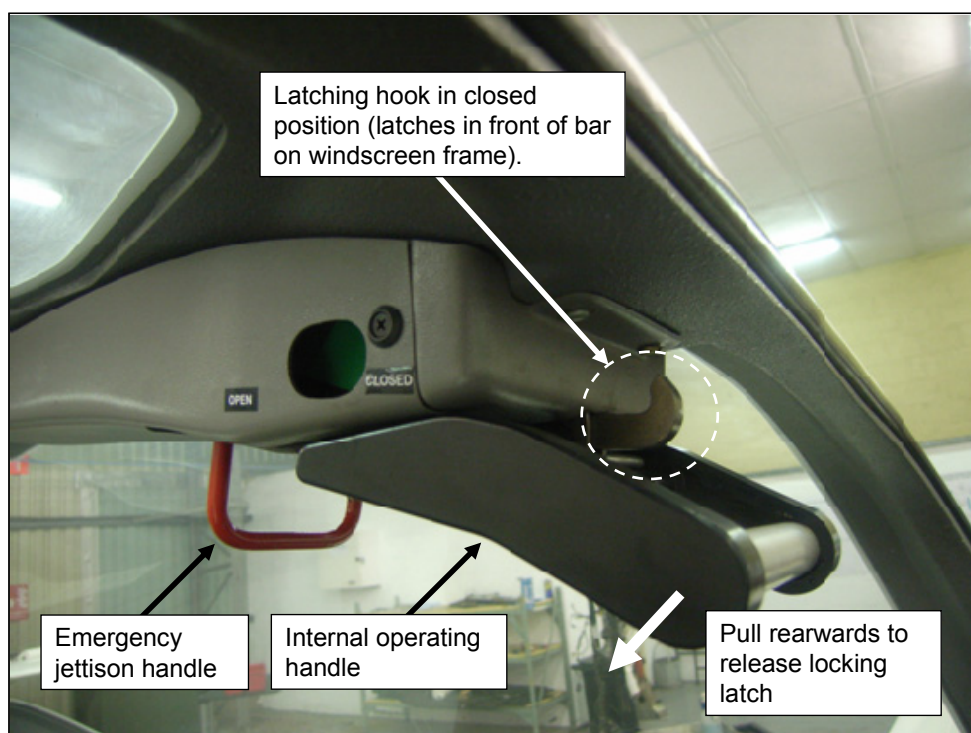
Figure 5

Internal handle in closed position (canopy open), viewed from right

Forensic examination of the canopy closing mechanism determined that the canopy was most likely unlocked at the point of impact with the ground. It also determined that the emergency handle had not been operated and was in its normal position at ground impact. Very little canopy perspex was located within the main wreckage. A significant amount was found along the wreckage trail, but not sufficient for a complete canopy.

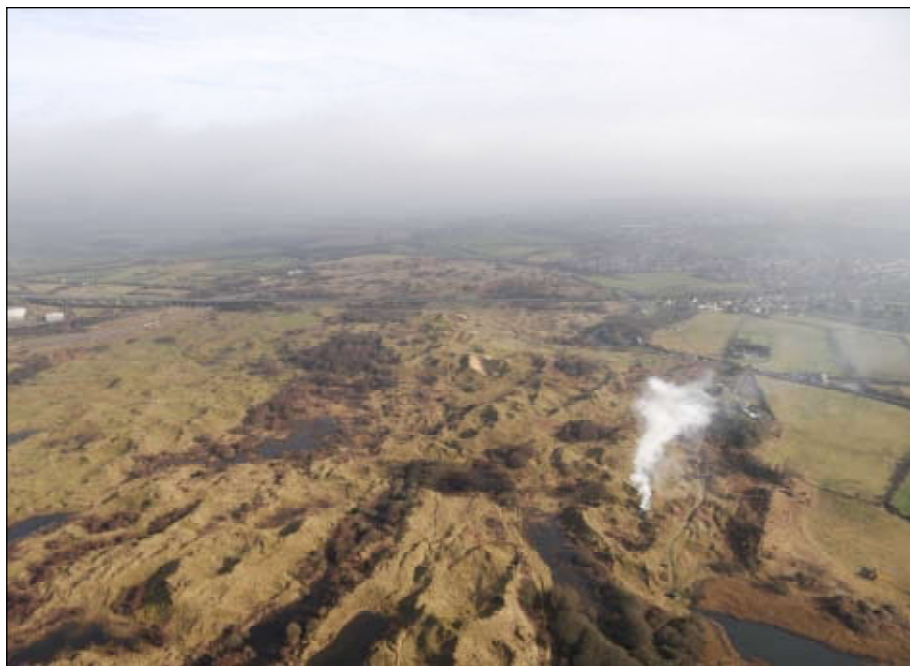
Figure 6

View from accident area looking north-east showing low cloud further inland.
Smoke in the foreground is from the G-BYVN crash site

Although the weather conditions were generally good, the photograph from the police helicopter (Figure 6) showed a layer of low stratus forming slightly inland from the accident area. It is notable that G-BYVN would have been flying against this background as it approached from the east, during the period when the pilot of G-BYUT had most opportunity to detect it. Although the aircraft would have appeared to move across the windscreen of G-BYUT, it

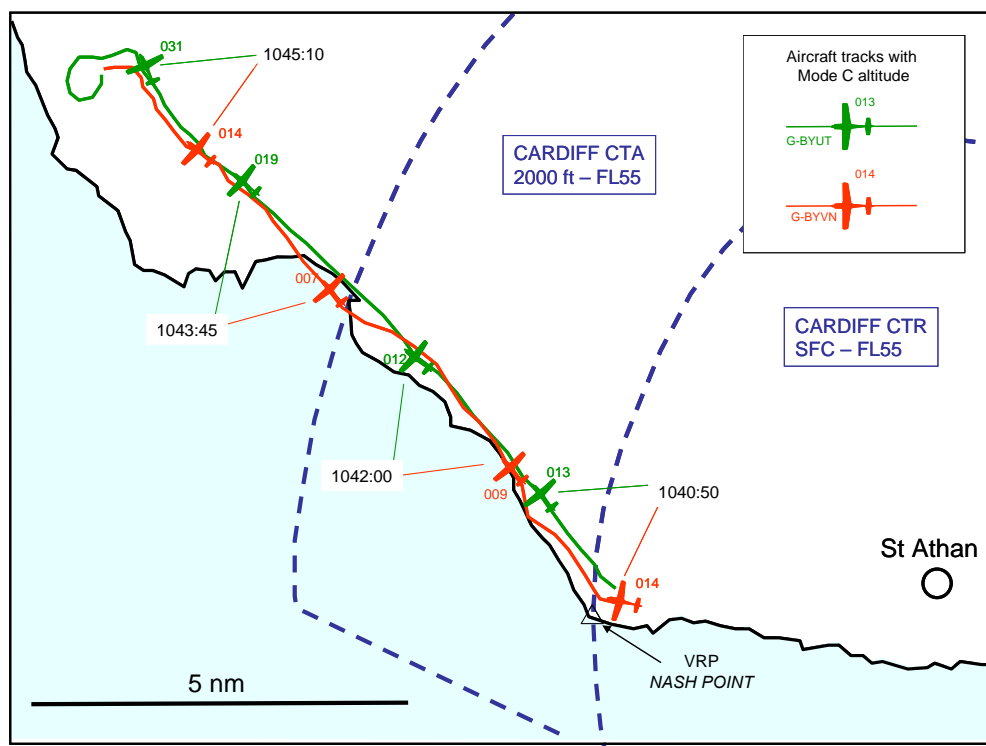
Figure 7

Radar derived sketch of the aircrafts' route to the accident area

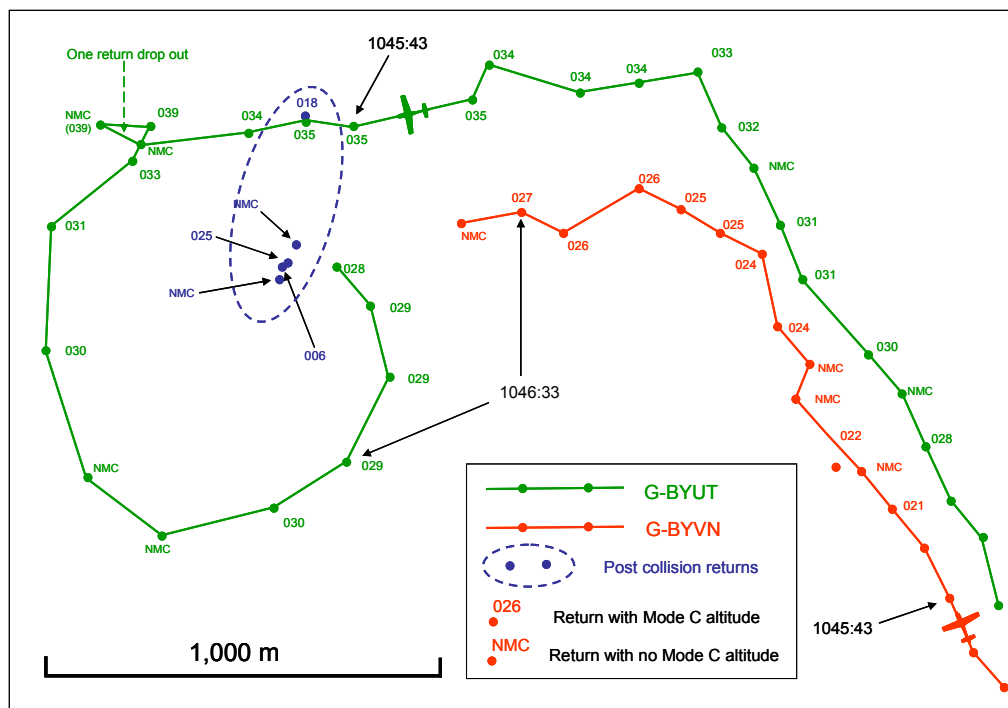
Figure 8

There were several radar returns after the estimated point of collision, over five further radar 'sweeps', or about 20 seconds. Most of the returns were close to the position where G-BYVN struck the ground, with one further to the north. For the reasons given above, some of the returns soon after the collision are probably erroneous, although the last return, showing an indicated 600 ft Mode C altitude, is likely to be a valid return for G-BYVN. Post-collision returns are shown in blue at Figure 8.

Radar derived sketch of the aircrafts' final flight paths to collision

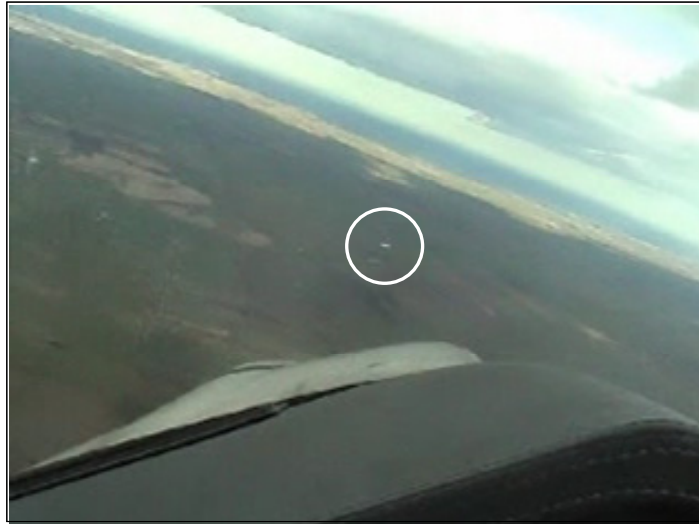
Figure 11

4. As the lead aircraft continued turning left, the second aircraft would have come into view in its forward windscreen. Because of the turn, it would have appeared to move from the area of the canopy operating handle (in the upper left of the pilot's forward vision), across the screen towards

Flight trial: forward view from lead aircraft about 10 seconds before collision point. Second aircraft (circled) moving across windscreen from upper left to lower right (RAF Service Inquiry)

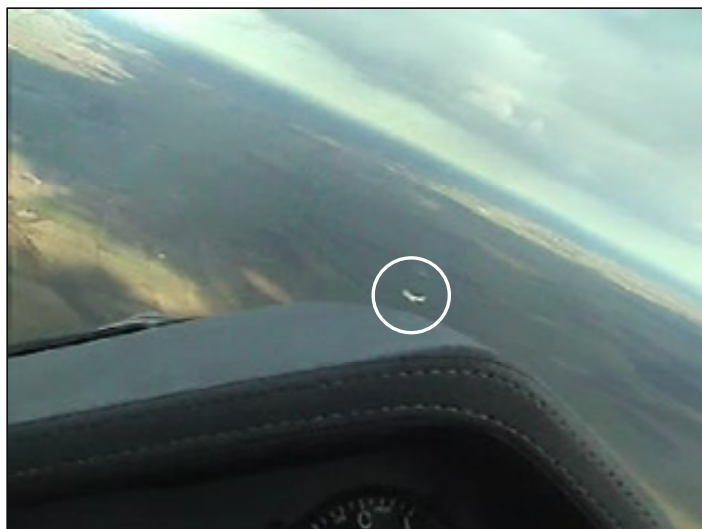
Figure 12

the bottom right of it (Figure 11). This would have taken about 14 seconds. For the remaining 10 seconds before the collision, the second aircraft would have appeared to remain approximately stationary in the low right hand area of the windscreen, possibly becoming obscured from view in the last few seconds by the aircraft structure (Figure 12).

Flight trial: forward view from lead aircraft about 3 seconds before collision point. Second aircraft (circled) is in lower right part of windscreen, or may have been obscured from view (RAF Service Inquiry)
