Air Accidents Investigation Branch

**Report on the accident to
Grob 115E Tutor, G-BYUT
and
Grob 115E Tutor, G-BYVN
near Porthcawl, South Wales
on 11 February 2009**

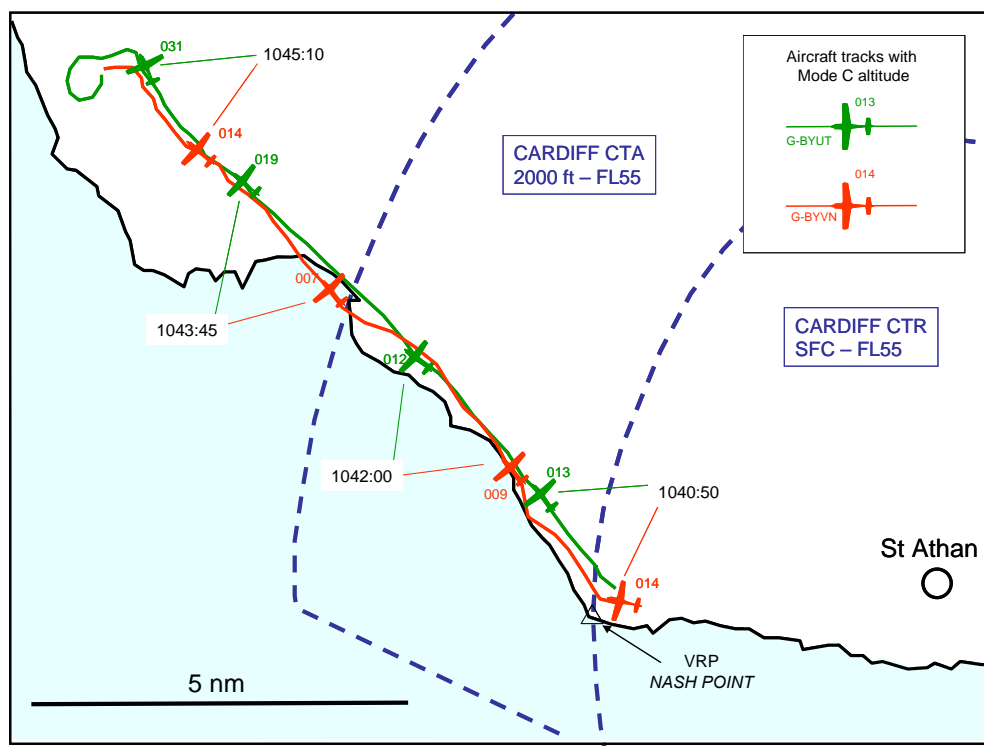
Figure 7

The radar tracks from Nash Point to the accident area are shown at Figure 7, with Mode C altitudes.

Radar derived sketch of the aircrafts' route to the accident area

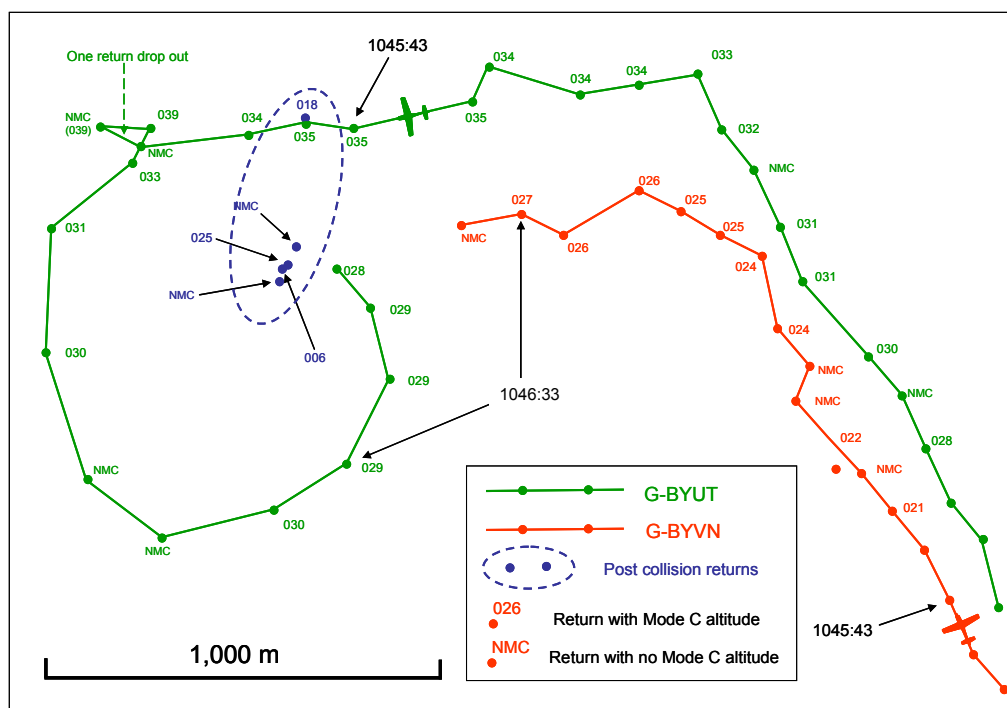
Figure 8

There were several radar returns after the estimated point of collision, over five further radar 'sweeps', or about 20 seconds. Most of the returns were close to the position where G-BYVN struck the ground, with one further to the north. For the reasons given above, some of the returns soon after the collision are probably erroneous, although the last return, showing an indicated 600 ft Mode C altitude, is likely to be a valid return for G-BYVN. Post-collision returns are shown in blue at Figure 8.

Radar derived sketch of the aircrafts' final flight paths to collision

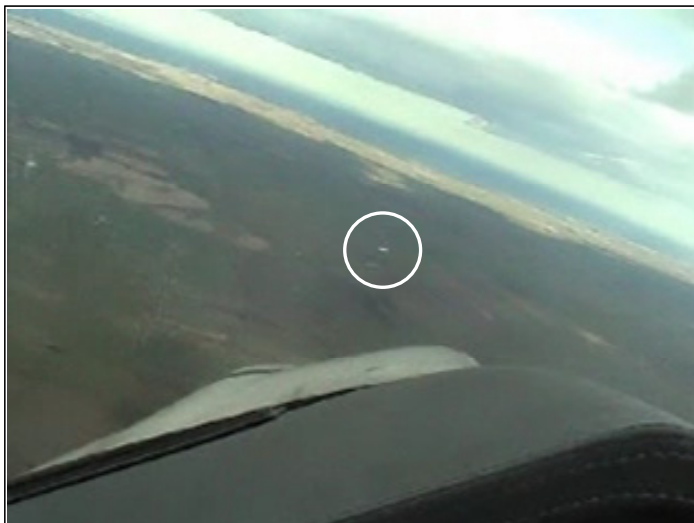
Figure 11

4. As the lead aircraft continued turning left, the second aircraft would have come into view in its forward windscreen. Because of the turn, it would have appeared to move from the area of the canopy operating handle (in the upper left of the pilot's forward vision), across the screen towards

the bottom right of it (Figure 11). This would have taken about 14 seconds. For the remaining 10 seconds before the collision, the second aircraft would have appeared to remain approximately stationary in the low right hand area of the windscreen, possibly becoming obscured from view in the last few seconds by the aircraft structure (Figure 12).

Flight trial: forward view from lead aircraft about 10 seconds before collision point. Second aircraft (circled) moving across windscreen from upper left to lower right (RAF Service Inquiry)

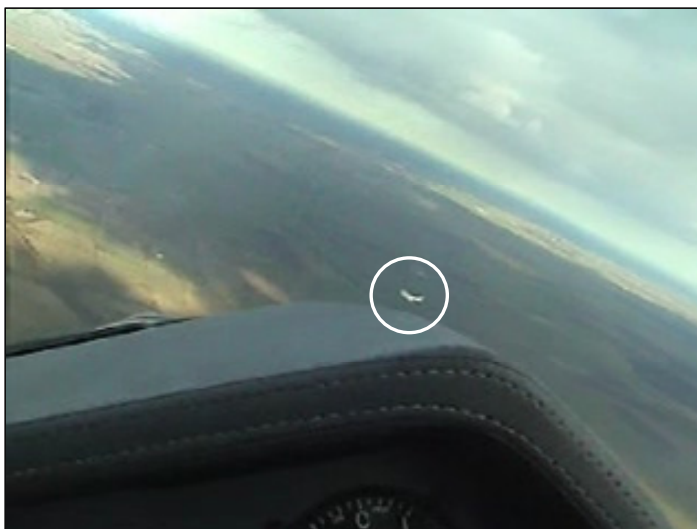
Figure 12

Flight trial: forward view from lead aircraft about 3 seconds before collision point. Second aircraft (circled) is in lower right part of windscreen, or may have been obscured from view (RAF Service Inquiry)
