**Report on the accident to
Grob 115E Tutor, G-BYUT
and
Grob 115E Tutor, G-BYVN
near Porthcawl, South Wales
on 11 February 2009**

Aircraft Accident Report No: 6/2010 (EW/C2009/02/02)

Aircraft Types: Two Grob Aerospace 115E Tutors

Registrations: 1) G-BYUT
2) G-BYVN

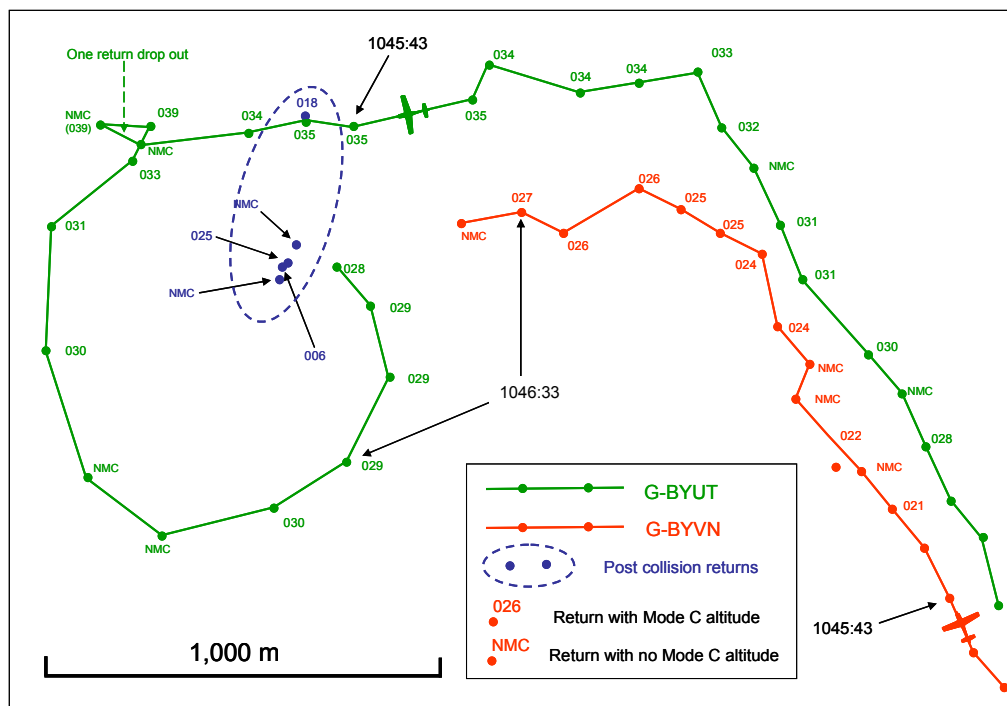
Figure 8

There were several radar returns after the estimated point of collision, over five further radar 'sweeps', or about 20 seconds. Most of the returns were close to the position where G-BYVN struck the ground, with one further to the north. For the reasons given above, some of the returns soon after the collision are probably erroneous, although the last return, showing an indicated 600 ft Mode C altitude, is likely to be a valid return for G-BYVN. Post-collision returns are shown in blue at Figure 8.

Radar derived sketch of the aircrafts' final flight paths to collision

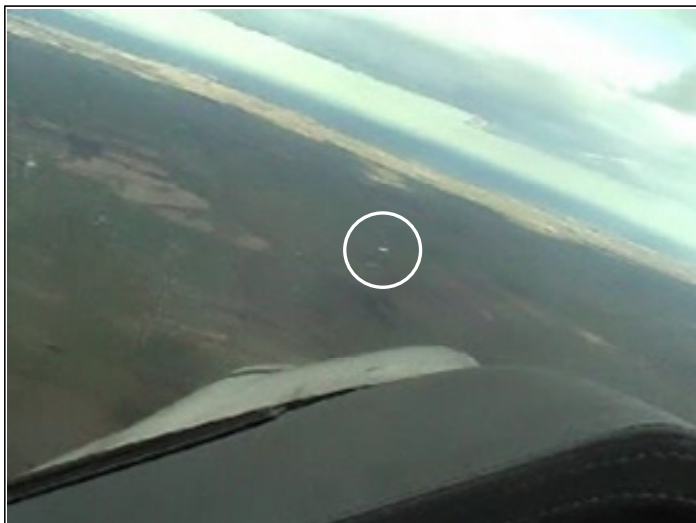
Figure 11

4. As the lead aircraft continued turning left, the second aircraft would have come into view in its forward windscreen. Because of the turn, it would have appeared to move from the area of the canopy operating handle (in the upper left of the pilot's forward vision), across the screen towards

the bottom right of it (Figure 11). This would have taken about 14 seconds. For the remaining 10 seconds before the collision, the second aircraft would have appeared to remain approximately stationary in the low right hand area of the windscreen, possibly becoming obscured from view in the last few seconds by the aircraft structure (Figure 12).

Flight trial: forward view from lead aircraft about 10 seconds before collision point. Second aircraft (circled) moving across windscreen from upper left to lower right (RAF Service Inquiry)

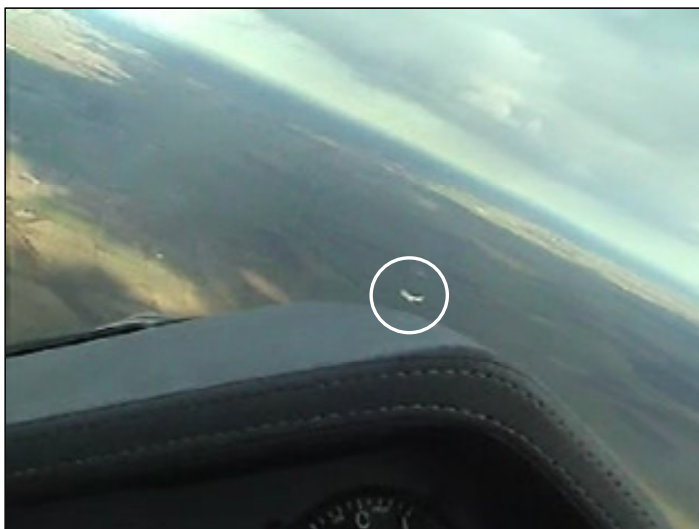
Figure 12

Flight trial: forward view from lead aircraft about 3 seconds before collision point. Second aircraft (circled) is in lower right part of windscreen, or may have been obscured from view (RAF Service Inquiry)
