**Air Accidents Investigation Branch**

**Report on the accident to  
Grob 115E Tutor, G-BYUT  
and  
Grob 115E Tutor, G-BYVN  
near Porthcawl, South Wales  
on 11 February 2009**

Published 3 November 2010

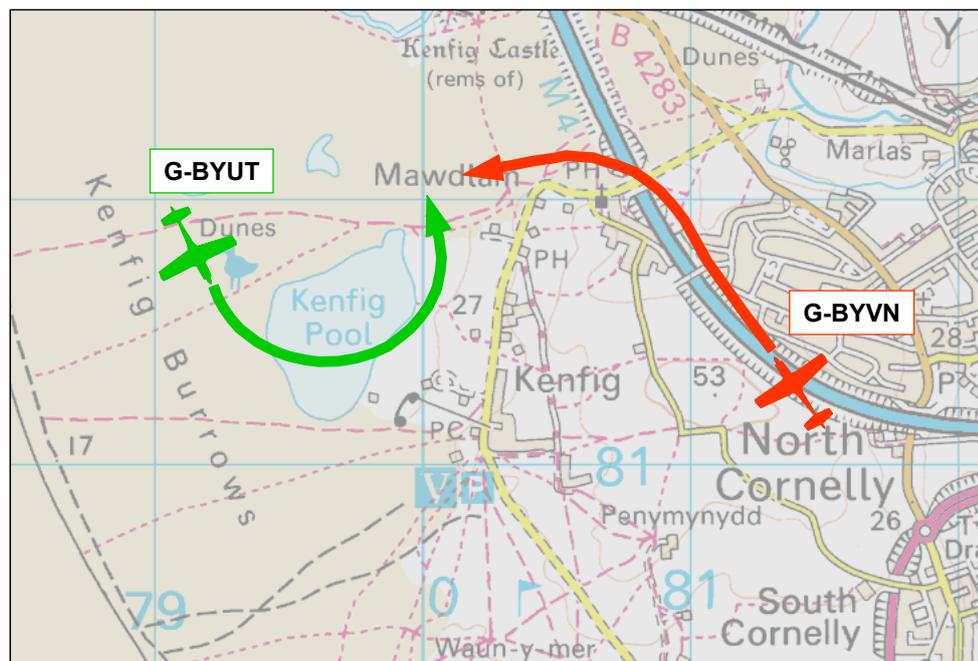
**Figure 3**

Sketch showing approximate flight paths immediately prior to collision

The two aircraft collided at about 2,900 ft, with G-BYVN on approximately a westerly heading and G-BYUT closing from the south, probably while still turning to the left. The right wing of G-BYUT struck the aft fuselage of G-BYVN, which detached from the aircraft. The right wing of G-BYUT also detached at, or very soon after, the point of collision. Both aircraft were thus rendered uncontrollable.

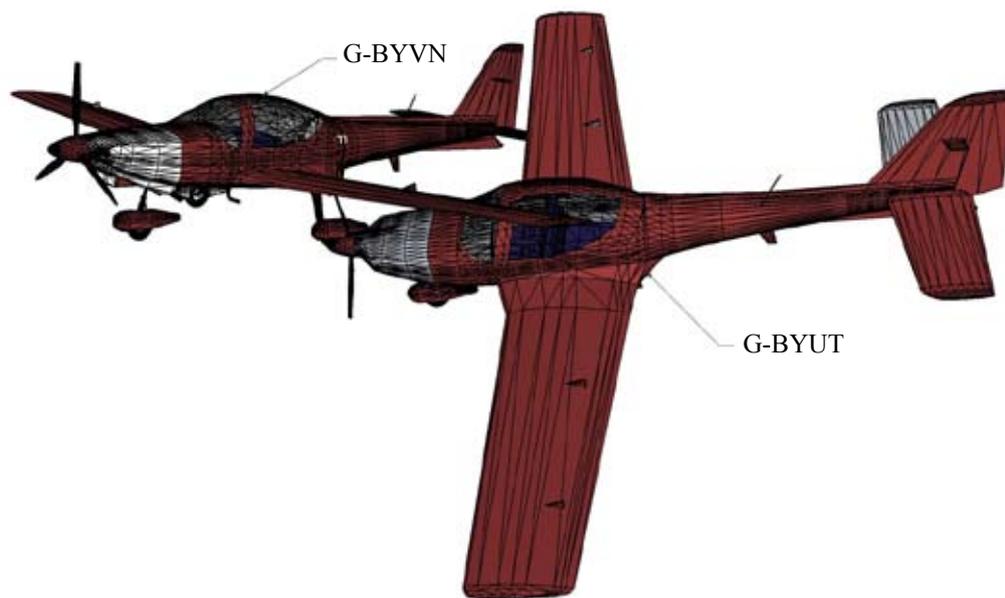
**Figure 4**

Based on eyewitness reports, radar data and physical evidence obtained during the wreckage examination of both aircraft, a 3-D model of the collision was constructed (Figure 4). The figure shows the attitude of each aircraft relative to the other. The precise orientation of the colliding aircraft with respect to the true horizon is less certain, but is believed to be accurately depicted. It should also be noted that the figure only represents a moment in time at the initial point of contact and does not represent the dynamic nature of two moving aircraft colliding.

Model of collision orientation

Damage observed to the left landing gear of G-BYVN and evidence from the propeller and nose structure of G-BYUT show that these were the initial points of contact in the collision. It is likely that G-BYUT sustained damage to the windscreen and canopy from the landing gear, though this could also conceivably have been caused by debris released at the point of collision. The right wing of G-BYUT, at approximately mid-span, then struck the tail section of G-BYVN, just behind the cockpit, causing both structures to fragment and detach.

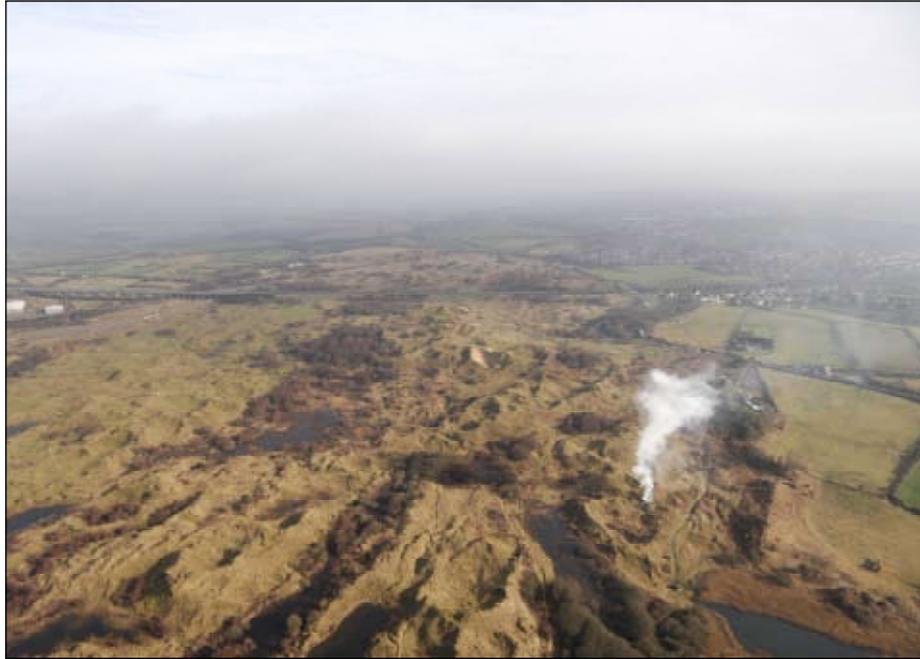
**Figure 6**

A police air support helicopter was on scene shortly after the accident and took photographs of the accident area. These included some which showed patches of low stratus cloud obscuring areas of ground further inland, beyond the M4 motorway (Figure 6). The presence of broken low cloud in this area is supported by the account of an eyewitness in the same area who reported seeing one of the aircraft disappear behind cloud prior to the collision, while witnesses more directly below the collision area generally reported no low cloud.

View from accident area looking north-east showing low cloud further inland.  
Smoke in the foreground is from the G-BYVN crash site

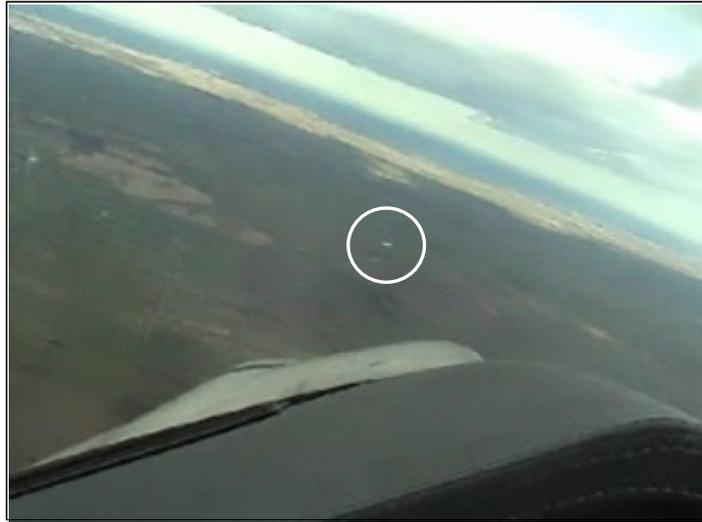
**Figure 11**

4. As the lead aircraft continued turning left, the second aircraft would have come into view in its forward windscreen. Because of the turn, it would have appeared to move from the area of the canopy operating handle (in the upper left of the pilot's forward vision), across the screen towards

the bottom right of it (Figure 11). This would have taken about 14 seconds. For the remaining 10 seconds before the collision, the second aircraft would have appeared to remain approximately stationary in the low right hand area of the windscreen, possibly becoming obscured from view in the last few seconds by the aircraft structure (Figure 12).

Flight trial: forward view from lead aircraft about 10 seconds before collision point. Second aircraft (circled) moving across windscreen from upper left to lower right (RAF Service Inquiry)

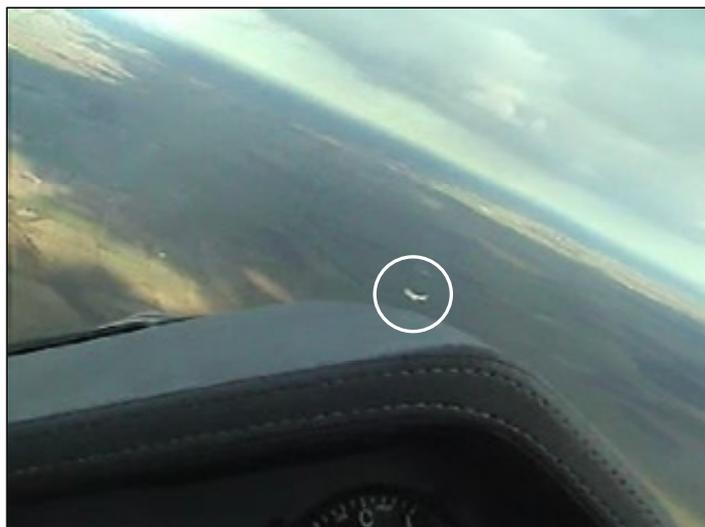
**Figure 12**

Flight trial: forward view from lead aircraft about 3 seconds before collision point. Second aircraft (circled) is in lower right part of windscreen, or may have been obscured from view (RAF Service Inquiry)

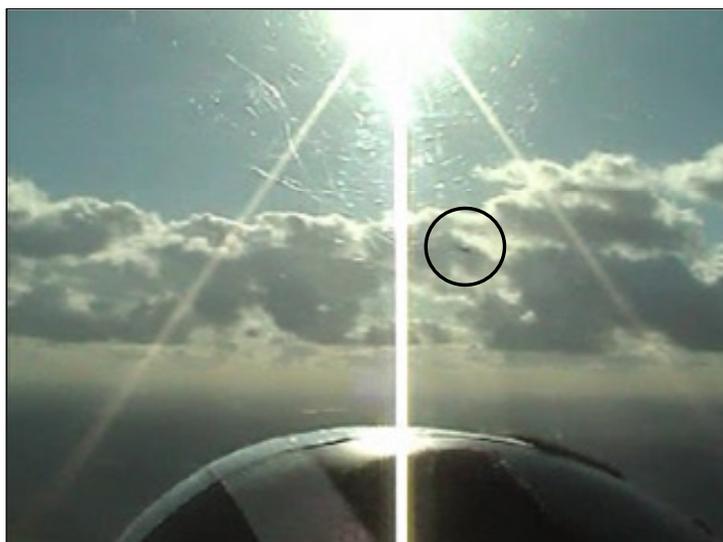
5. From the second aircraft, most or all of the leading aircraft's final approach was probably masked by the canopy arch or, in the final seconds before collision, possibly by the cadet in the left seat.
6. In the final seconds before the collision, the lead aircraft would have been approaching the second aircraft from approximately the direction of the sun, making visual detection less likely due to glare (Figure 13).

Flight trial: Looking left from second aircraft towards lead aircraft (circled). Note that camera position is elevated above pilot's eye position; otherwise aircraft would be obscured by left seat occupant's helmet (RAF Service Inquiry)
