Air Accidents Investigation Branch

**Report on the accident to
Grob 115E Tutor, G-BYUT
and
Grob 115E Tutor, G-BYVN
near Porthcawl, South Wales
on 11 February 2009**

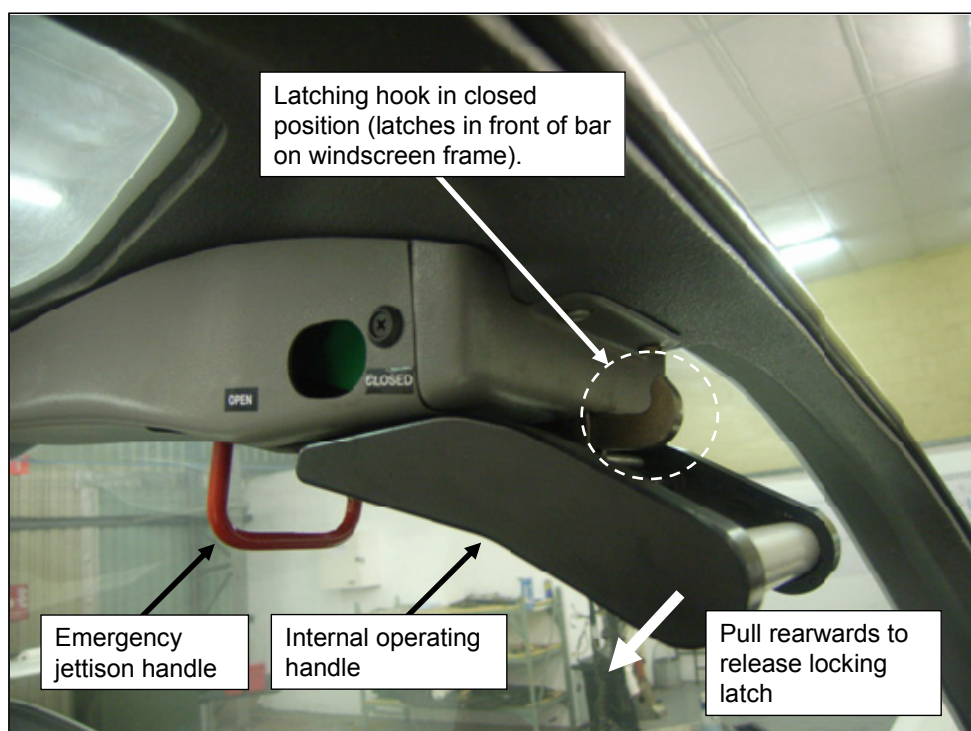
Figure 5

Internal handle in closed position (canopy open), viewed from right

Forensic examination of the canopy closing mechanism determined that the canopy was most likely unlocked at the point of impact with the ground. It also determined that the emergency handle had not been operated and was in its normal position at ground impact. Very little canopy perspex was located within the main wreckage. A significant amount was found along the wreckage trail, but not sufficient for a complete canopy.

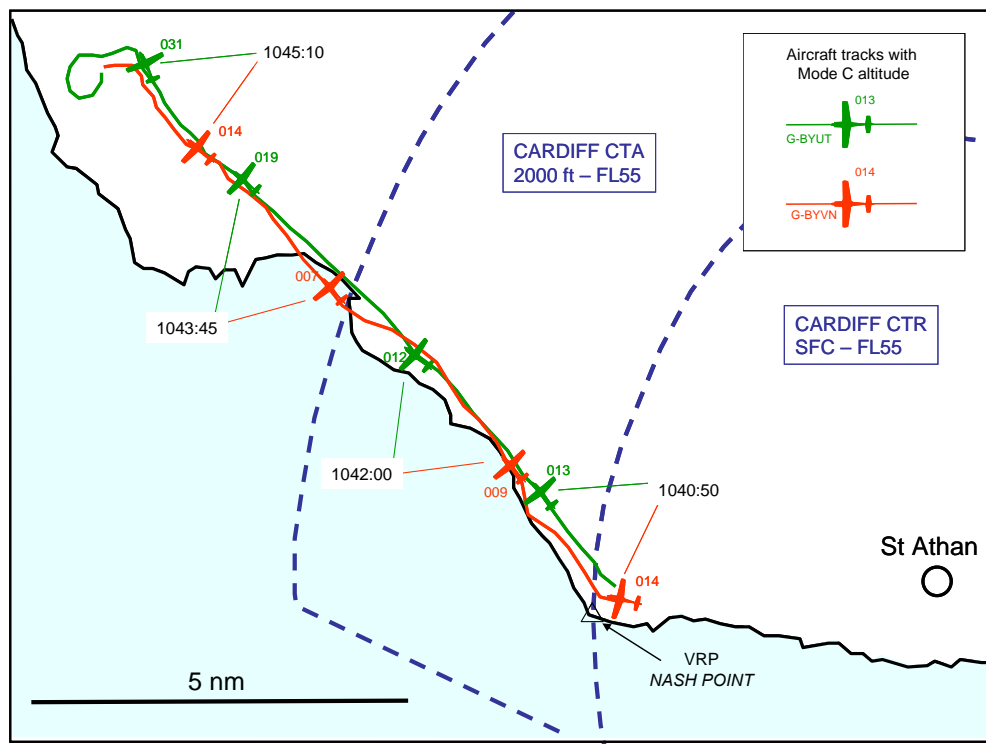
Figure 7

Radar derived sketch of the aircrafts' route to the accident area
