No: 9/91

Ref: EW/C1195

Aircraft Type and Registration: Bell 214ST, G-BKFN
No & Type of Engines: 2 General Electric CT7-2A turboshaft engines
Year of Manufacture: 1982
Date & Time (UTC): 24 December 1990 at 1856 hrs
Location: Near the Cormorant A platform in the North Sea
Type of Flight: Public Transport
Persons on Board: Crew - 2 Passengers - None
Injuries: Crew - None Passengers - N/A
Nature of Damage: Serious failure of fin structure
Commander's Licence: Airline Transport Pilot's Licence (Helicopters)
Commander's Age: 43 years
Commander's Flying Experience: 9,692 hours (of which 916 hours were on type)
Information Source: AAIB Field Investigation

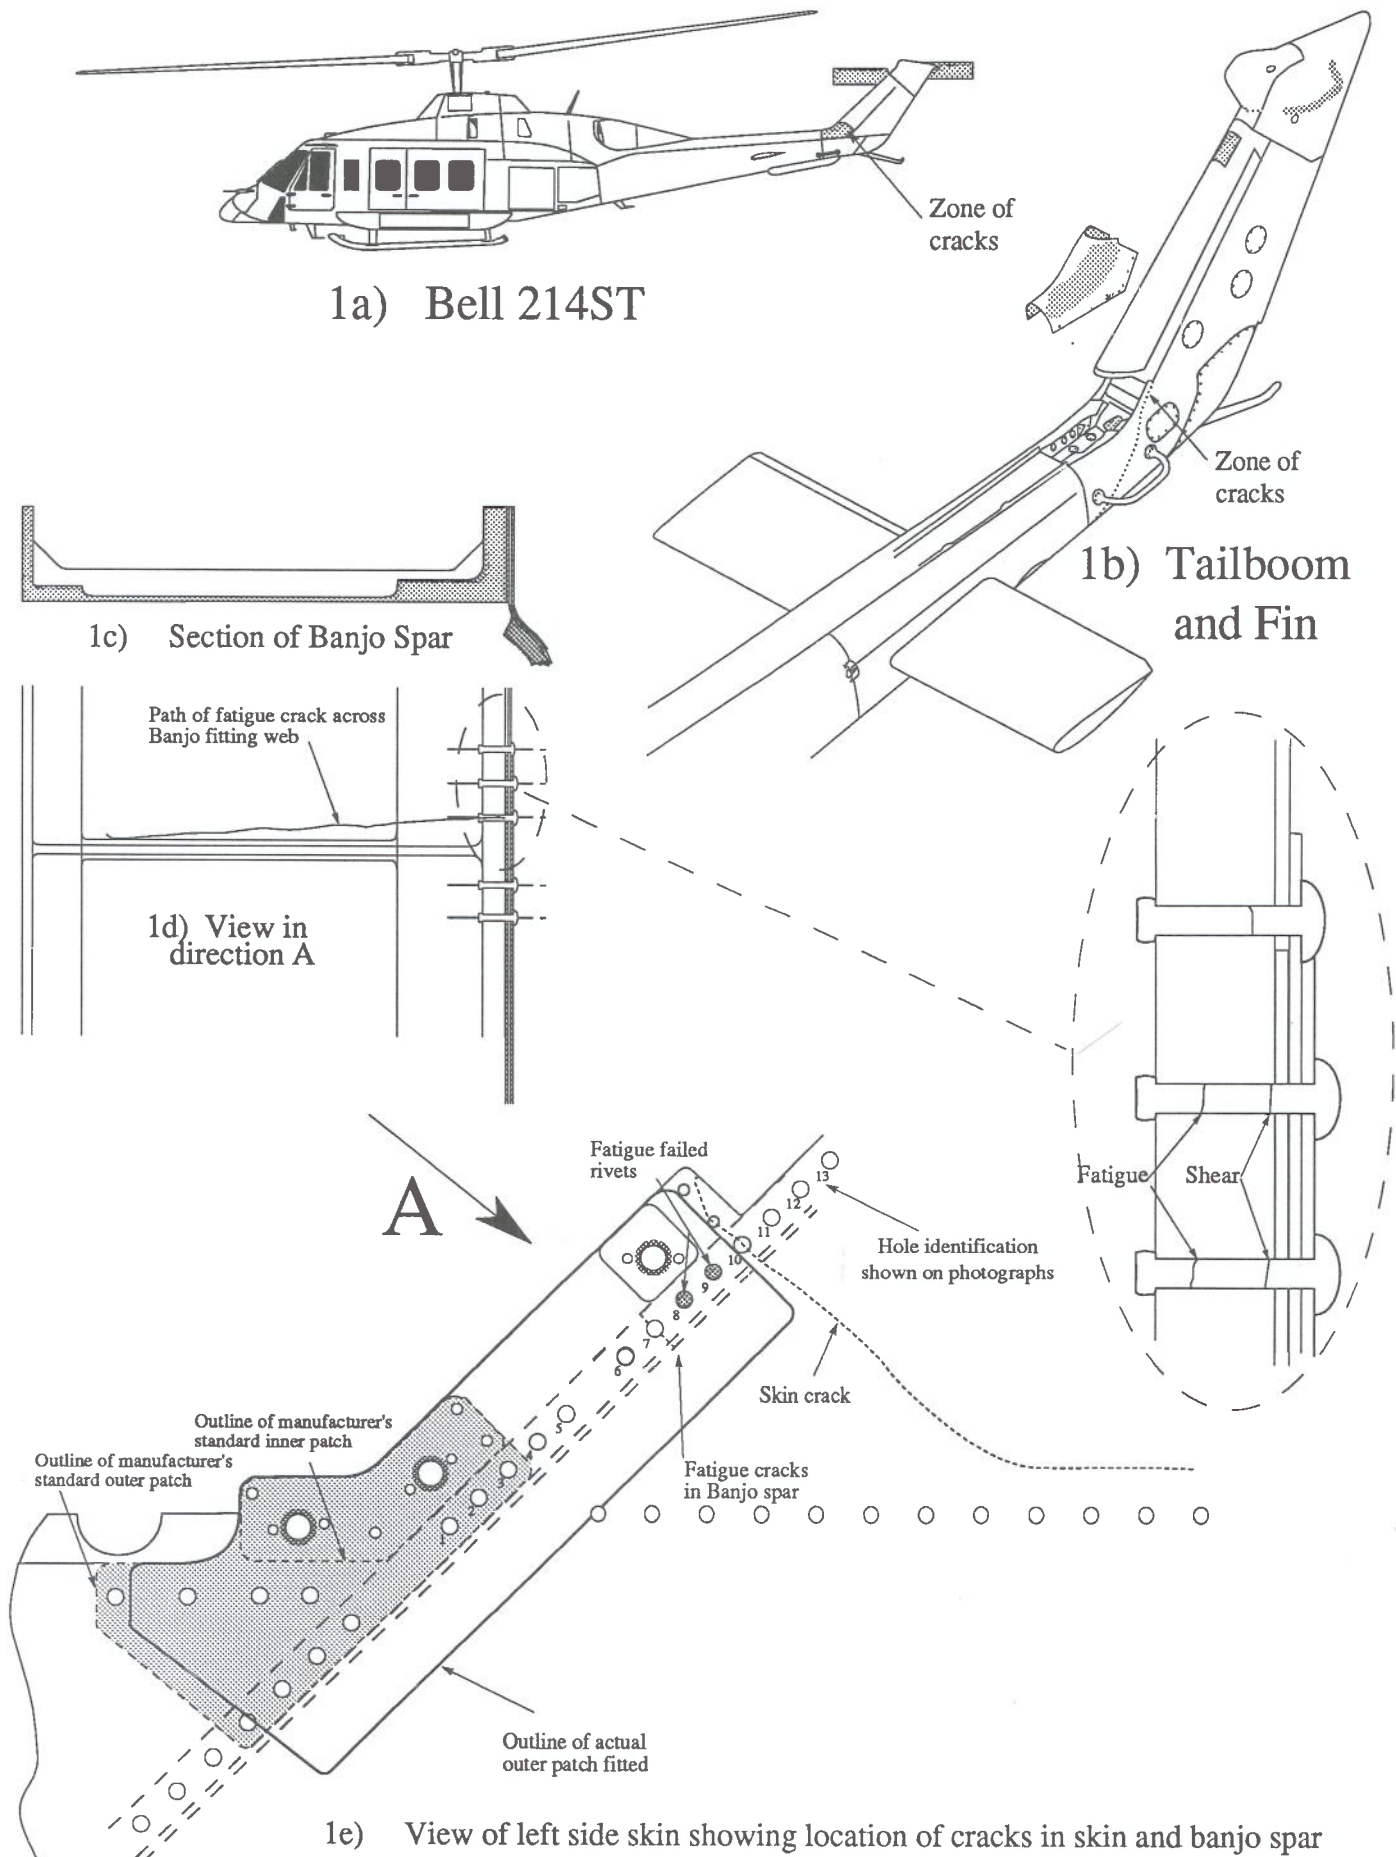
An initial inspection by the maintenance staff on board Safe Gothia revealed cracks in the fin root structure, in the zone around the 42° gearbox, in both the left hand side skin and the inclined fin front spar web fitting (known as the 'Banjo' fitting). This cracking was deemed sufficiently serious to preclude further flight before the tailboom/fin had been replaced. Although replacement of the tailboom and detailed examination of the failure was severely delayed by bad weather, on 15 January 1991 the manufacturer issued an Alert Service Bulletin calling for inspection of the affected area before the next flight and at 25 hour intervals subsequently.

After recovery the fin and tailboom assembly was examined by AAIB, together with the manufacturer and the operator, at one of the operator's maintenance bases. It was found that the crack in the fin front spar web had progressed across about 80% of the spar width and the crack in the left side skin had progressed about halfway towards the fin rear spar. (The left side skin is predominantly subjected to tensile stress arising from tail rotor loads.) This had resulted in a major degradation of the strength and stiffness of the fin attachment. The position of the crack in the spar web was in such a location that, in normal service, the presence of the 42° gearbox at the fin root and the natural oiliness and dirtiness of the zone would have made the crack difficult to see during routine inspections.

Figure 1 Details of banjo fitting and skin cracking on Bell 214ST G-BKFN

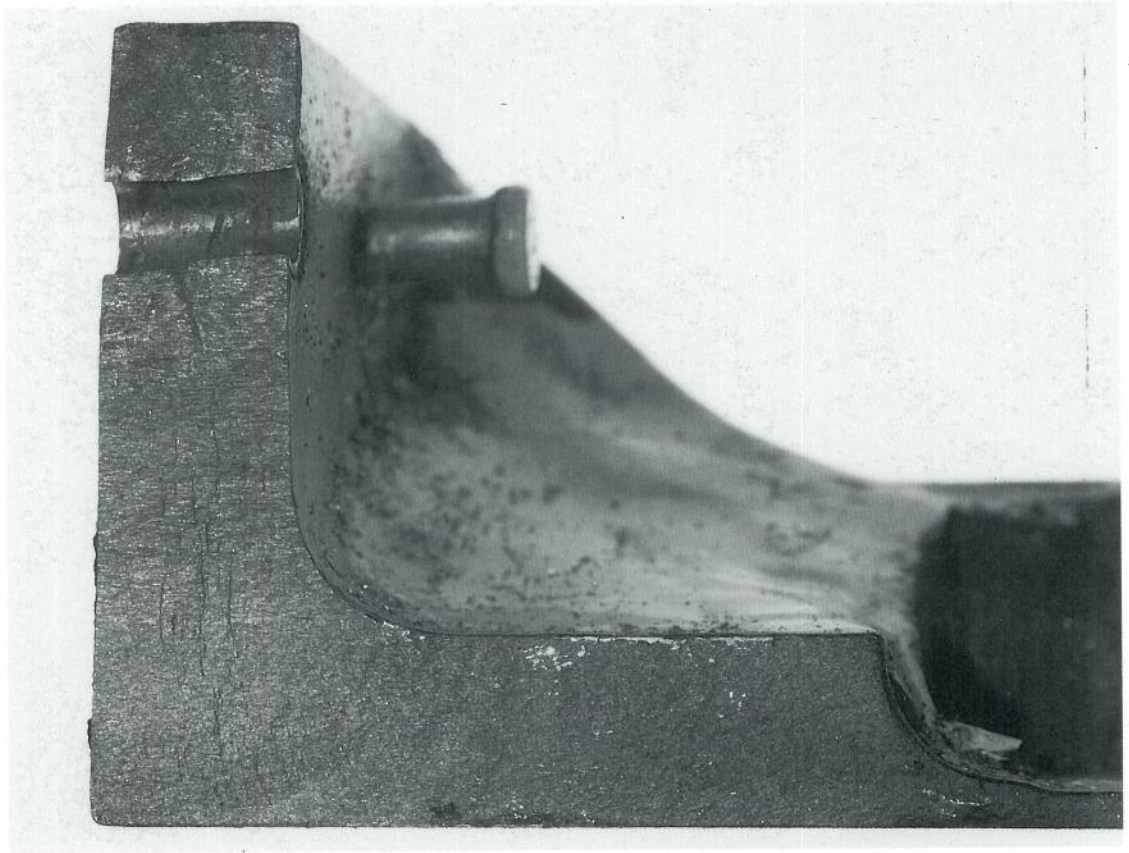
The fin together with the rear section of the tailboom was separated from the main tailboom at a manufacturing joint and taken to RAE Farnborough for detailed metallurgical examination. This revealed that the mechanism of crack initiation and progression in both the spar web and the skin had been by fatigue which had nucleated, in the spar, from a poorly finished rivet hole (No.7 in Fig.1e: associated photographs show the appearance of crack face and hole finish) and in the two rivet holes (No 10 and the adjacent hole above in Fig.1e) just aft of a doubler patch on the left side skin. The fatigue cracks appeared to have propagated steadily at first but the rate had accelerated during the later stages. Evidence of fatigue and shear failures in the two rivets Nos.8 & 9 suggested that they failed completely at the same time and, by joining the two fatigue cracks, lead to the apparently sudden change in the stiffness characteristics. Although the fatigue striations were clearly visible it has not, as yet, been possible to identify any particular load cycle and thereby make an assessment of the period of fatigue growth.

Photograph 1 Fatigue failure zone emanating from rivet hole

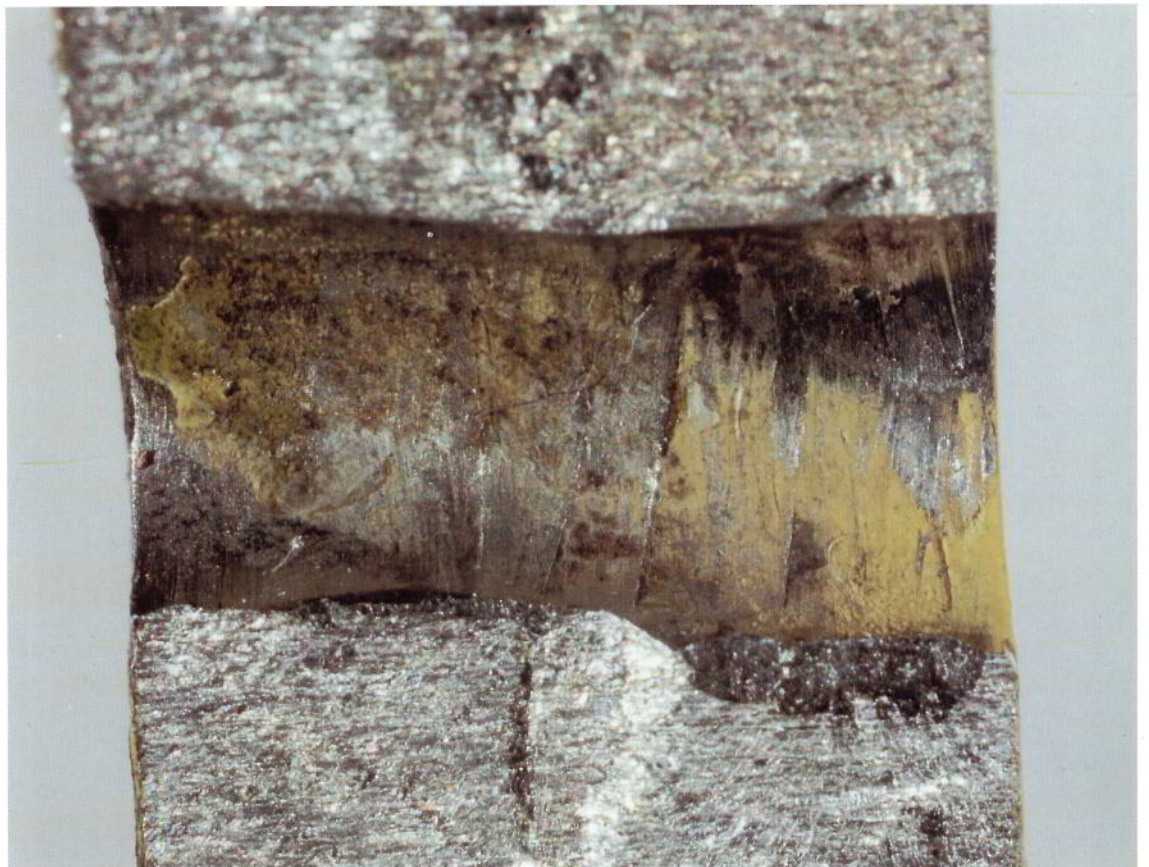
Alignment of the new holes in the doubler with the existing holes in the spar flange was apparently difficult since the spar side flange twists and curves at this location, making the direction of the rivet holes difficult to judge. The photographs show the resultant damage to the original rivet hole surfaces caused by the drill-bit whilst hole alignment was being attempted. This damage is typical of that expected when rivets are removed and replaced without drilling-out to an oversize diameter and fitting appropriate oversize rivets. However, such an increase in rivet and hole size should not be undertaken without the approval and consent of the design authority and manufacturer.

Photograph 2 Close up of damaged rivet hole
(note scoring of hole surface and uneven shape)
