**ACCIDENT**

<b>Aircraft Type and Registration:</b>	Dragon 200, G-MMAE	
<b>No &amp; Type of Engines:</b>	1 Fuji-Robin EC-44-PM piston engine	
<b>Year of Manufacture:</b>	1983	
<b>Date &amp; Time (UTC):</b>	11 August 2007 at 1010 hrs	
<b>Location:</b>	Sandown Airport, Isle of Wight	
<b>Type of Flight:</b>	Private	
<b>Persons on Board:</b>	Crew - 1	Passengers - 1
<b>Injuries:</b>	Crew - None	Passengers - None
<b>Nature of Damage:</b>	Undercarriage collapsed, propeller damaged	
<b>Commander's Licence:</b>	Private Pilot's Licence	
<b>Commander's Age:</b>	59 years	
<b>Commander's Flying Experience:</b>	876 hours (of which 50 were on type) Last 90 days - 13 hours Last 28 days - 2 hours	
<b>Information Source:</b>	Aircraft Accident Report Form submitted by the pilot and AAIB inquiries

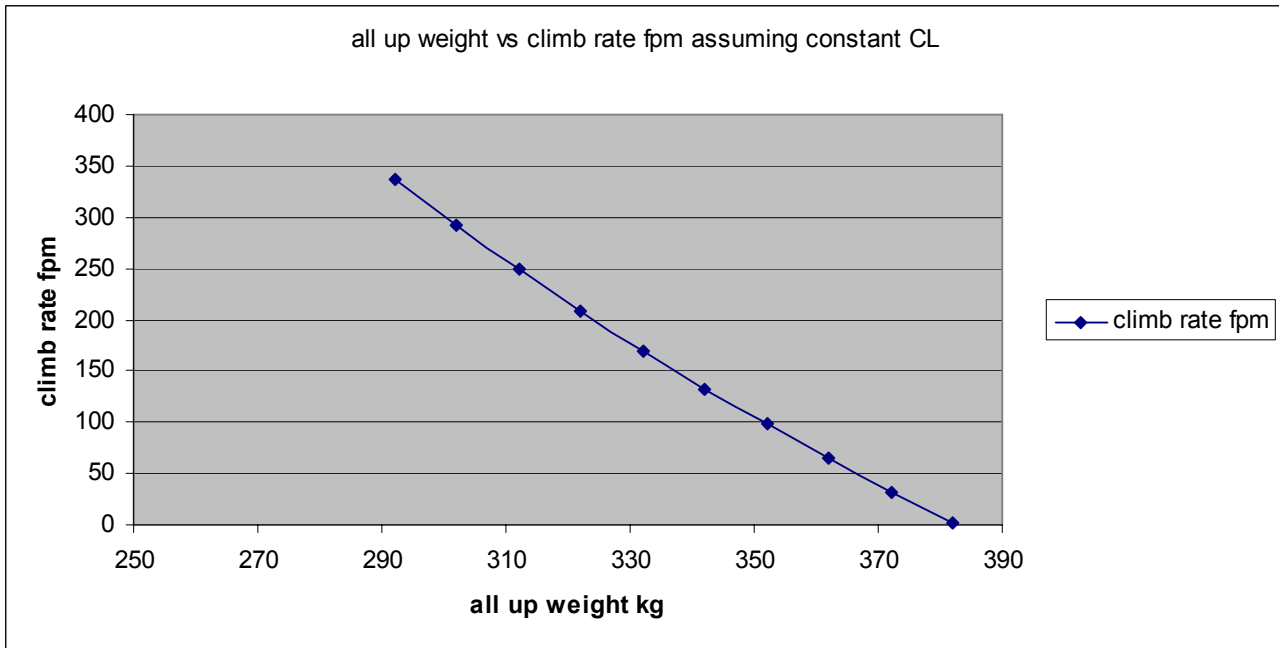
Figure 1

The designer of this aircraft was asked to extrapolate the results from the test flight to provide an estimate of the aircraft's performance for a takeoff weight of 373 kg, which was the takeoff weight at Sandown on 11 August 2007. His calculations produced the graph at Figure 1.

It can be seen that at a takeoff weight of 373 kg the aircraft designer estimated that the aircraft would have been able to achieve a rate of climb of less than 30 fpm, which is equivalent to a gradient, in still air, of approximately 1%.

The Fuji Robin EC-44-PM engine produced 50 bhp (brake horse power) when certified in the Dragon 200. The designer calculated that a rate of climb of 333 fpm at 292 kg equates to the engine producing only 39.5 bhp.
