AAIB Bulletin No: 4/94

Aircraft Type and Registration: Auster J1N Alpha, G-APOA

Date & Time (UTC): 15 November 1993 at 1051 hrs

Location: Chelsfield, Orpington, Kent

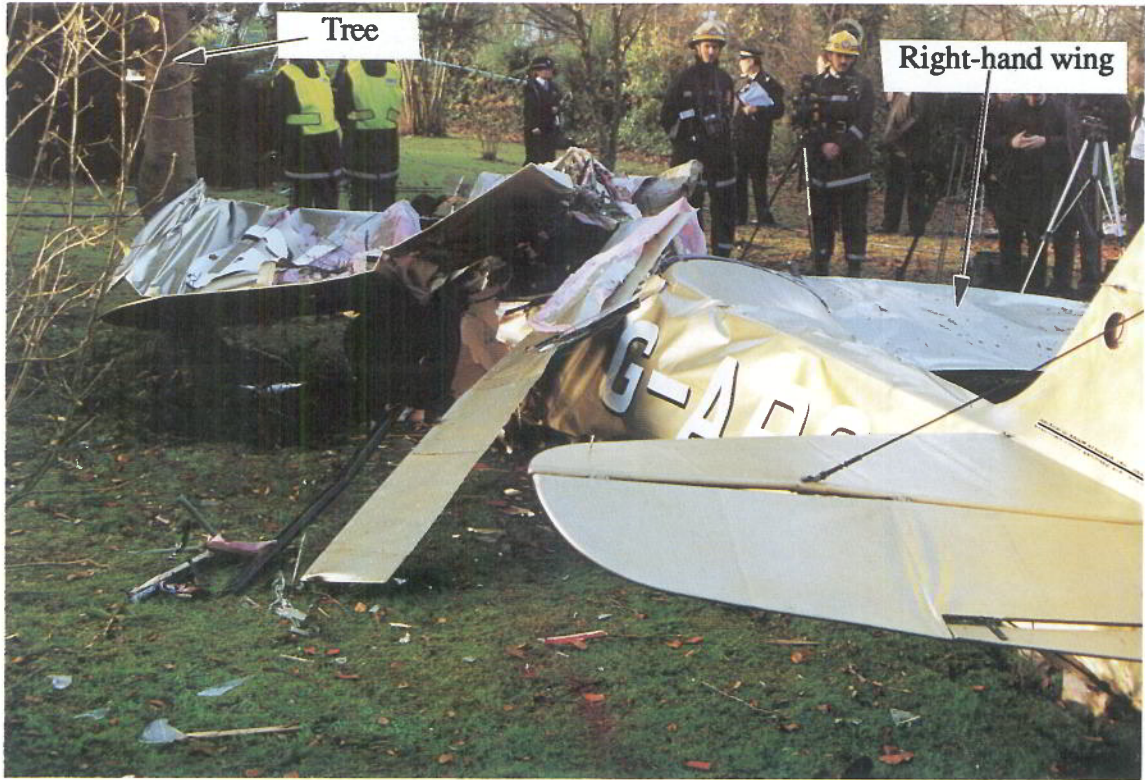
At the accident site the aircraft was found facing approximately 270°M, with the empennage only slightly damaged and the right-hand wing in its correct orientation relative to the fuselage (Figure 1). Broken branches and a detached piece of fabric wing covering (Ceconite) showed that the aircraft had descended through the top of nearby deciduous trees. The broken branches at a height of 70 feet indicated a trajectory of some 65° below the horizon in a direction of 144°M. Ground marks showed that, as the aircraft continued towards the ground, it had rotated to the right through about 125° from its first impact. The second, and major, impact occurred when the left-hand wingtip struck a substantial tree trunk 4 feet above ground level (Figure 2); this impact collapsed the left-hand wing to a length of approximately 6 feet although it had clearly still been in its correct orientation at impact. The main impact of the fuselage on the ground had been with the aircraft nearly level, causing very high vertical impact loads in the cabin area.

Figure 1 - G-APOA, 15/11/93 - View looking forward

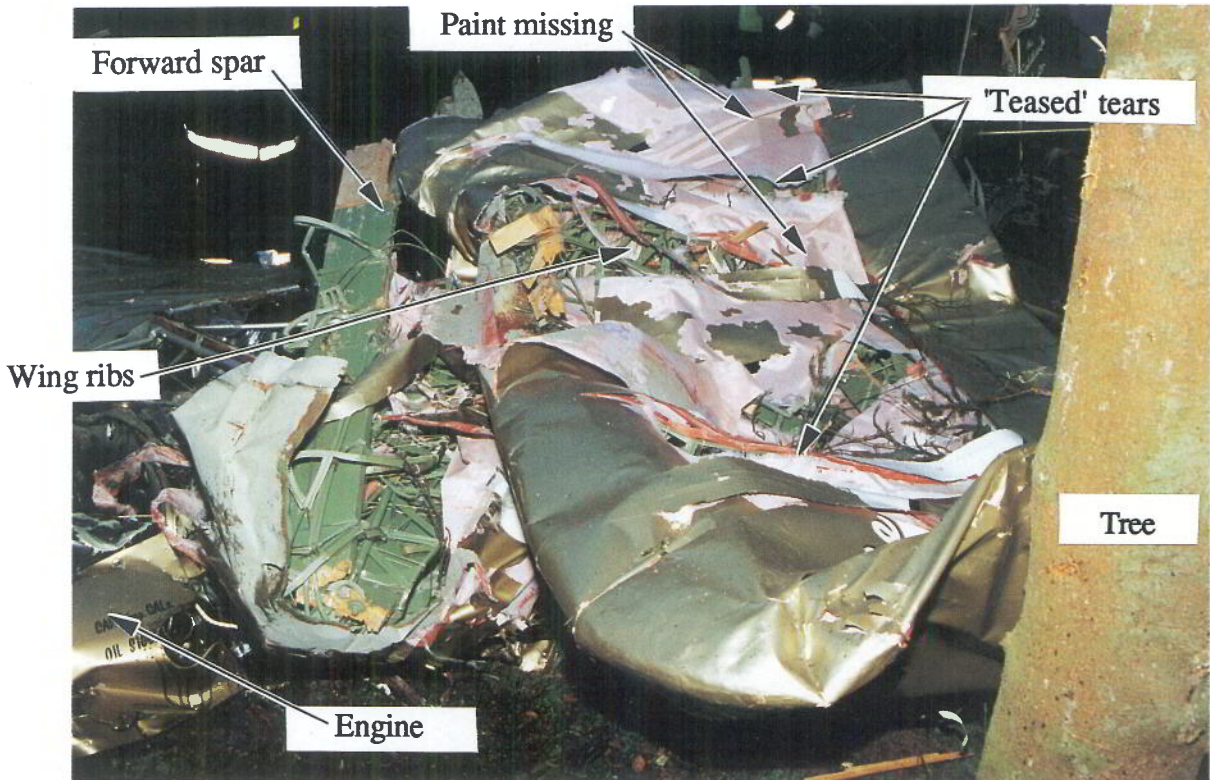
Damage to the left-hand wing suggested in-flight structural failure; distinctive features included a number of structural failures in the forward and aft wing spars and extensive damage to the fabric wing covering (Figure 2). A number of the tears in the fabric were along the rib-stitching lines of the wing ribs and these tears showed frayed or 'teased' edges, indicating that the tears had occurred in flight. The in-flight tearing damage was most severe in the mid-span portion of the wing and less severe towards the wingtip and the wing root. Matching the tearing damage were very large areas over which the distinctive gold paint finish had become detached from the Ceconite fabric (Figure 2). This delamination was not matched in areas in which the fabric was contorted due to the wing's impact with the tree trunk, or on the right-hand wing, showing that the areas of missing paint finish had separated due to flapping of the fabric in flight. The portion of fabric recovered from the trees which the aircraft had first contacted was identified as being a complete panel of upper surface fabric between adjacent ribs, approximately two-thirds of the distance between the wing root and the strut attachment point.

Examination of the wooden wing spars showed them to be formed from good quality Sitka Spruce and there was no evidence of fungal attack or other deterioration. When the failures in the left-hand wing spars were examined, it became apparent that almost all these failures had occurred when the wingtip struck the tree trunk: the failures were either pure compressive failures or chord-wise bending failures, not consistent with flight loads on the wing. It was also apparent that, had these failures occurred in flight, the left-hand wing would not have been in its correct orientation at the impact with the tree trunk. One failure in the forward (that is, main) spar did, however, show characteristics consistent with failure under high flight loads as well as secondary impact damage on the outboard fracture face, indicating that the spar failed in flight. This failure in the forward spar was approximately 22 inches inboard of the wing strut attachment point, close to the outboard edge of the fabric panel recovered from the trees.

In summary, therefore, it appears most likely that the initial structural failure had occurred in the left-hand wing forward spar, approximately 22 inches inboard of the wing strut attachment point and that the left-hand wing was then subjected to large distortions, loading the upper and lower wing surfaces and causing the extensive damage to the fabric coverings.

Figure 2 - G-APOA, 15/11/93 - Left-hand wing, looking inboard
