## ACCIDENT

<b>Aircraft Type and Registration:</b>	Lindstrand 105A hot air balloon, G-RIMB	
<b>No &amp; Type of Engines:</b>	None	
<b>Year of Manufacture:</b>	2002	
<b>Date &amp; Time (UTC):</b>	11 December 2005 at 1455 hrs	
<b>Location:</b>	Darwen, Lancashire	
<b>Type of Flight:</b>	Public Transport (Passenger)	
<b>Persons on Board:</b>	Crew - 2	Passengers - 3
<b>Injuries:</b>	Crew - None	Passengers - 1
<b>Nature of Damage:</b>	Basket and burner support structure bent, arcing damage to burner	
<b>Commander's Licence:</b>	Commercial Pilot's Licence	
<b>Commander's Age:</b>	63 years	
<b>Commander's Flying Experience:</b>	950 hours (all on type) Last 90 days - 20 hours Last 28 days - 20 hours	
<b>Information Source:</b>	Aircraft Accident Report Form submitted by the pilot and information provided by the Met Office

## Synopsis

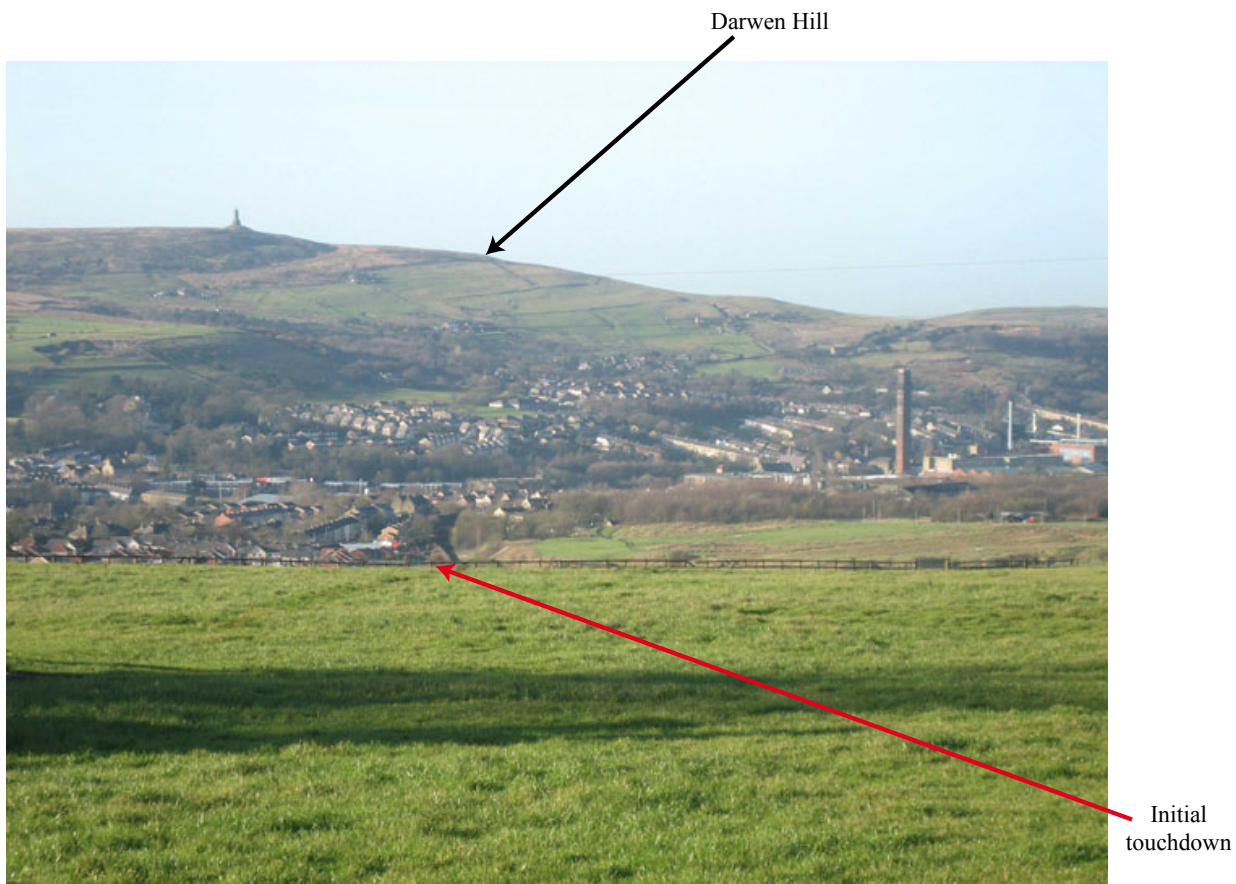
**Figure 1**

The landing site was on gently rising ground near the top of a ridge whose summit is at 1,063 ft amsl. Upwind, approximately 2 nm to the west of the landing site, the northern tip of Darwen Moor rises to almost 1,300 ft amsl. This promontory is visible in the background of the photograph in Figure 1. The area is dominated by numerous hills and valleys, aligned broadly north-south, with typical gradients of approximately 7%.

View west towards Darwen Hill

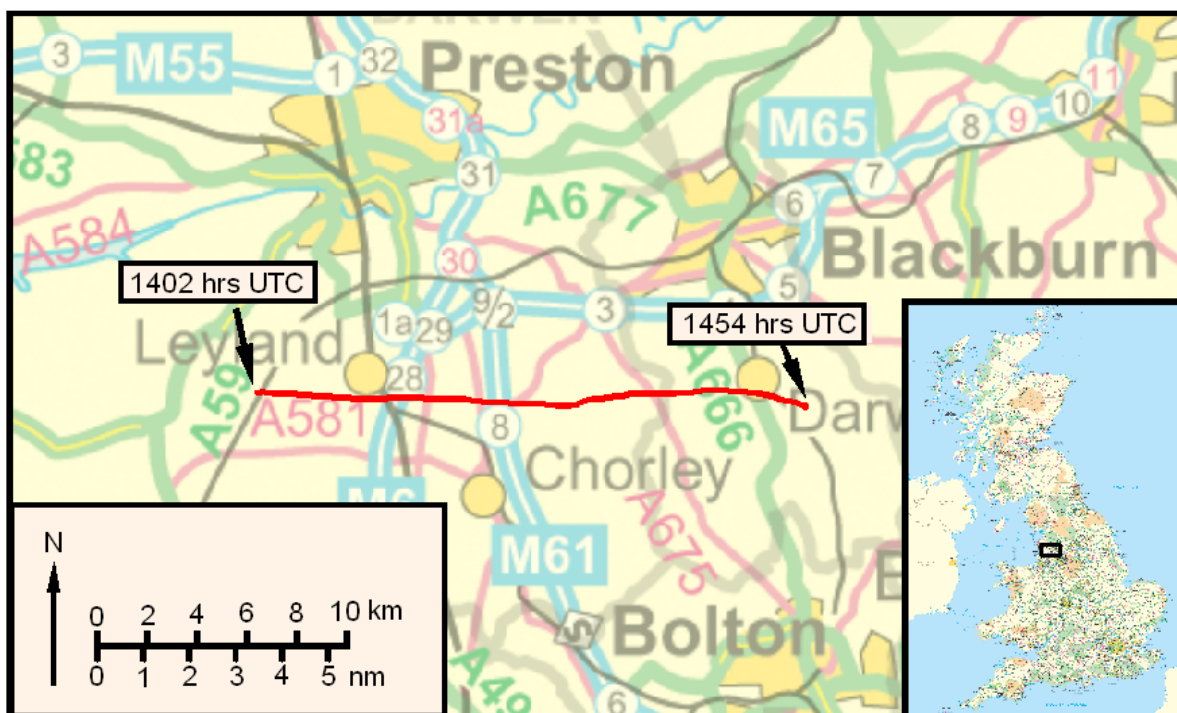
**Figure 2**

The flight recorded on the day of the accident started at 1402 hrs UTC, lasted 52 mins and covered 12 nm. The flight path of the accident flight is shown in Figure 2. Figure 3 shows a plot of the average ground speed of the GPS unit between the recorded track points. Figure 4 shows the end of the flight overlaid on an aerial photograph, aligned by reference to photographs of the landing points provided.

Flight path overview

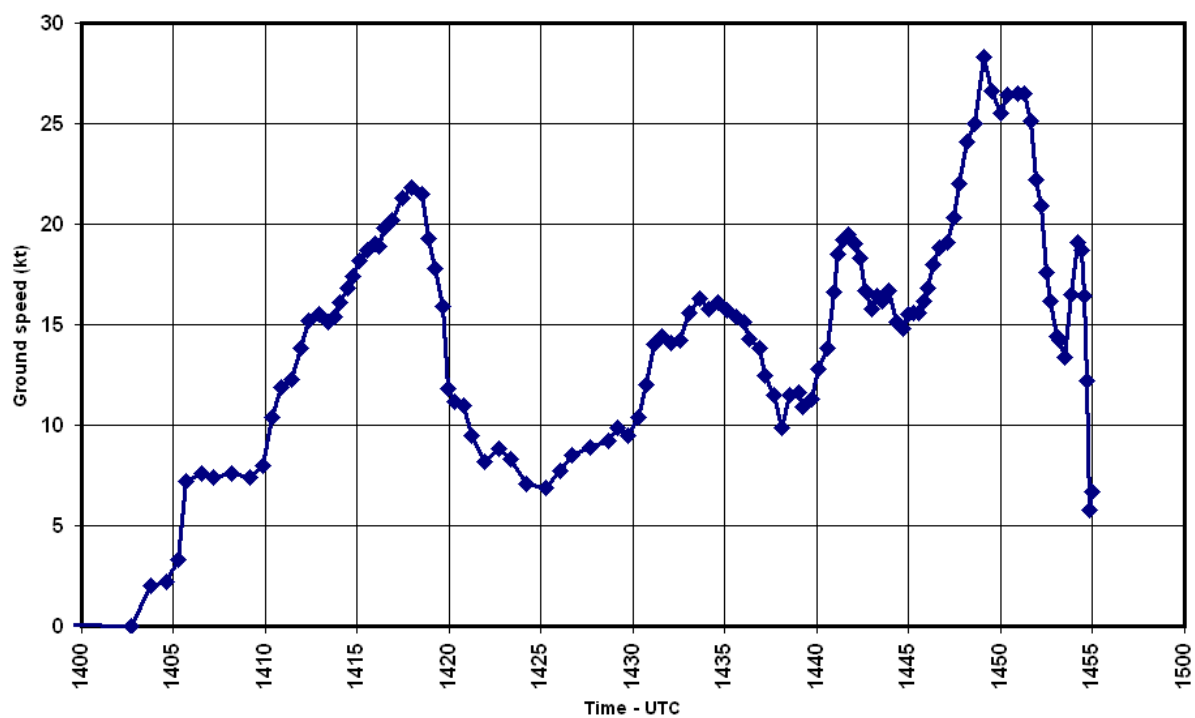
**Figure 3**

GPS speed

The ground speed of the balloon rose to approximately 22 kt during the first 15 minutes of flight. It then dropped to about 7 kt during the next 7 minutes and then climbed again, peaking at just over 28 kt, 5½ mins before the first touch down. The average ground speed between points then reduced to a minimum of just over 13 kt and climbed again by 6 kt in less than a minute, with an average 19 kt ground speed in the 21 seconds before the first touch down.

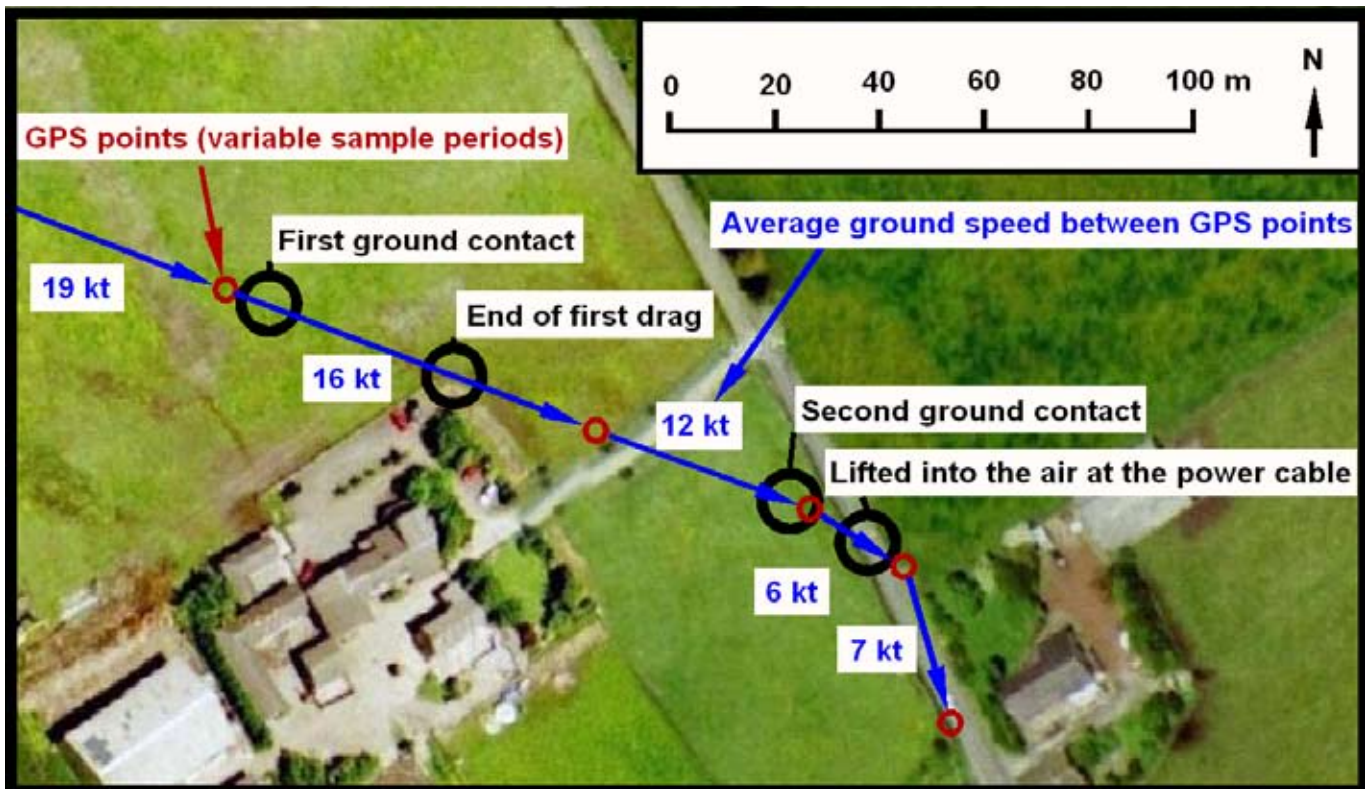
**Figure 4**

Final flight path
