AAIB Bulletin No: 11/94

Ref: EW/C94/7/3

Aircraft Type and Registration:	Kolb Twinstar Mk 3, G-MWWF	
No & Type of Engines:	1 Rotax 503 piston engine	
Year of Manufacture:	1992	
Date & Time (UTC):	21 July 1994 at 1845 hours	
Location:	Stradbroke, Suffolk	
Type of Flight:	Private	
Persons on Board:	Crew - 1	Passengers - 1
Injuries:	Crew - Fatal	Passengers - Fatal
Nature of Damage:	Landing gear collapsed, damage to propeller, fuselage and wing structure	
Commander's Licence:	Private Pilot's Licence (Microlight Aircraft)	
Commander's Age:	54 years	
Commander's Flying Experience:	214 hours (of which 62 were on type) Last 90 days - 10 hours Last 28 days - 2 hours	
Information Source:	AAIB Field Investigation

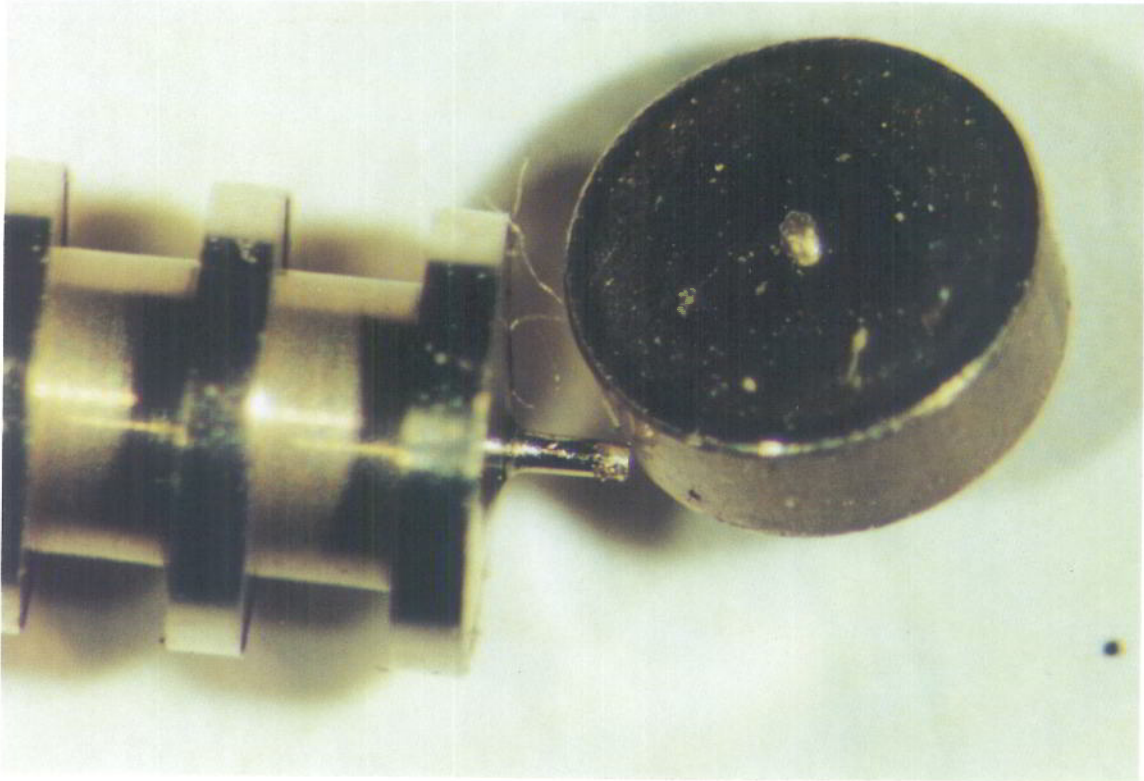
The wings and fuel containers were removed to transport the aircraft to Farnborough, and as the wires to the magneto switches had been disconnected by the fire service the engine was 'live', consequently the spark plug leads were removed from the plugs for safety. On arrival at Farnborough the engine systems were reconnected with the intention of running it with the minimum amount of disturbance from its condition at the crash site. The engine started on third pull, but could only be accelerated to 3,500 RPM by using choke as well as throttle, and at this speed the engine was rough. At 3,500 RPM the throttle position was as found at the accident site. Opening the throttle beyond this position caused a reduction in RPM. Both magnetos were proved to be serviceable and the fuel filter, although slightly contaminated, did not impede the flow of fuel. The needle on the rear carburettor was found to have worn through at the circlip and had dropped into the carburettor jet, restricting the flow of fuel to the rear cylinder. The needle was replaced and the engine easily achieved 6,000 RPM.

The needle was retained in position by a circlip which was split at the apex of the hole holding the needle; the edges of the split had 'machined' away the groove in the needle as it rotated under the forces generated by vibration. The split still held some fine continuous swarf when the needle was examined. Photographs show the needle with the tip 'machined' off, and the apex of the circlip recess.

Carburettor Needle showing 'machined' off tip and fine swarf

Rotax are developing a modification for new production which will introduce an 'O' ring to each side of the circlip to prevent the needle rotating. The modification is due on the production line at the end of the year. It is therefore recommended that :

94-35 The CAA require that the modification to the carburettor needle fixture on Rotax engines be made retrospective and mandatory, and that in the meantime the 50 hour check be also made mandatory.

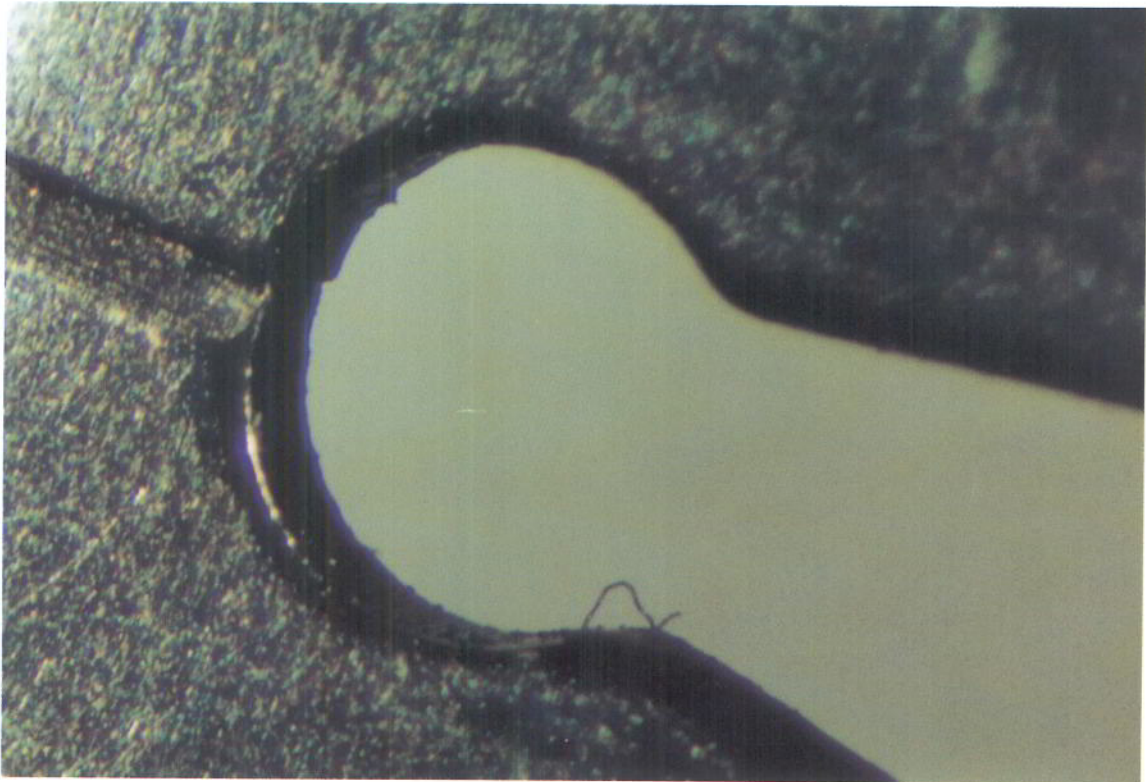
Circlip showing split in apex
