ACCIDENT

Aircraft Type and Registration:	1) Mainair Blade 912, G-MZBA 2) Schleicher ASW19B, G-DELA
No & Type of Engines:	1) 1 Rotax 912 UL piston engine 2) No engine
Year of Manufacture:	1) 1996 (Serial no: 1068-0296-7-W870) 2) 1981 (Serial no: 19346)
Date & Time (UTC):	6 May 2012 at 1251 hrs
Location:	Aboyne airfield, Aberdeenshire
Type of Flight:	1) Private 2) Private
Persons on Board:	1) Crew - 1 Passengers - None 2) Crew - 1 Passengers - None
Injuries:	1) Crew - 1 (Serious) Passengers - N/A 2) Crew - None Passengers - N/A
Nature of Damage:	1) Damage to airframe, pylon, wing and engine 2) Damage to right wing, tailplane and fin
Commander's Licence:	1) National Private Pilot's Licence 2) National Private Pilot's Licence
Commander's Age:	1) 62 years 2) 68 years
Commander's Flying Experience:	1) ~ 2,400 hours (of which 17 were on type) Last 90 days - 30 hours Last 28 days - 6 hours 2) 4,351 hours (of which 200 were on type) Last 90 days - 17 hours Last 28 days - 5 hours

Synopsis

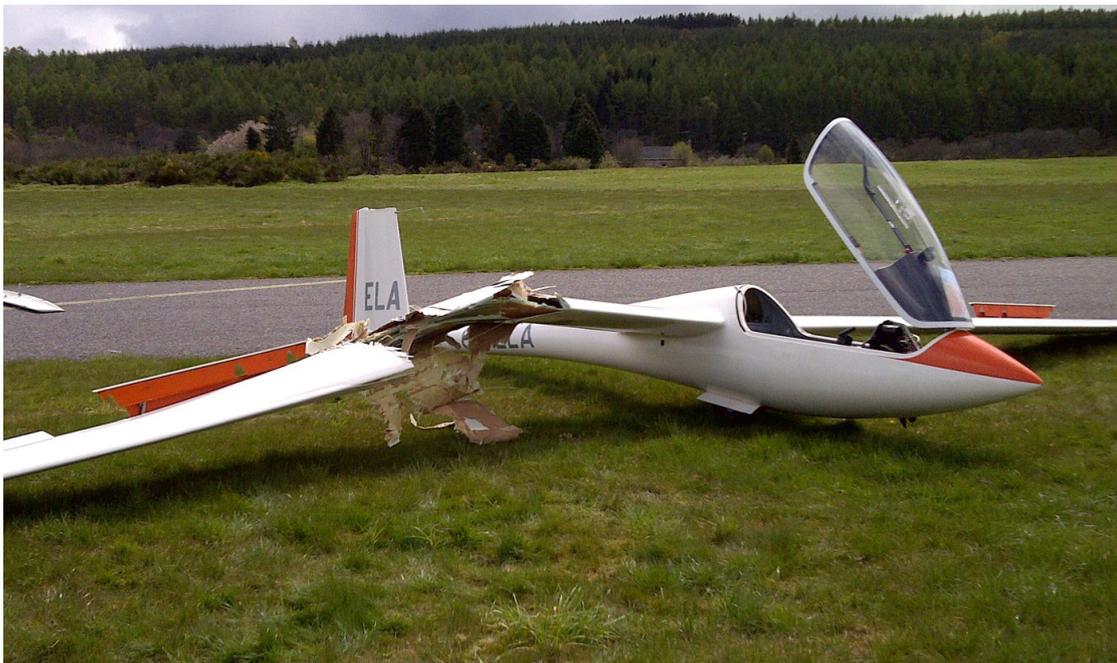
Figure 2

left at about the 10 o'clock position, and he instinctively applied full left rudder to avoid the microlight, but then there was a loud bang as the glider's right wing struck G-MZBA. When the dust cleared he found that his aircraft had come to rest on the northern side of the runway facing towards the north (Figure 2). He was not injured and was able to exit the glider unaided.

Damage to right wing of G-DELA
(photograph courtesy Martin Gallagher)
