**SERIOUS INCIDENT**

<b>Aircraft Type and Registration:</b>	Jetstream 4100, G-MAJA
<b>No &amp; Type of Engines:</b>	2 Garrett Airesearch TPE331-14GR-807H turboprop engines
<b>Year of Manufacture:</b>	1994 (Serial no: 41032)
<b>Date &amp; Time (UTC):</b>	18 July 2012 at 0835 hrs
<b>Location:</b>	In the cruise, 80 nm north of Newcastle
<b>Type of Flight:</b>	Commercial Air Transport (Passenger)
<b>Persons on Board:</b>	Crew - 3                      Passengers - 12
<b>Injuries:</b>	Crew - None                      Passengers - None
<b>Nature of Damage:</b>	None
<b>Commander's Licence:</b>	Airline Transport Pilot's Licence
<b>Commander's Age:</b>	29 years
<b>Commander's Flying Experience:</b>	2,600 hours (of which 158 were on type) Last 90 days – 158 hours Last 28 days - 50 hours
<b>Information Source:</b>	AAIB Field Investigation

**Synopsis**

The flight crew experienced a period of EFIS screen blanking whilst passing through an area of electrostatic activity.

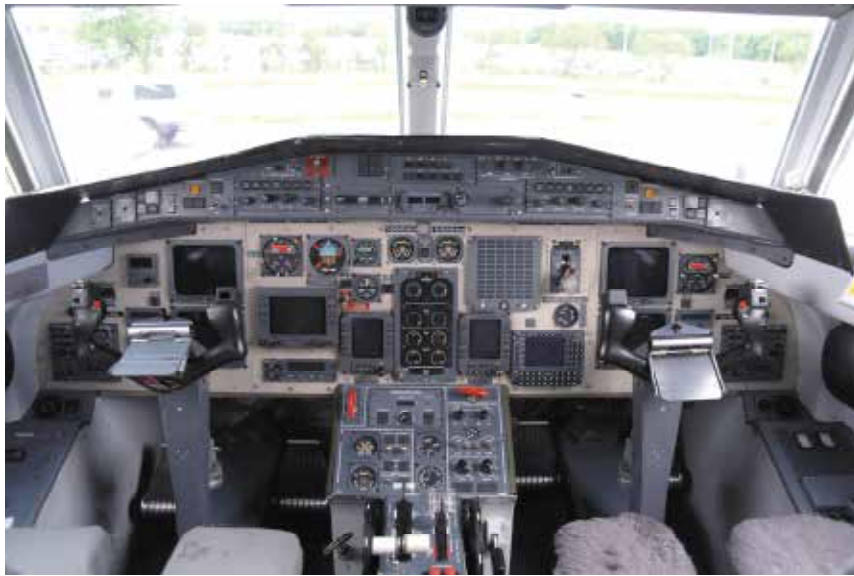
**Figure 1**  
G-MAJA cockpit

About 2 minutes after initial failure, the three remaining EFIS screens went blank. The commander took control and flew the aircraft with reference to the aircraft's main altimeter and standby instruments, situated left

of centre on the main instrument panel (Figure 1). The co-pilot declared a PAN to ATC. After discovering that the current weather to the north was unfavourable for their situation, the crew elected to divert to Newcastle International Airport.
