SERIOUS INCIDENT

Aircraft Type and Registration:	AS365N3 Dauphin II, G-REDG	
No & Type of Engines:	2 Turbomeca Arriel 2C turboshaft engines	
Year of Manufacture:	2010	
Date & Time (UTC):	18 April 2011 at 0837 hrs	
Location:	Norwich Airport	
Type of Flight:	Commercial Air Transport (Passenger)	
Persons on Board:	Crew - 2	Passengers - 5
Injuries:	Crew - None	Passengers - None
Nature of Damage:	None	
Commander's Licence:	Airline Transport Pilot's Licence	
Commander's Age:	37 years	
Commander's Flying Experience:	2,300 hours (of which 1,300 were on type) Last 90 days - 73 hours Last 28 days - 20 hours	
Information Source:	AAIB Field Investigation

Synopsis

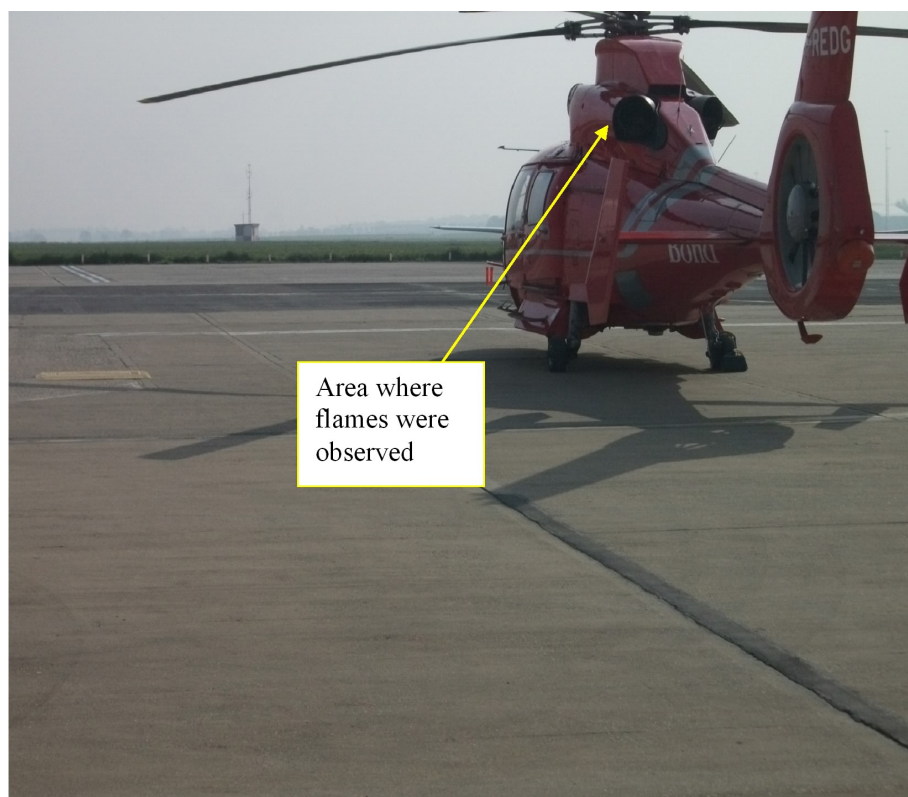
Figure 2

The engineer reported that as the helicopter taxied away, he observed flames coming from the 7 to 11 o'clock position on the No 1 (left) engine, between the engine and the engine cowling (Figure 2). He did not recollect seeing any smoke at this time. The engineer informed the operator's base manager, who was also in the operations room, to contact the flight crew by radio and tell them to shut the engines down. The base manager attempted to contact the crew but was unsuccessful.

View of the helicopter from the operations room (helicopter pointing east)

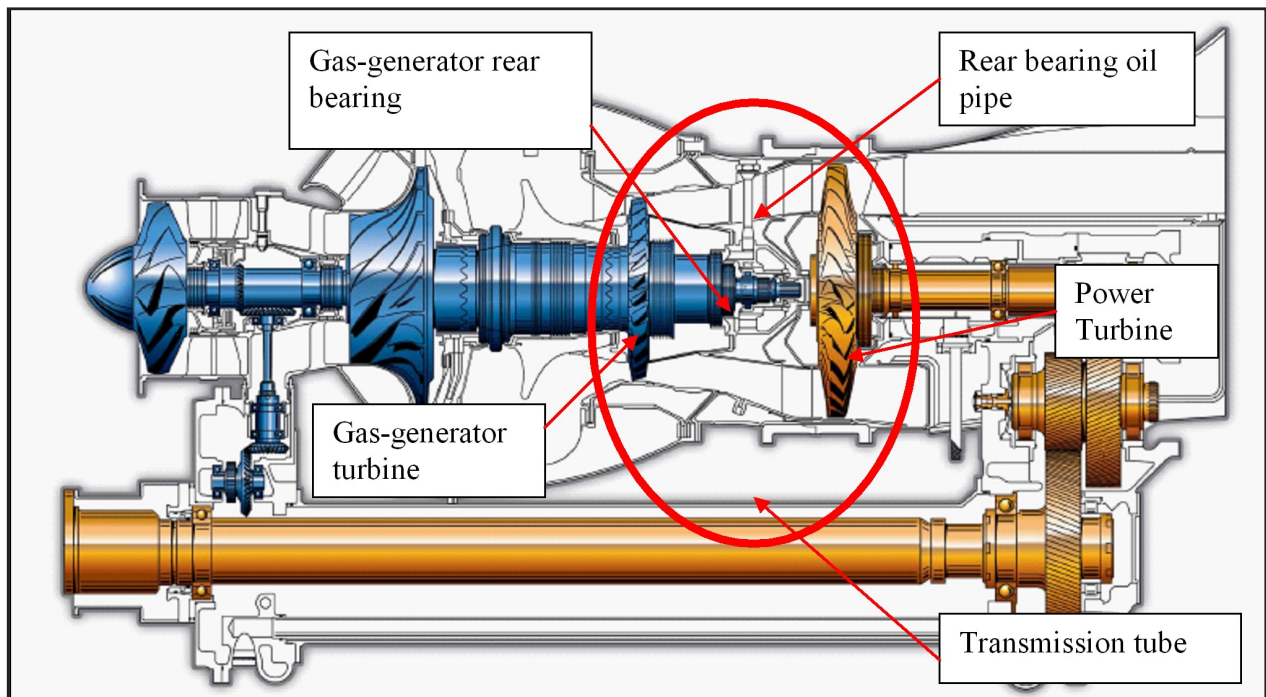
Figure 3

The engineer then opened the No 1 engine cowl and reported seeing a large plume of smoke and a single flame about 6 to 8 inches long on the underside of the engine, with oil dripping from the flange between the gas-generator turbine and power turbine modules onto the transmission tube (Figure 3).

Location of the oil leak and fire

The operator considered that the leaking oil from the lower duct connection had pooled in the bottom of the casing, then exited at the split line between the gas-generator and power turbine modules before igniting on the hot engine casing. However, they stated that the torque on the duct had not been changed during the maintenance check. The operator stated that in their opinion the internal oil leak was supplemented by a leak at the o-ring seal (the same o-ring that had been replaced during the maintenance check), as evidenced during the engine strip inspection by oil streak marks on the outer casing, originating from this area. They considered that the o-ring might have been damaged during installation.

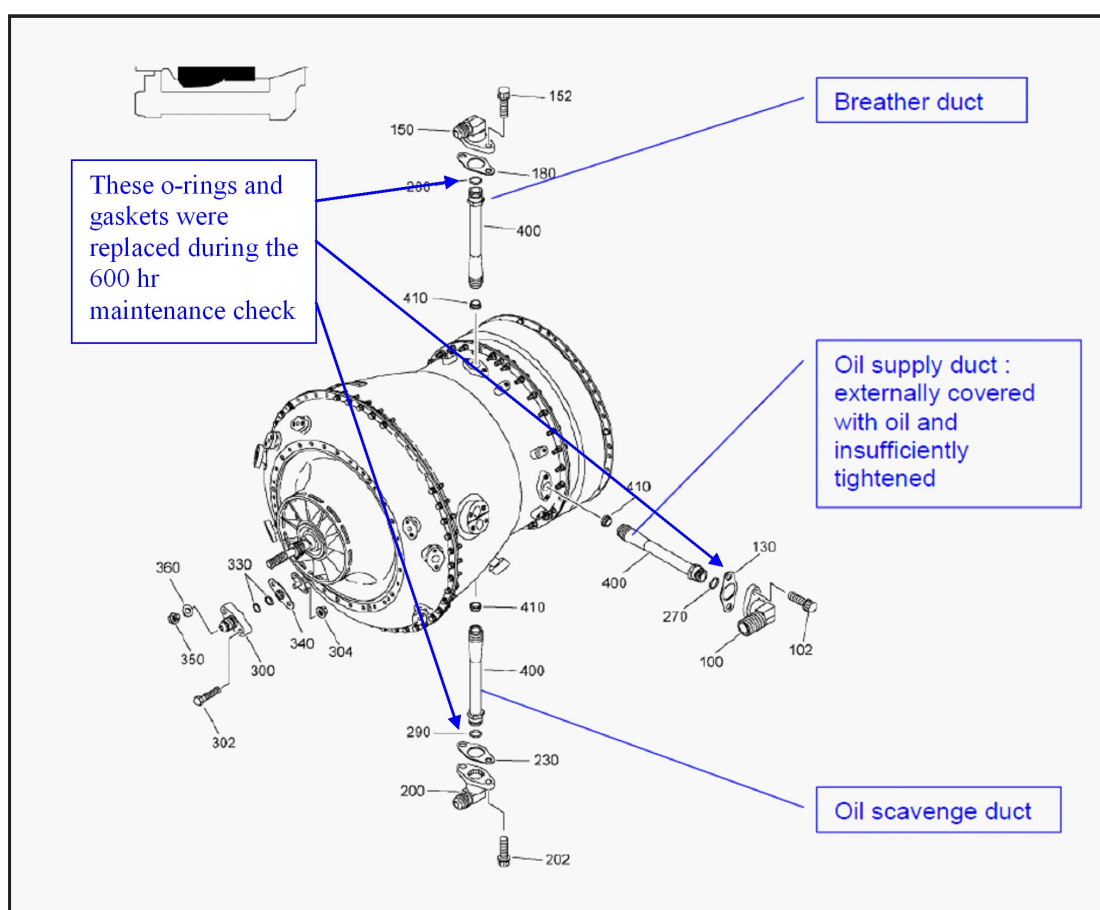
Figure 4
Engine strip findings

The operator removed the engine following the incident and returned it to the manufacturer, who carried out a detailed strip examination. This identified evidence of oil leaking around the split line of the module three and four casings, the lower thermocouple probe ports, and the lower area of the exhaust. Oil contamination was also found in the air cooling system. This indicated that oil was likely to have entered the gas path whilst the engine was operating. During disassembly, the lower connection of the gas-generator rear-bearing oil supply duct was found to have a torque of 10 Nm rather than the required 20 Nm. The outside of the duct was also wet with oil (Figure 4).

Given that the engine had been operated for 600 hrs without a reported oil leak and the star-shaped fitting prevents rotation of the duct in normal operation, it is unlikely that the low torque on the oil supply duct existed prior to the maintenance input. It is, therefore, possible that the oil supply duct was rotated anti-clockwise during removal or refitting of the flanged union, lowering the torque on the duct from the required 20 Nm to 10 Nm and reducing the contact pressure on the copper seal, thus creating the leak path.

It is recommended that Turbomeca add a caution to the Arriel 2C Maintenance Manual to highlight the consequences of rotating the gas-generator rear-bearing oil ducts during removal or refitting of the flanged unions and to publish suitable technical advice to operators to raise awareness of this risk.

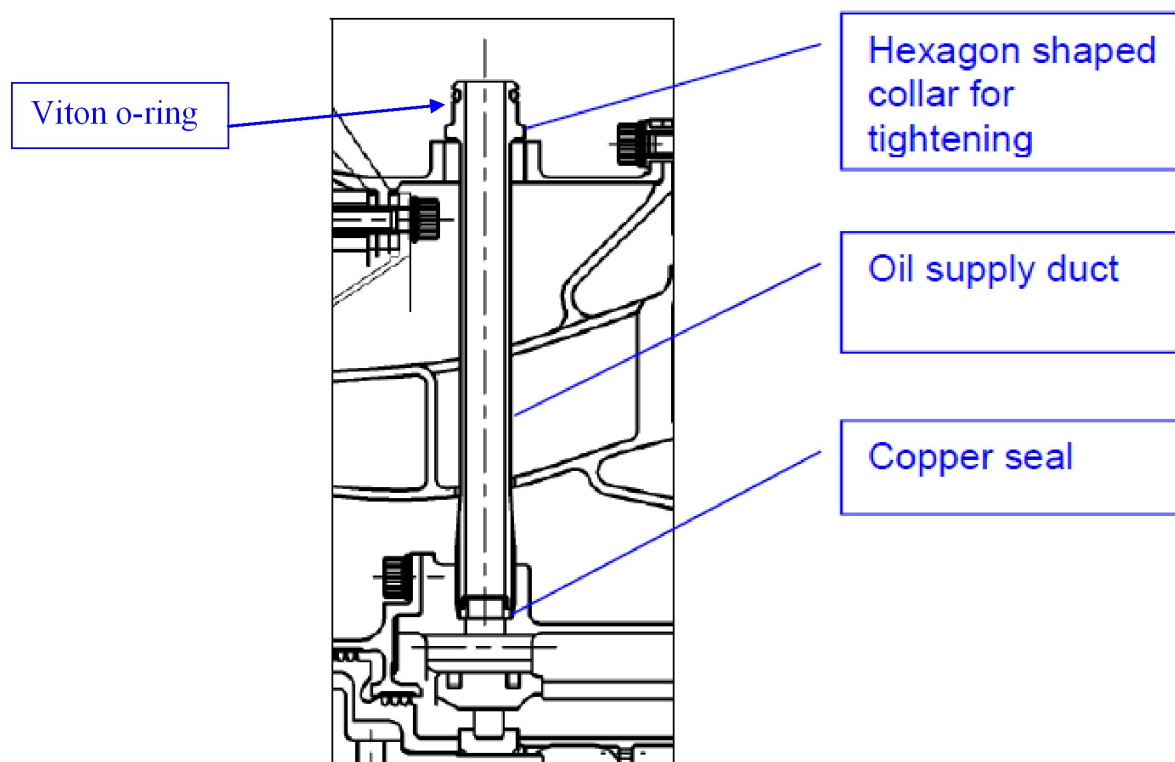
Figure 5

The oil ducts have a thread at the lower end, which screws into the bearing housing, with the torque loading sealing the duct against a copper seal. This is achieved by means of a hexagonal collar at the external end of the duct (Figure 5). The right-angle flanged union that

caps the duct has a star-shaped fitting, which prevents the duct rotating in service. The flanged union is located by two screws, which screw into a boss on the engine casing. The duct is sealed with the flange by a viton o-ring on the duct and a copper gasket between the flange and the casing. The flange therefore, has to be removed to allow replacement of the o-ring and gasket, which is required every 600 hrs. As a consequence of the star-shaped fitting, if the flanged union is refitted, such that the screw holes do not line up with the casing, the duct has to be rotated clockwise to ensure torque in the lower fitting of the duct is increased rather than reduced. If the duct is rotated anti-clockwise, the torque will be reduced and the duct would no longer seal properly on the copper seal, potentially resulting in an oil leak. The manufacturer advised that there had been no previous experience of a leak caused by loss of torque on the duct. Their experience of oil leaks at the upper connection of the duct immediately after installation, indicated the cause to be damage to the o-ring during its replacement.

Bearing oil supply duct

The engine manufacturer advised that they have amended the maintenance manual to include a note identifying the need to rotate the oil ducts in the direction that increases torque on the lower connection rather than reducing it, when aligning the screw holes of the flanged union with the casing. The note states:

'Note: If the passage holes of the attaching screws of the flange union and the turbine casing are not aligned, increase duct tightening, refer to task 72-43-10-900-801'
