AAIB Bulletin No: 2/96

Ref: EW/A95/12/1

Aircraft Type and Registration: Boeing 747-436, G-BNLT

Nature of Damage: Damage to APU and surrounding structure

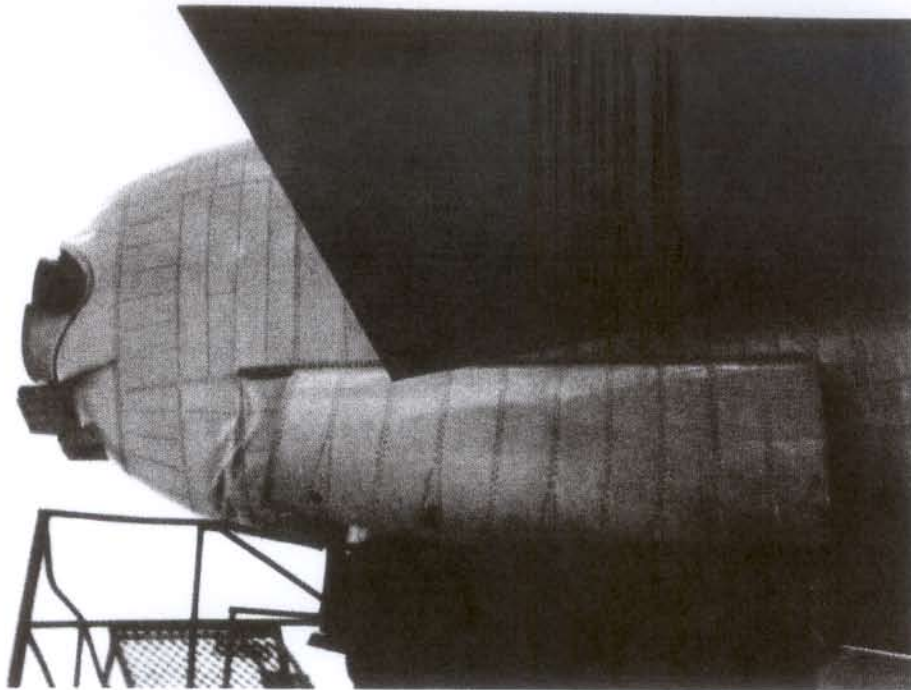
Examination of the aircraft by engineering personnel from the operator revealed that although the level of fire/heat damage was relatively low, structural damage had occurred to the tailcone/APU bay, bay doors and intake ducting (Figure 1), with evidence to show that the tailcone had 'sprung' in excess of 4 inches to the right to make contact with the inboard end of the inner elevator. Inspection of the APU itself, type P&WC 901A, revealed that a pipe nut on the secondary fuel manifold was apparently loose where it connected to the No 1 (12 o'clock position) fuel nozzle. Figure 2 shows this nut, as found, and it may be seen that several turns of the thread on the nozzle assembly are exposed when compared to the primary connection, which was found tight. After a temporary repair had been made to the damaged structure the aircraft was flown, without passengers, to the operator's base at Heathrow where a full examination was carried out and rectification work instituted.

Damage to tailcone. Internal damage included broken/deformed frames and bent APU support struts

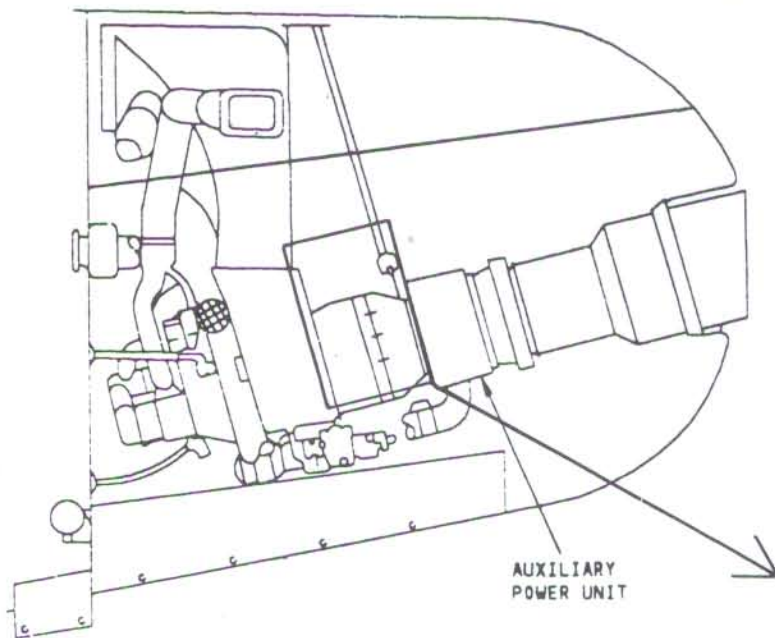
Sooting/heat damage to APU

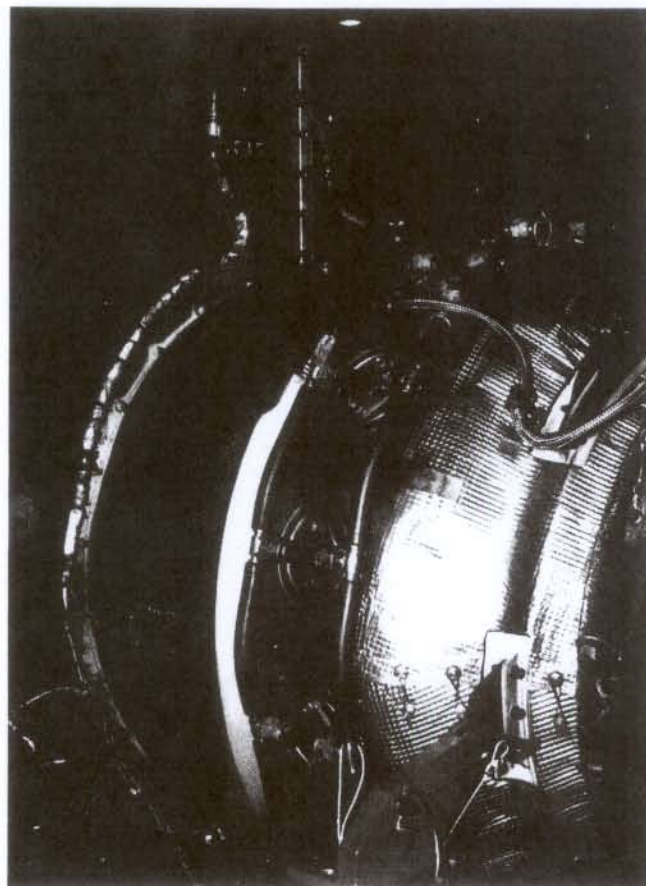
Figure 2

Examination of the components from the loose connection revealed the presence of brown coloured deposits over most of the thread forms, particularly on the pressure faces, and the conical sealing surfaces of the pipe flare and nozzle fitting. This was not typical of other manifold connections, all others examined exhibiting bright, relatively polished, surfaces. This comparison is shown in Figure 4 and indicates that the pipe nut may have been loose for a period of time.

Loose pipe nut as originally found

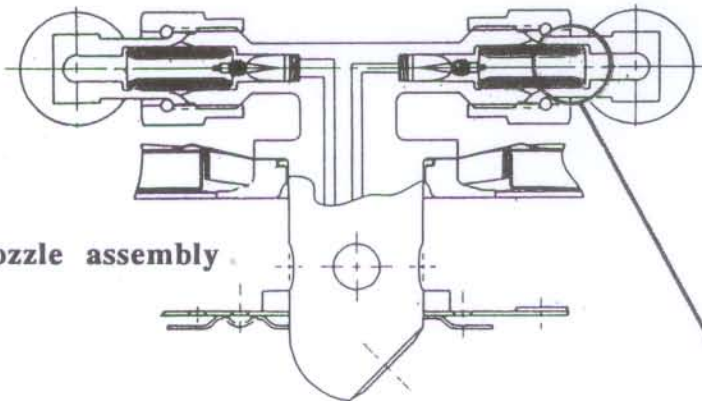
Primary connection

Secondary connection

Nozzle assembly

Mechanical and rubber witness marks
