AAIB Bulletin No: 2/96

Ref: EW/A95/12/1

| Aircraft Type and Registration: | Boeing 747-436, G-BNLT | |
| Nature of Damage: | Damage to APU and surrounding structure | |

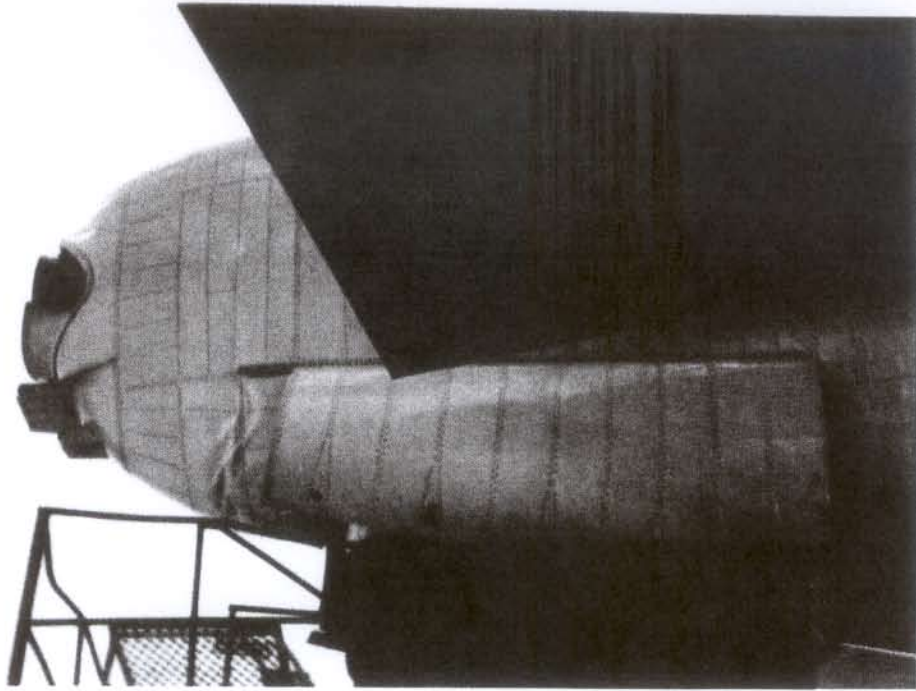
Examination of the aircraft by engineering personnel from the operator revealed that although the level of fire/heat damage was relatively low, structural damage had occurred to the tailcone/APU bay, bay doors and intake ducting (Figure 1), with evidence to show that the tailcone had 'sprung' in excess of 4 inches to the right to make contact with the inboard end of the inner elevator. Inspection of the APU itself, type P&WC 901A, revealed that a pipe nut on the secondary fuel manifold was apparently loose where it connected to the No 1 (12 o'clock position) fuel nozzle. Figure 2 shows this nut, as found, and it may be seen that several turns of the thread on the nozzle assembly are exposed when compared to the primary connection, which was found tight. After a temporary repair had been made to the damaged structure the aircraft was flown, without passengers, to the operator's base at Heathrow where a full examination was carried out and rectification work instituted.

Damage to tailcone. Internal damage included broken/deformed frames and bent APU support struts

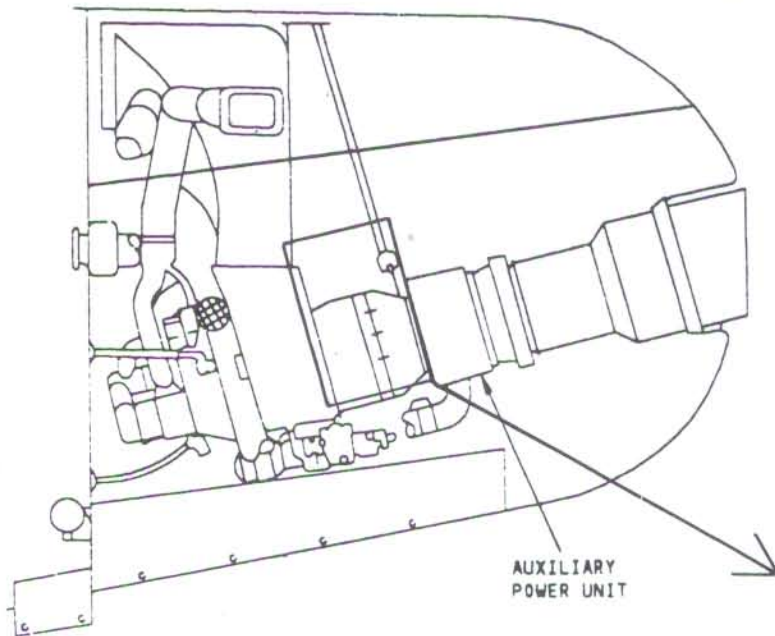
Sooting/heat damage to APU

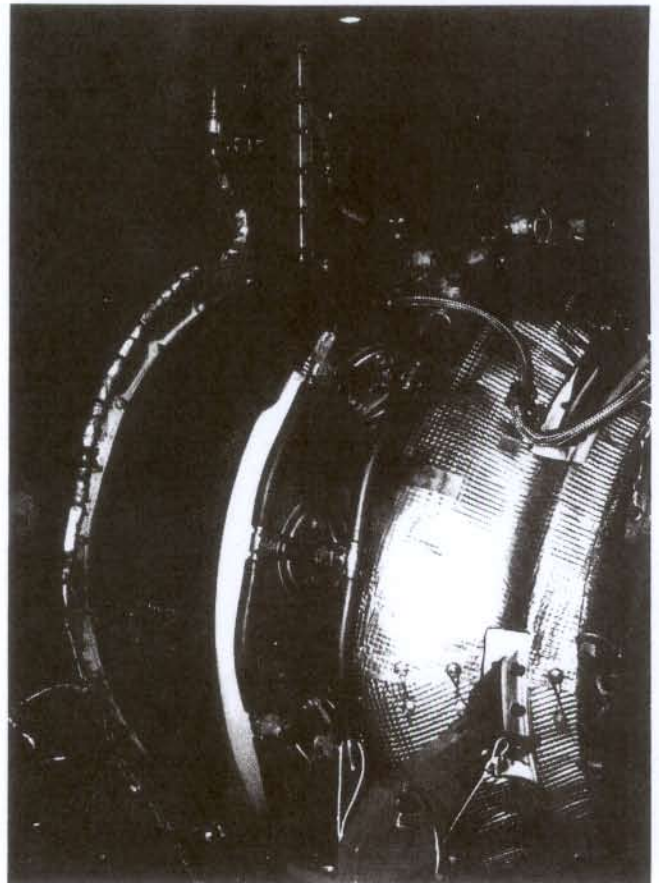
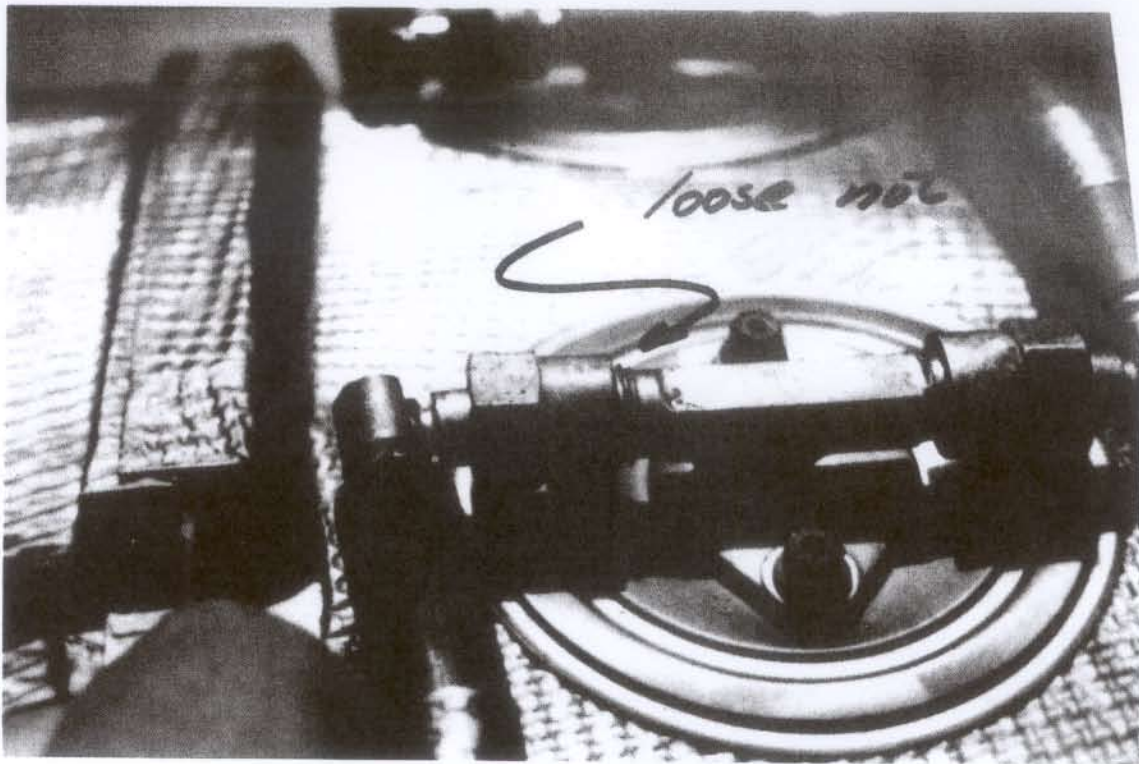
Figure 2

Examination of the components from the loose connection revealed the presence of brown coloured deposits over most of the thread forms, particularly on the pressure faces, and the conical sealing surfaces of the pipe flare and nozzle fitting. This was not typical of other manifold connections, all others examined exhibiting bright, relatively polished, surfaces. This comparison is shown in Figure 4 and indicates that the pipe nut may have been loose for a period of time.

Loose pipe nut as originally found

Primary connection

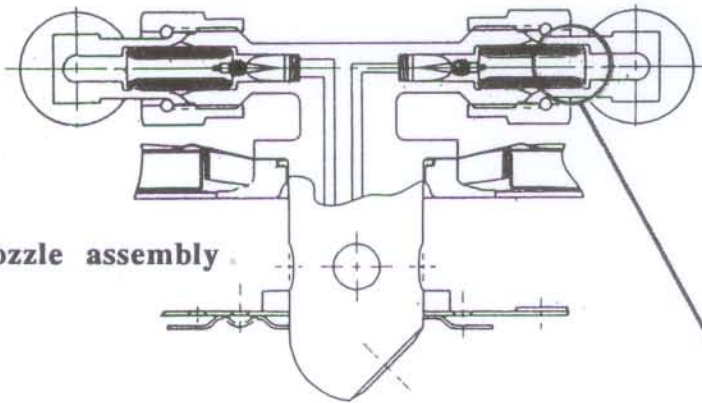
Nozzle assembly

Mechanical and rubber witness marks
