ACCIDENT

Aircraft Type and Registration:	Piper PA-32R-301 Saratoga SP, G-BJCW	
No & Type of Engines:	1 Lycoming IO-540-K1G5D piston engine	
Year of Manufacture:	1981 (Serial no: 32R-8113094)	
Date & Time (UTC):	6 June 2013 at 1701 hrs	
Location:	Humberside Airport	
Type of Flight:	Private	
Persons on Board:	Crew - 1	Passengers - 3
Injuries:	Crew - None	Passengers - None
Nature of Damage:	Damage to left wing	
Commander's Licence:	Commercial Pilot's Licence	
Commander's Age:	61 years	
Commander's Flying Experience:	671 hours (of which 300 were on type) Last 90 days - 10 hours Last 28 days - 2 hours	
Information Source:	Aircraft Accident Report Form submitted by the pilot, occurrence reports submitted by the pilot and Aerodrome Controller; additional information from Humberside ATC

Synopsis

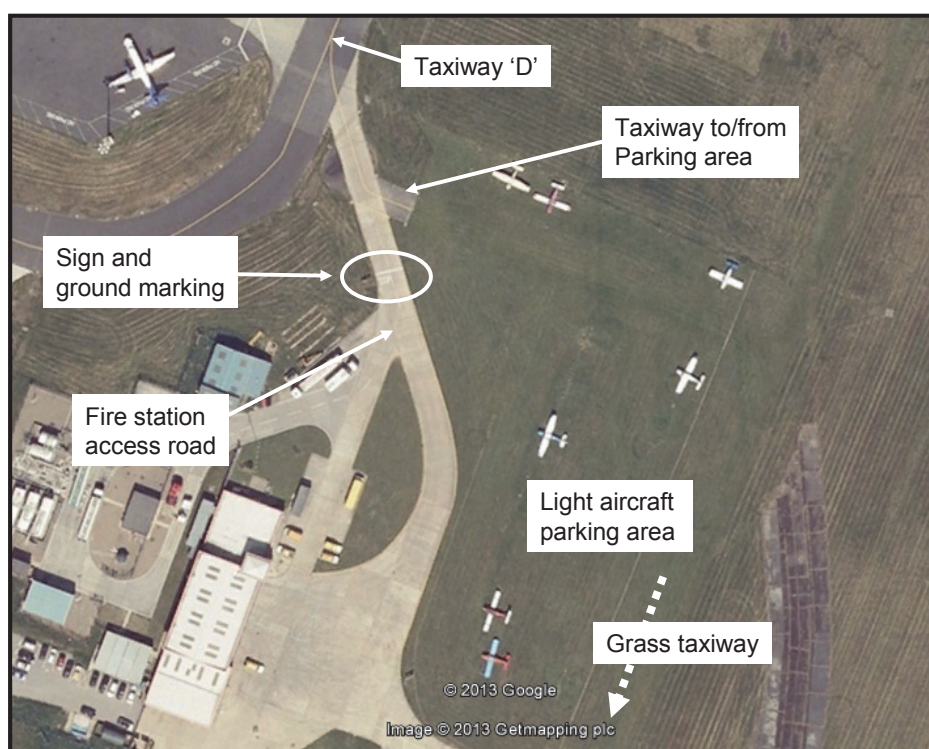
Figure 1

The pilot prepared the aircraft for a flight with three passengers from Humberside to Southend. It was daylight and the weather conditions were good. The aircraft was parked facing about 020° on a grass area designated as the light aircraft parking area (Figure 1). It

The pilot taxied the aircraft onto a concrete roadway to his left. However, this section of concrete was the fire station access road and was not for use by aircraft. The controller had intended to direct the pilot to Taxiway Delta via the concrete ramp which joined the access road further along, this being the normal access from the parking area to the hard taxiway. The boundary between the parking area and the access road that the aircraft crossed was marked by seven low-level signboards with arrows pointing towards the access ramp. There were also triangular black-and-white striped ‘bad ground’

Light aircraft parking area with surrounding roads and taxiways

A Unit Investigation at Humberside made two recommendations intended to prevent reoccurrence. These covered the provision of enhanced taxiing information to pilots using the light aircraft parking area and options to reduce the hazard posed by the signpost in case other aircraft inadvertently taxied onto the roadway.
