**AAIB Bulletin No: 2/94**      **Ref: EW/G93/08/20**      **Category: 1.3**

**Aircraft Type and Registration:** Morane Saulnier Rallye 110ST, G-BKGT  
**No & Type of Engines:** 1 Lycoming O-235-L2A piston engine  
**Year of Manufacture:** 1982

**Date & Time (UTC):** 18 August 1993 at 1110 hrs  
**Location:** Wellesbourne Mountford Airfield, Warwickshire  
**Type of Flight:** Private  
**Persons on Board:** Crew - 1      Passengers - 1

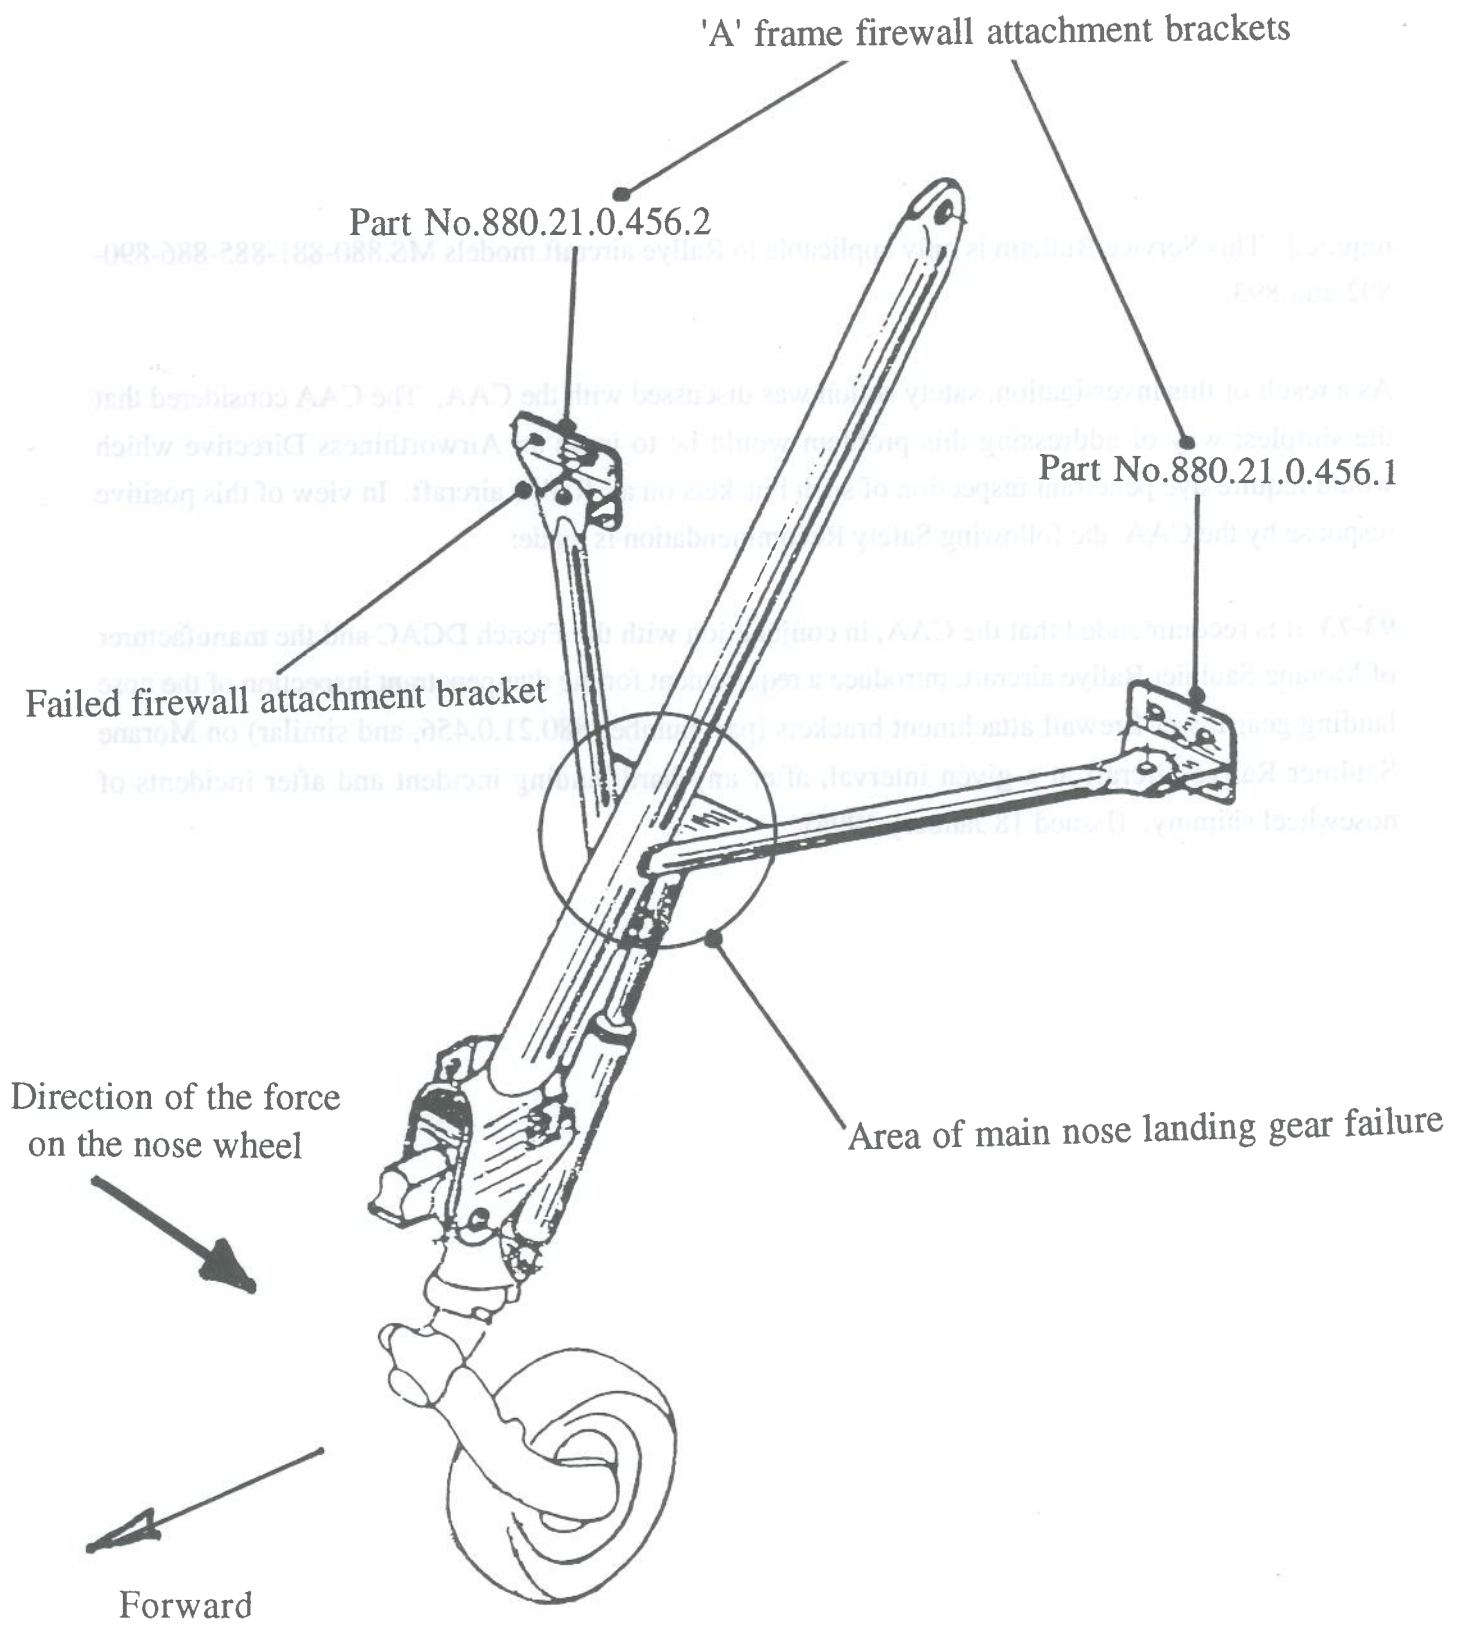
Figure 1 Nose Landing Gear

Examination of the failed nose landing gear showed that the main failure was in the area where the support 'A' frame was welded to the landing gear leg (see Figure 1). This failure was of a buckling and overload nature, predominantly in a rearwards direction, with some buckling towards the left side of the aircraft. There was no evidence of fatigue or of pre-existing defect in the area of the main failure. Further examination of the nose landing gear and the aircraft revealed that the right-hand 'A' frame firewall attachment bracket (see Figure 1), part number 880.21.0.456.2 had failed some time prior to the nose landing gear failure. Metallurgical examination of the bracket concluded that a crack,

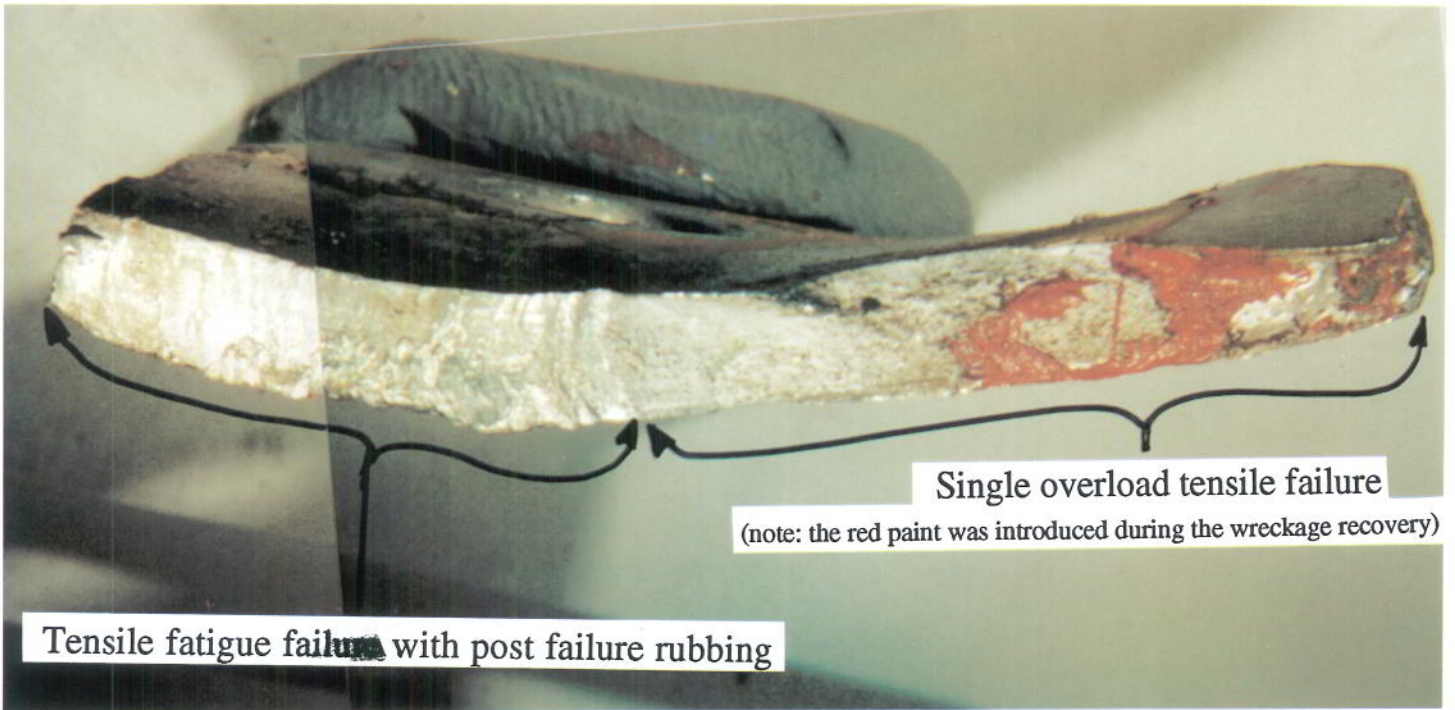
approximately half the width of the attachment bracket, had been initially caused by a single large overload force from the right-hand side (Photograph No.1). The remainder of the bracket had failed in fatigue over a period of time. Evidence of metal-to-metal rubbing on the failed faces of the bracket indicated that this failure had been present during a number of aircraft cycles prior to the nose landing gear failure. Examination of the nosewheel revealed severe damage to the right-hand rim which had occurred some time prior to the nose landing gear failure. There was no damage to the nosewheel tyre side wall, or to the inflation valve on the right-hand side of the wheel, indicating that the nosewheel tyre had been renewed between the time that the damage had occurred to the nosewheel rim and the nose landing gear had failed. There were no entries in the aircraft's log book to indicate that any damage or impact in the nosewheel area had taken place, although a new nosewheel tyre had been fitted on 31 May 1991. Since the nosewheel tyre was changed a Certificate of Airworthiness maintenance Check, an Annual Maintenance Check and numerous 50 hour Maintenance Checks had been carried out. Examination of the aircraft's Maintenance Manual did not reveal any requirement to check the nose landing gear lower firewall attachment brackets for cracks during any routine maintenance check.

Photograph No 1 **Fractured Nose Landing Gear 'A'  
Frame Firewall Mounting  
Bracket**  
(note: the photograph is upside down)

**93-73** It is recommended that the CAA, in conjunction with the French DGAC and the manufacturer of Morane Saulnier Rallye aircraft, introduce a requirement for the dye-penetrant inspection of the nose landing gear lower firewall attachment brackets (part number 880.21.0.456, and similar) on Morane Saulnier Rallye aircraft at a given interval, after any hard landing incident and after incidents of nosewheel shimmy. (Issued 18 January 1994)

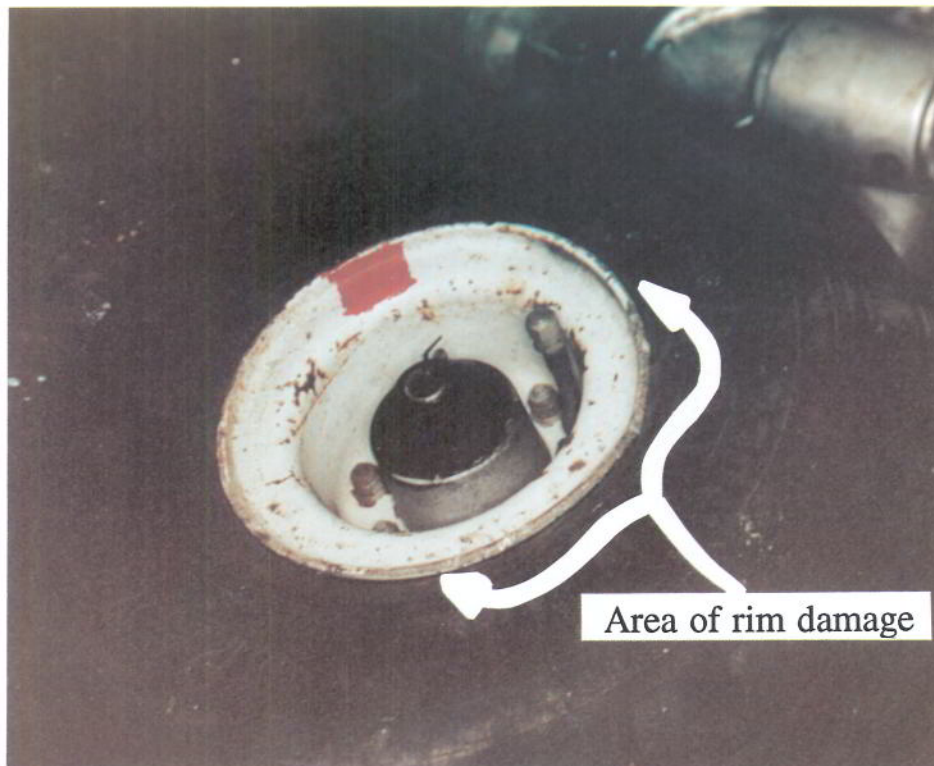
Photograph No 2 **Damaged Nose Wheel right-hand  
Rim**
