ACCIDENT

| Aircraft Type and Registration: | Boeing 737-436, G-DOCT | |
| Location: | Aberdeen Airport | |

Synopsis

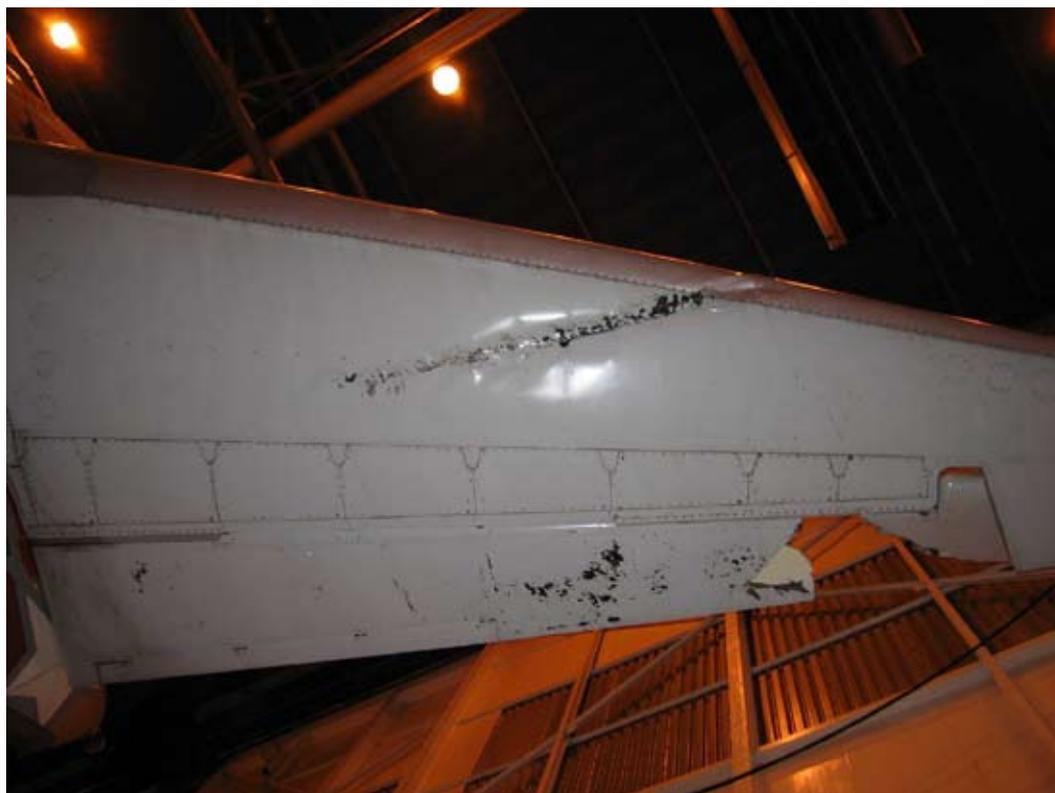
Figure 2

The aircraft sustained damage to its left tailplane and left elevator. There was a dent 2.4 metres long on the underside of the left tailplane as depicted in Figure 2. The dent contained pieces of black bitumen from the asphalt section that had struck it. Some of the tailplane skin within the dent had torn and some ribs had buckled. A section of the elevator, approximately 0.9 m by 0.6 m, had completely detached, causing a separation between the outboard section of the elevator (containing the balance weights) and the remainder of the elevator – see Figure 3. The elevator underside was peppered with pieces of black bitumen. The damaged sections of elevator were found in the grass area behind the Runway 16 threshold, close to the extended runway centreline. The farthest pieces were found 132 metres behind the threshold.

Damage to left tailplane and left elevator on G-DOCT

The damage to G-DOCT's left tailplane and left elevator was caused by one or more strikes from large sections of asphalt that had been lifted from the blast pad by the force of the aircraft's jet blast. The largest section of dislodged asphalt found was approximately 1.8 m by 1.5 m, but the 2.4 m dent on the underside of the tailplane indicated that it had been struck by a larger section which had then split. The flight crew of the following aircraft, who had observed the lifting of the asphalt sections, estimated the largest to be 2 m by 3 m, and such a section, 6 cm thick, would have weighed approximately 756 kg. It was not possible to determine accurately where the tailplane was located relative to the blast pad at the time of the strikes, but it would have been positioned approximately where it is depicted in Figure 4.

The damage to the tailplane would have had minimal aerodynamic effect, but the elevator was missing a section almost 1 metre long and this would have reduced the elevator's effectiveness. In the event, the flight crew did not have any difficulty rotating the aircraft to takeoff attitude and did not report any control difficulties during the flight. However, further elevator surface loss could have prevented rotation and resulted in an aborted takeoff beyond V_1^5 speed and a potential runway over-run. A more severe outcome could have resulted if the elevator's structure had been compromised to the point where the aerodynamic loads in flight caused further elevator damage and possible separation. The change in the elevator's aerodynamic and mass properties could also have made the elevator more susceptible to flutter.

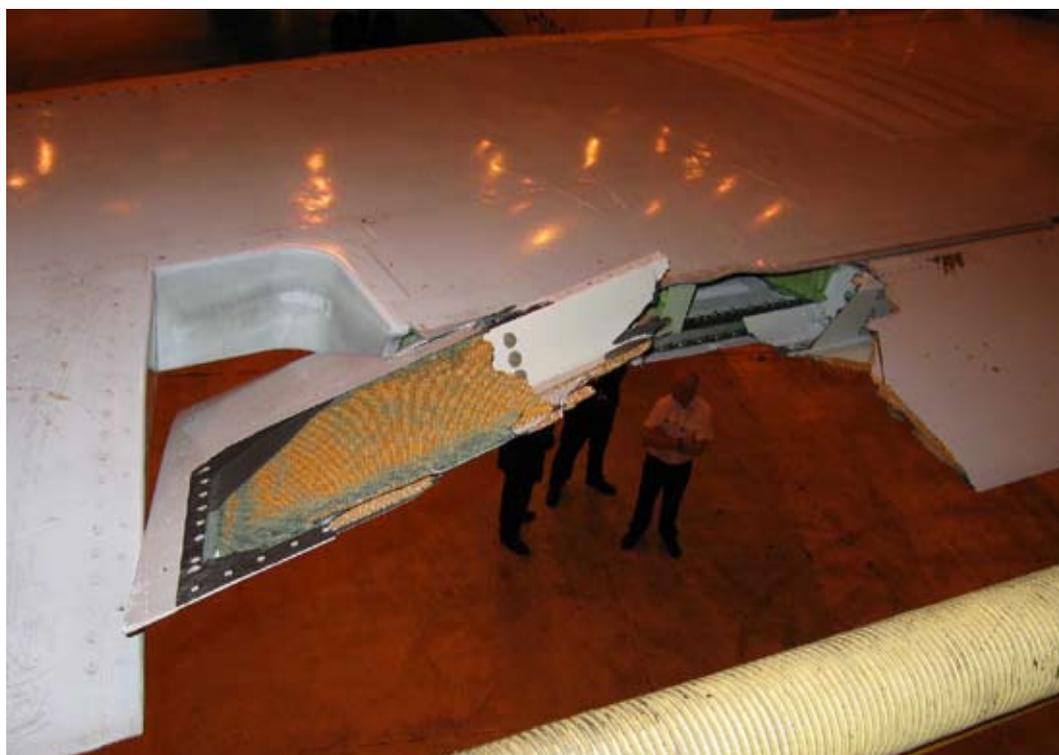
Figure 3

Damage to left elevator of G-DOCT, showing separation of outboard section

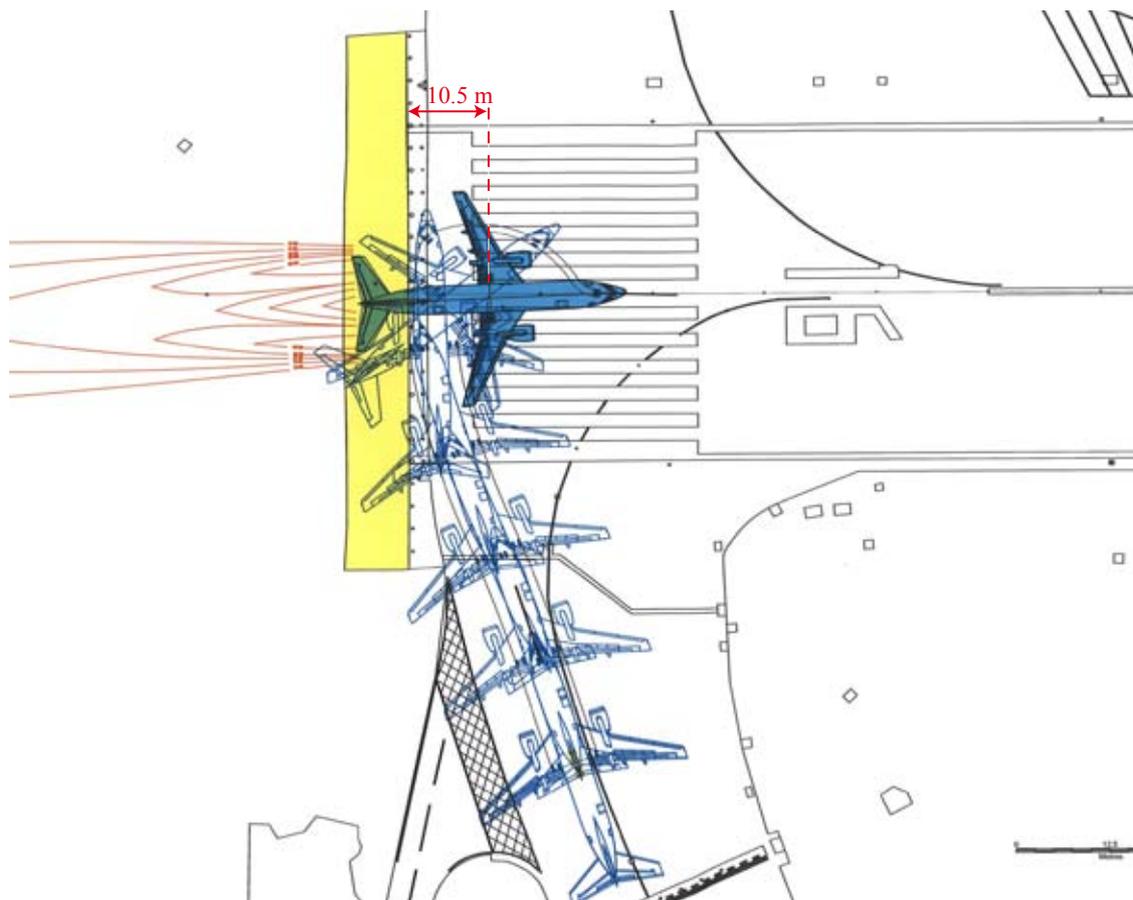
Predicted line-up path for a 737-400 trying to maximize takeoff distance available without running over the blast pad (blast pad shown in yellow)

damage because the pad was not designed to withstand the taxiing loads of aircraft. From the modelling shown in Figure 4 it was determined that the left gear would have passed very close to, and possibly directly over, the blast pad in order to place the tailplane in a position to be struck by blown sections of the pad. On this occasion, both the flight crew of G-DOCT and that of the following aircraft stated that no wheel passed over the blast pad. It is probable, however, that in the past other aircraft had taxied over the blast pad surface because aircraft had been observed manoeuvring close to the runway end and an aircraft tyre mark was seen on the re-surfaced blast pad. The cumulative effect of these occasional aircraft taxiing loads could have weakened the blast pad surface.

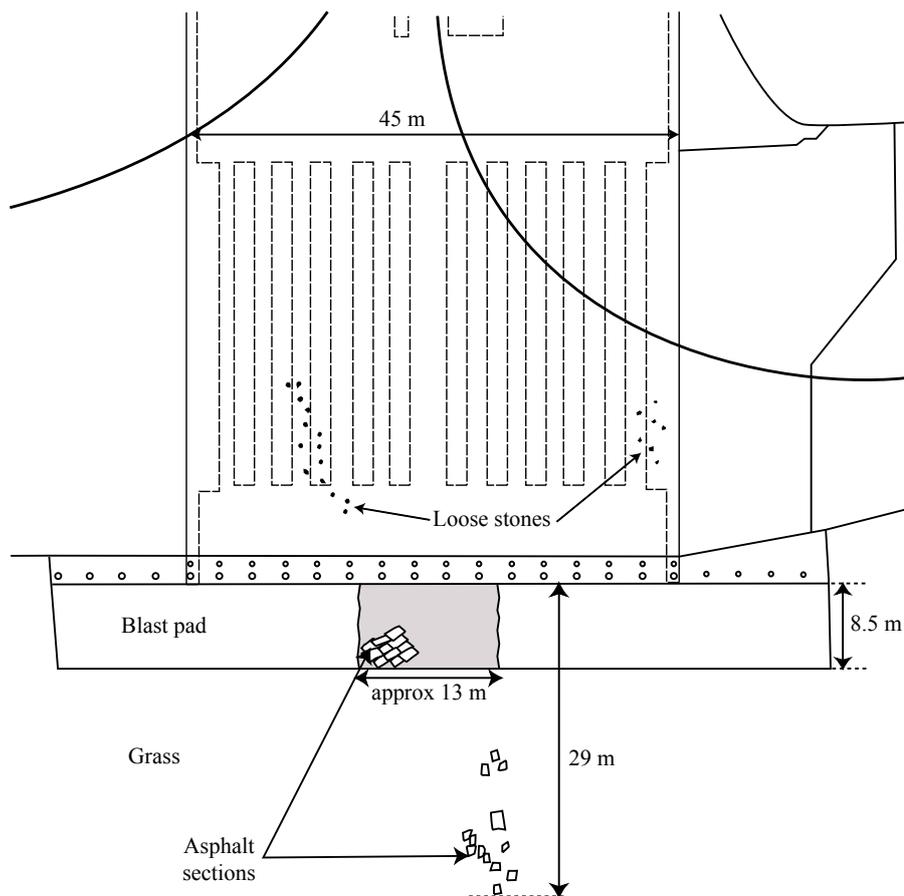
Figure 5

The blast pad (also known as an erosion strip) at the Runway 16 threshold at Aberdeen Airport was a paved area 8.4 m long and 72 m wide, extending beyond both sides of the 45 metre-wide runway (area shown in yellow in Figure 4). The asphalt surface of the central section of this blast pad, approximately 6.5 m either side of the runway centreline, had completely detached. Most sections of asphalt had been blown aft into a grass area – some were found 20 metres behind the end of the blast pad. The remainder of the asphalt sections were piled up in the damaged area of the blast pad (see Figure 5), the largest of which was approximately 1.8 m by 1.5 m and 6 cm thick, weighing approximately 340 kg. The exposed surface below the removed asphalt consisted of stones and dirt with almost no bitumen residue. Some of the stones from this surface were found on the runway. The majority of the bitumen overband sealing (designed to create a flush surface, without cracks, between the runway and blast pad) had detached with the asphalt.

Blast pad debris following accident to G-DOCT.
Grey area denotes delaminated portion of blast pad

The important question, therefore, is what enabled the jet blast to penetrate between the asphalt surface and the sub base. A bitumen overband sealing was laid along the length of the joint between the blast pad surface and the runway surface and this sealing is designed to create a flush surface, without cracks, between the runway and blast pad. A deterioration of this seal would have made it easier for the jet blast to penetrate. However, no deterioration of the overband sealing was noted during the runway inspections that were carried out on the morning of the accident and just prior to the aircraft's departure.

Following the accident to G-DOCT the remaining asphalt from the central section of the blast pad was dug up and the sub base was compacted. Then a 4.5 cm to 6.5 cm thick layer of stone mastic asphalt (SMA) was laid down to serve as a temporary repair. This repair was completed at 0130 hrs on 9 July 2005, the day after the accident. Between 15 and 16 July 2005 yellow diagonal line markings were painted on the surfaces of both the Runway 16 end blast pad and the Runway 34 end blast pad to warn pilots that the surfaces were not suitable for taxiing.

Some time after the accident the decision was taken by the airport authority, in consultation with the CAA, to remove completely both the Runway 16 end blast pad and the Runway 34 end blast pad, and replace each with a new thicker surface that could accommodate the occasional passage of a Boeing 767. The new blast pads consisted of four layers. The bottom layer was a thin geotextile material. Above this was a 35 cm thick Granular Sub Base (GSB) Type 1 stone material. The next layer was a 5 cm thick section of Heavy Duty McAdam (HDM) and the top layer was a 5 cm thick section of SMA. The total asphalt thickness was therefore 10 cm. To reduce further the possibility of jet blast penetrating beneath the blast pad the final surface was finished at a level 2.5 cm below the runway level. However, this 2.5 cm vertical step caused problems when the runway edge surface began to break off as a result of airport vehicle traffic. Subsequently a small asphalt filler ramp was added to protect the vertical surface.

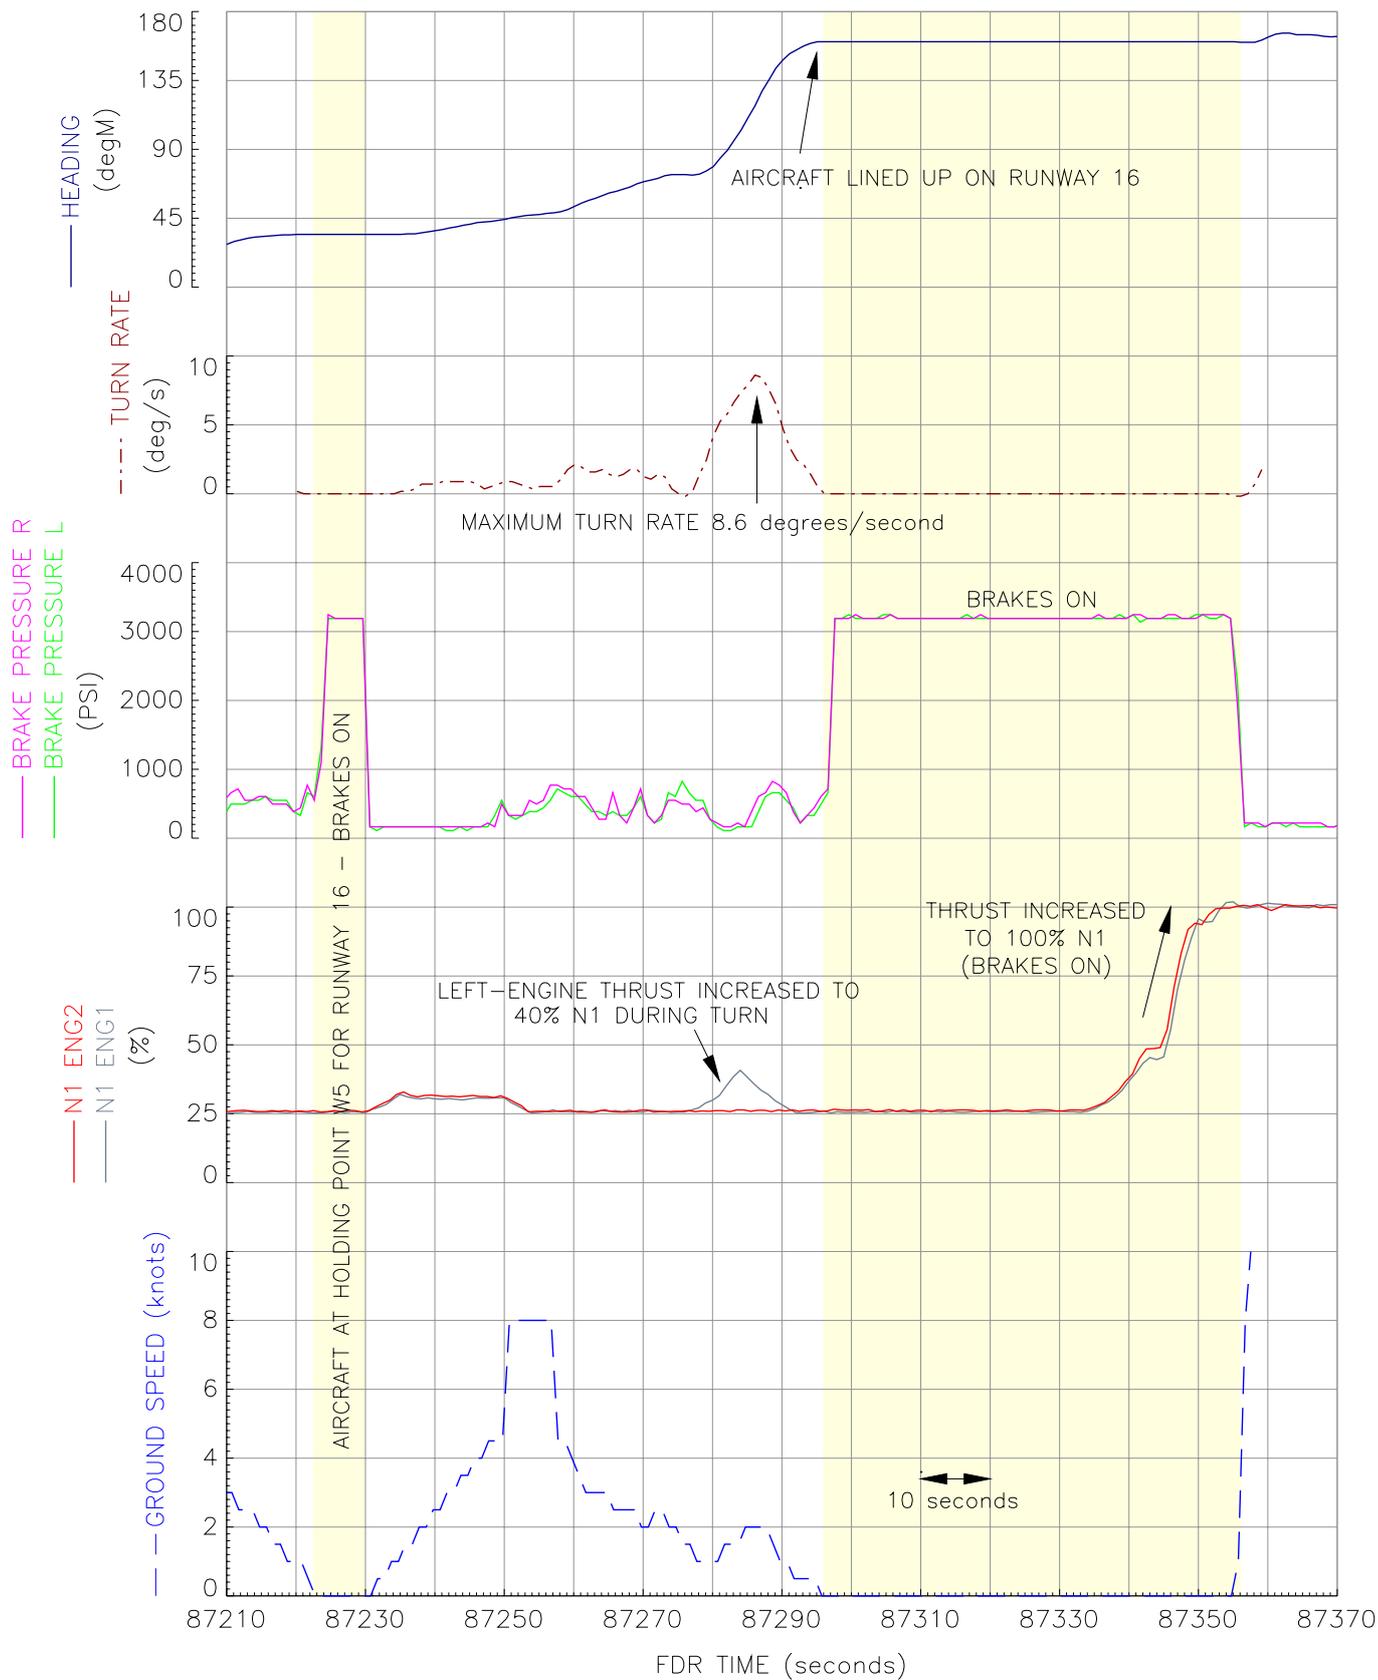
Figure 6
Salient FDR parameters

A time-history plot of the relevant parameters during the accident at Aberdeen is given at Figure 6. The data presented at Figure 6 starts just before G-DOCT came

to a halt at holding point W5 for Runway 16, where the aircraft remained for eight seconds with brakes applied.

As the brakes were released, the aircraft began moving, turning through 40° to the right over a period of 40 seconds (at a maximum turn rate of 2°/second), on to a heading of 075°(M). The ground speed peaked at eight knots during this turn. The aircraft remained on this heading for five seconds before turning to the right through a further 85°, over 16 seconds, onto the runway heading of 160°(M). Left-engine thrust, up to 40% N_1 , was applied during the turn and the aircraft's turn rate reached a maximum of 8.6°/sec while the ground speed peaked at two knots. Once on the runway heading, the brakes were applied and the aircraft came to a stop.

The aircraft remained lined up on the runway with brakes applied for one minute. After 38 seconds (ie 22 seconds before brake release), the thrust on both engines started to increase from 25% N_1 to 45% on the left engine, and to 49% on the right engine, where they remained for three seconds. The thrust then continued to increase, at a slightly faster rate, reaching 95% N_1 five seconds before the brakes were released. The thrust remained at 95% N_1 for about two seconds before again increasing, reaching 100% N_1 two seconds before brake release. From brake release, it took a further two seconds for the brake pressure to drop to zero by which time the aircraft was already moving forward and accelerating through seven knots.

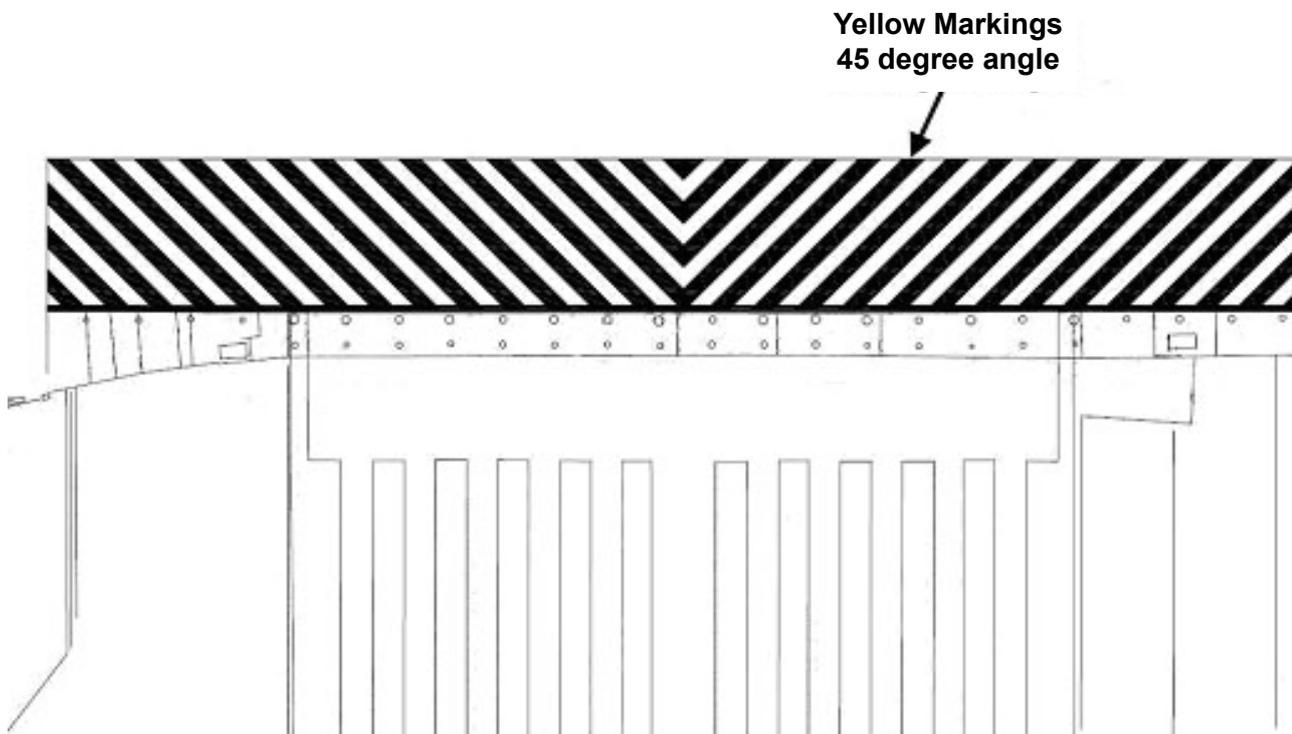
Figure 7

Following the new blast pad construction a new paint marking scheme was applied to alert pilots that the surface was not part of the runway. The paint marks

consisted of diagonal yellow lines, joining at the centre to form small chevrons as depicted in Figure 7.

Paint marking scheme applied to the ‘permanent repair’ blast pads at both ends of Aberdeen Runway 16/34, after the accident to G-DOCT

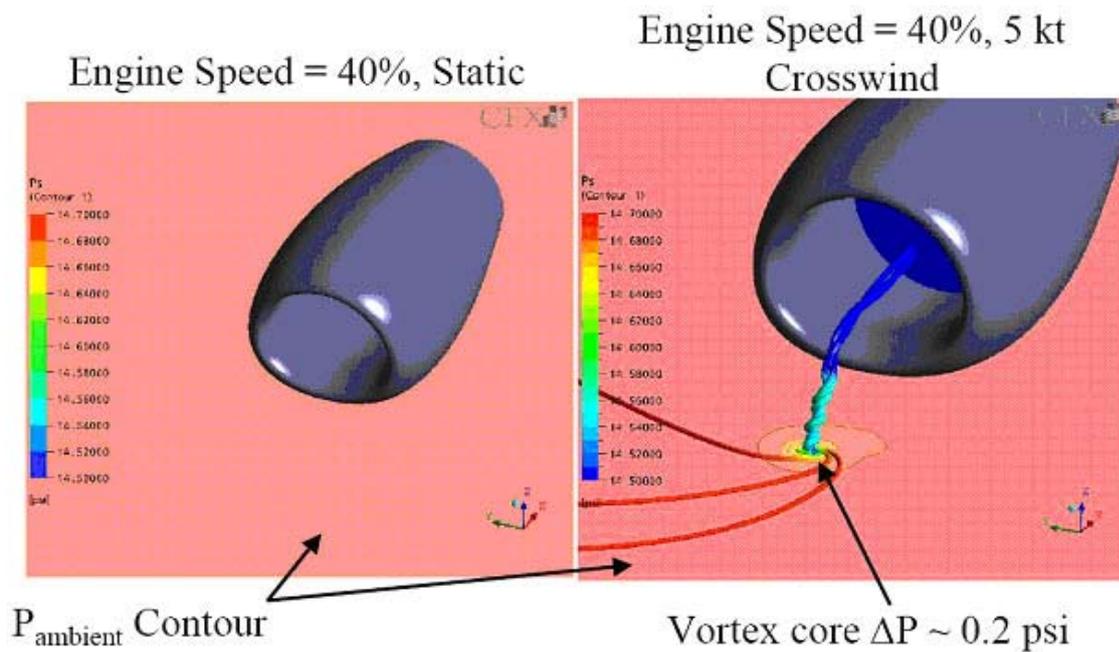
A further study was then conducted to examine the suction effects from the engine inlet. As G-DOCT made its tight final right turn, to line up with the runway, its left engine was spooled up to 40% N_1 and the path of the left engine probably passed over the blast pad surface. The study was therefore carried out at 40% N_1 . The results indicated that in 'nil wind' conditions the static pressure on the ground, in front of the engine inlet, was equal to ambient pressure. However, when a 5 kt cross-wind was introduced into the model, a vortex was generated in front of the engine inlet which applied a suction force of 0.2 psi to the ground. The cross-wind induced flow asymmetry and this triggered the vortex formation. Figure 9 shows the vortex and the pressure contours for a power setting of 40% N_1 .

Results from the engine manufacturer's engine inlet study which revealed a 0.2 psi suction force at ground level with a power setting of 40% N_1 and a 5 kt cross-wind

Another possible cause of blast pad damage is as a result of suction from the engine inlet. While manoeuvring to position a Boeing 737 close to the end of the runway, the engine inlet from one of the engines may pass over the blast pad even without the main gear passing over it. There is no prohibition against allowing an engine to pass over a non-load-bearing surface. The pressure study carried out by the engine manufacturer revealed that, in conditions of light cross-wind, a vortex can form forward of the engine inlet. In the case of G-DOCT, with 40% N_1 power set on the left engine and a cross-wind of approximately 6 kt, a suction force of approximately 0.2 psi would have been applied at ground level. Based on the density of the asphalt surface, this suction force might have been sufficient to start to lift the asphalt surface and cause blistering or cracks. However, this would have been dependent upon the strength of the bond between the asphalt surface and the sub base and the adhesive strength between the asphalt surface and the surrounding material. The results are not conclusive but suggest that further research should be carried out to examine the effects of engine inlet suction on paved surfaces.

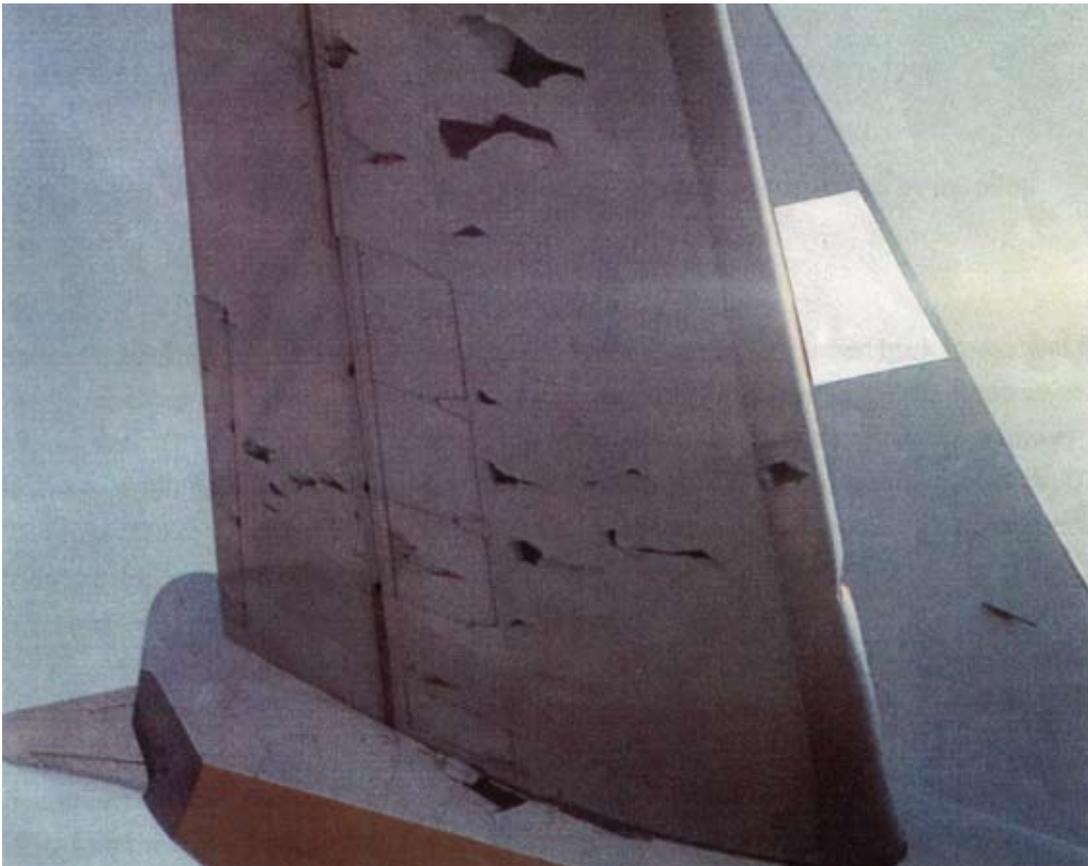
Figure 10

Damage to right tailplane underside of Boeing 737, G-MONM,
at Luton Airport on 22 September 1992,
following strikes by paving blocks from the turnpad area

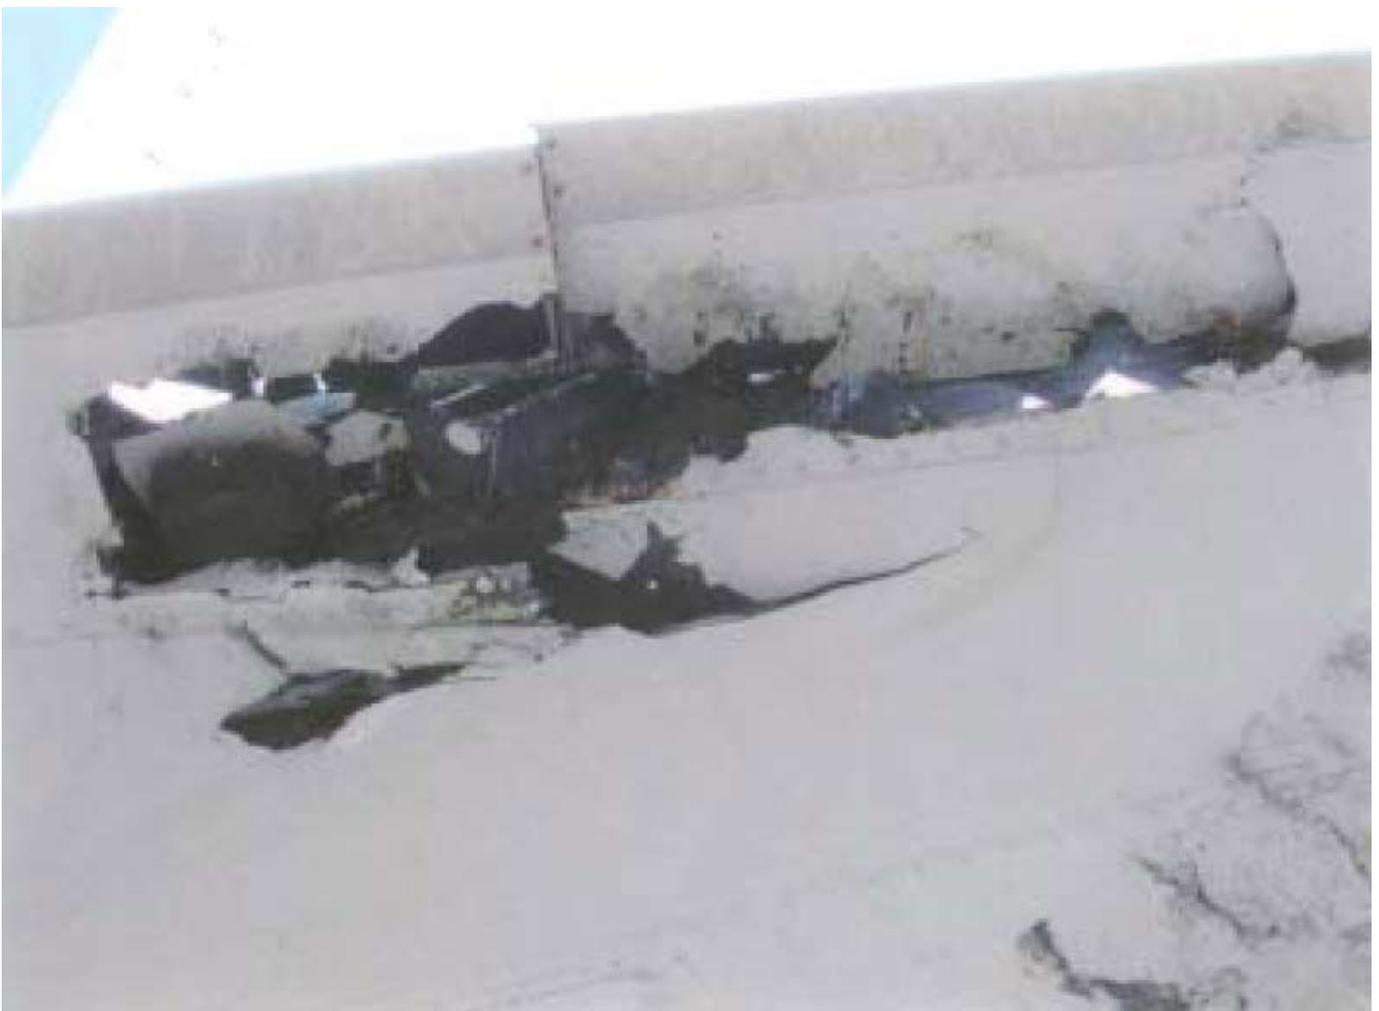
Figure 11

blue hydraulic system loss so he aborted the takeoff run. Sections of asphalt from the stopway aft of the 07 threshold had been blown up by the jet blast and struck the aircraft's tailplane – the damage is shown in Figure 11. The stopway had been painted with a white arrow rather than with yellow chevrons and the ANSV report questioned the surface's ability to meet the structural requirements of a stopway.

Damage to left tailplane leading edge of Airbus A320 at Treviso S. Angelo airport in Italy on 6 August 2002, following a strike by a large section of asphalt from the stopway
