ACCIDENT

Aircraft Type and Registration:	Eurocopter AS350B2 Squirrel, G-CBHL	
No & Type of Engines:	1 Turbomeca Arriel 1D1 turboshaft engine	
Year of Manufacture:	1992	
Date & Time (UTC):	15 September 2007 at 1505 hrs	
Location:	Lanark, Scotland	
Type of Flight:	Private	
Persons on Board:	Crew - 1	Passengers - 3
Injuries:	Crew - 1 (Fatal)	Passengers - 3 (Fatal)
Nature of Damage:	Helicopter destroyed	
Commander's Licence:	See text	
Commander's Age:	39 years	
Commander's Flying Experience:	965 hours (of which 490 were on type) Last 90 days - 50 hours estimated Last 28 days - 15 hours estimated	
Information Source:	AAIB Field Investigation

Synopsis

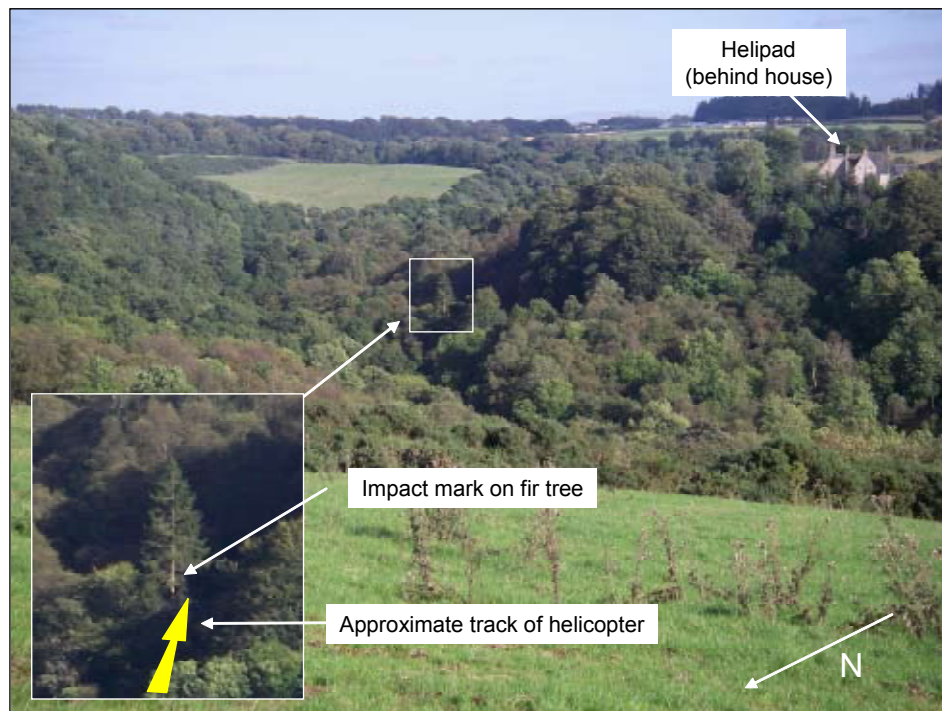
Figure 1

Water valley, approximately 1.5 nm north of Lanark, Figure 1. The initial impact, which was on a track of about 110°(M), had occurred with the upper branches of two substantial trees: the left side of the rotor disc had impacted the trunk of a fir about 30 ft from its top, with the fuselage and the rest of the rotor disc striking an oak tree, dislodging a large bough together with several smaller branches. The damage to the rotor head resulted in a complete main rotor blade being released, which then flew above the tree tops, landing in a field approximately 150 m beyond the initial impact point. The main gearbox was torn from its mountings on impact with the trees and fell to the ground nearby.

A closer examination of the fir tree at the initial impact revealed that the trunk bore evidence of a broad, horizontal, scar with a number of small branches that had surrounded

Accident location, looking along approximate track at impact

it having been broken off. It was concluded that the scar had been made by a single strike of a main rotor blade, only one of which exhibited any evidence of significant leading edge impact damage. This had resulted in the liberation of the outboard 0.6 m of the blade, which was subsequently located north of the river.

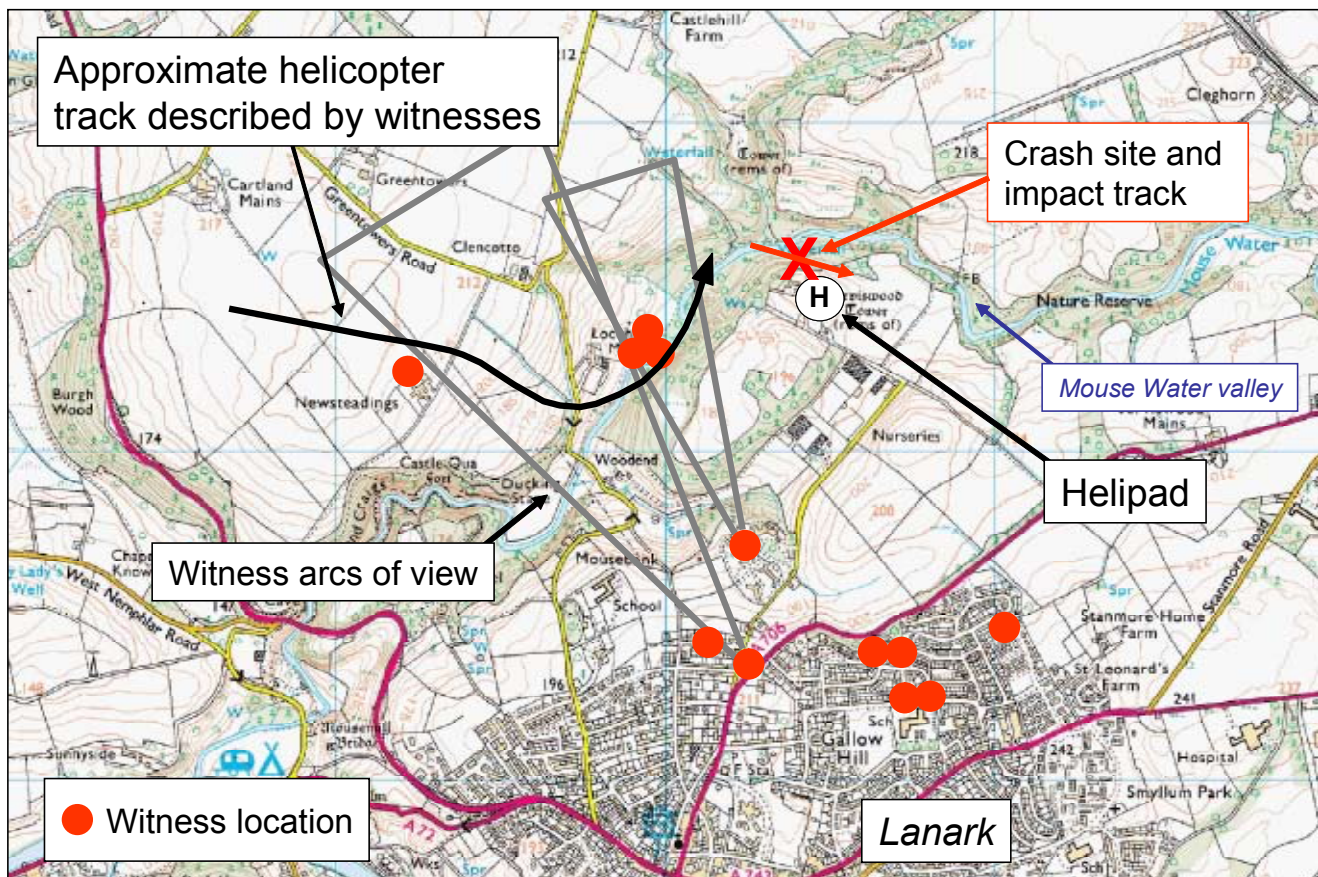
Figure 2
Witness information

airborne main rotor blade that was released in the initial impact. The locations of these witnesses are shown at Figure 2, together with an indication of the flight path they described. From their combined accounts, the helicopter approached the area from the west, initially flying across the Mouse Water valley in the general direction of the helipad. It then made a brief right turn before banking steeply to the left and descending into the valley. It adopted a marked nose-low, banked attitude as it descended, and was generally described as flying much faster than normal. The arcs of view shown in Figure 2 are of two witnesses who described seeing the helicopter in the steep left bank when it went out of view.

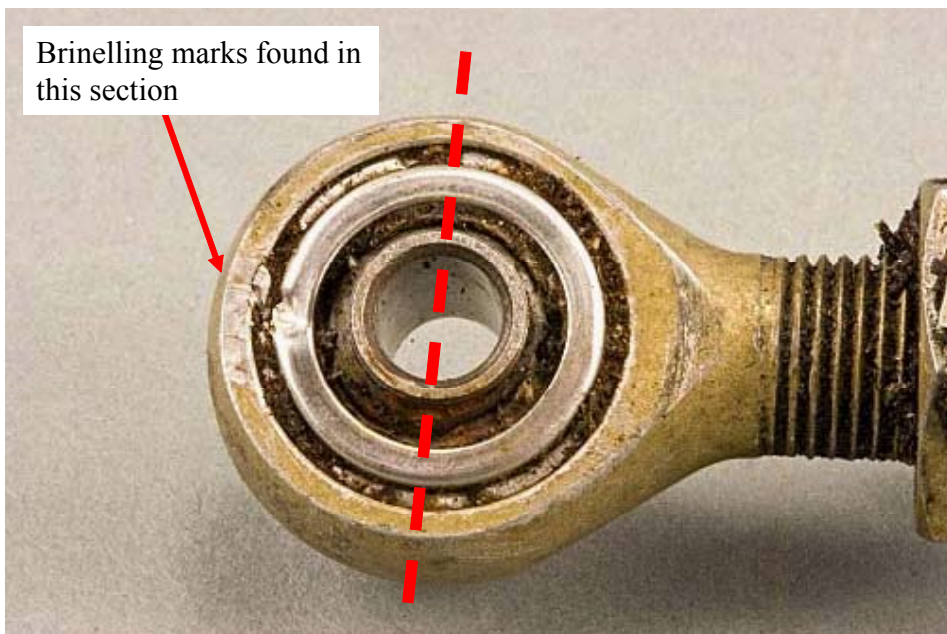
Figure 5

As noted earlier, the main rotor gearbox had been torn from its mountings on the initial impact with the trees. Thus, as the airframe continued on its trajectory, the servo operating rods would have been exposed to predominantly tensile loads, which had led to failures in two of the three rods. Both these rods had been attached to bellcranks located beneath the transmission deck and there was evidence to suggest that the failures had occurred partly as a result of a guillotining effect at the point where they emerged from their respective apertures in the transmission deck. The third rod, with the undamaged eye end, had remained attached to the servo input linkage on the gearbox and was in good condition, apart from a slight bend. This was probably caused as a result of the rod becoming trapped beneath the gearbox as it rolled along the ground.

In view of the apparent lack of damage to the servo rod eye end, additional investigation was conducted on this component in order to determine whether a bolt or rivet had been present at the time of the impact.

Forward servo rod eye end from G-CBHL

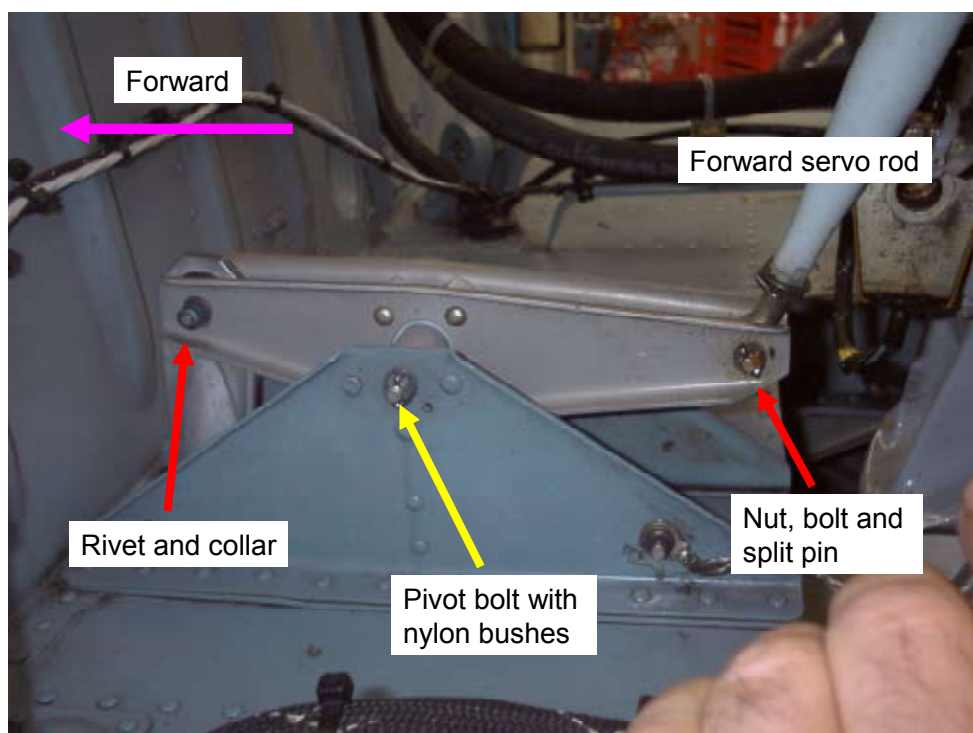
Figure 6

The bellcrank on the transmission deck of an intact aircraft, showing bolted and riveted connections

The technician who replaced the bushes still worked for the maintenance organisation that conducted the inspection and he stated that he recalled carrying out the task. At the time of the work, the main rotor gearbox had been removed from the airframe, with the upper end of the servo rod having been disconnected from the servo. This greatly facilitated access to the push-fit nylon bushes which was accomplished simply by removing the bellcrank pivot bolt (arrowed in Figure 6) and lifting the bellcrank clear of its mounting.

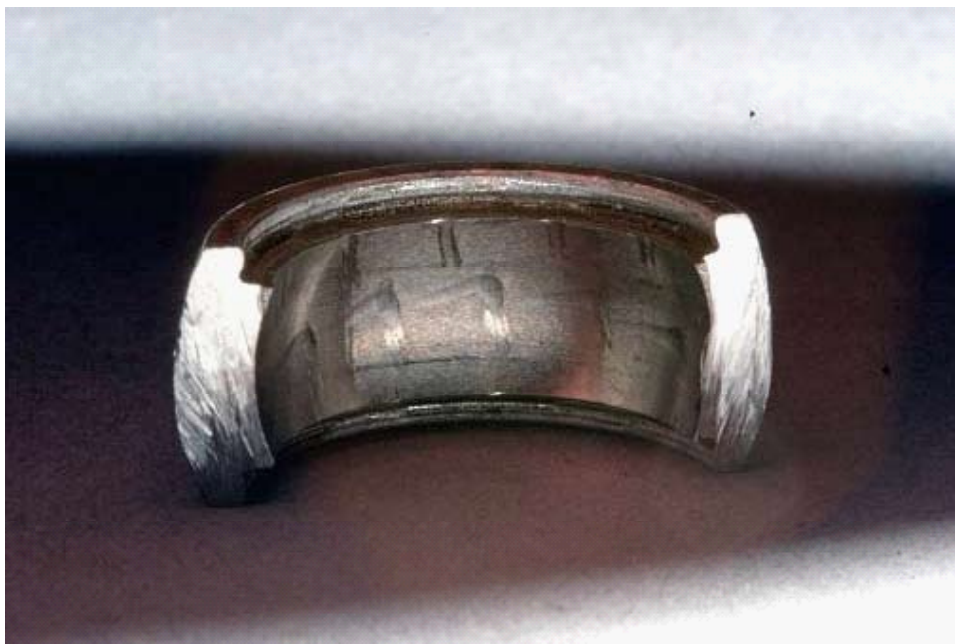
Figure 7

Brinelling marks on the forward servo input rod lower eye end

The test, in conjunction with the examination of the servo input rod end from the accident aircraft, provided conclusive proof that this area of the flying control linkage was intact at the time of the accident. The rivet represented the weakest link in this part of the system and failed as a result of forces generated during the impact, evidence of which was provided in the form of brinelling marks on the eye end outer race.

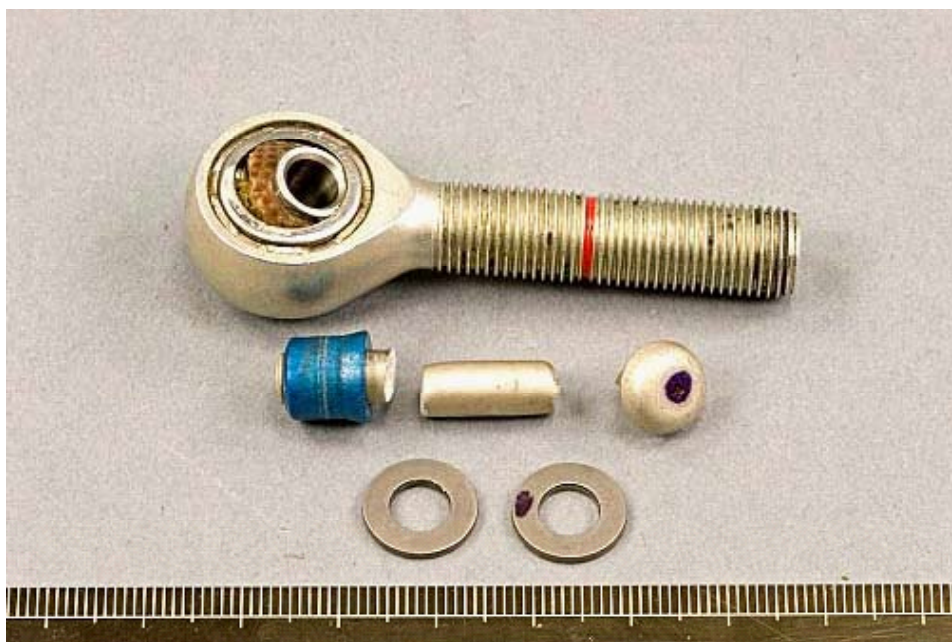
Figure 8

which were actually the result of a combination of bending and shear, were not exactly simultaneous; this had led to the central portion of the eye end twisting on its ball bearings during the failure process, which in

turn had caused the balls to mark the outer race surface in a similar manner to that seen on the accident aircraft. The bore of the central, eye, in which the rivet had been located, was undamaged.

Results of eye end test conducted by the manufacturer. Note failed rivet and undamaged eye

The actual failure load in the test was 1,680 daN. The manufacturer conducted a stress analysis of the subject area of the flying controls and concluded that approximately similar loads could result in the failure of the bellcrank mounting to the transmission deck. Thus, if a steel bolt had been used in place of the rivet, its superior strength would have resulted in it remaining intact, with failure most probably occurring in the bellcrank mounting.

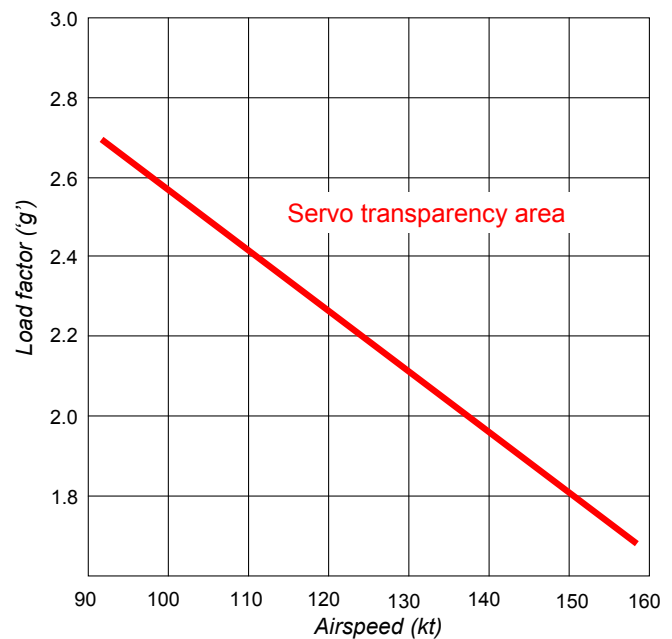
Figure 9

As part of the investigation, Eurocopter were asked to predict at what point G-CBHL would have encountered servo transparency, given the helicopter's known mass and the atmospheric conditions. The predictions, in terms of airspeed and load factor, are shown in graphical form at Figure 9. They assume

that maximum continuous power is applied; flight tests have shown that servo transparency does not occur under any circumstances with the collective pitch lever less than 50% raised. At 130 kt, the onset of servo transparency was predicted to occur at a load factor of 2.1 g.

Predicted conditions for the onset of servo transparency

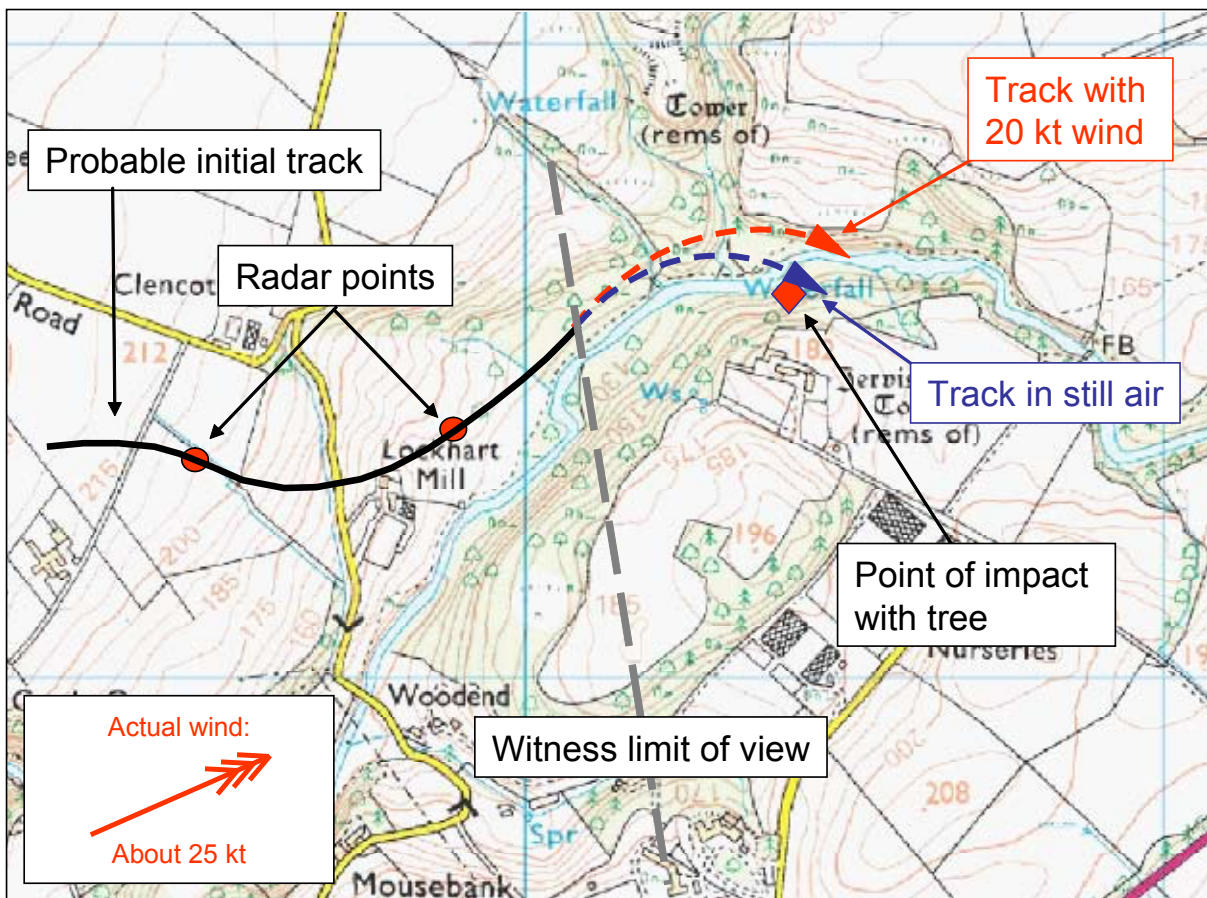
Figure 10

descended, it would not have actually turned a great deal or it would have flown out of the valley to the north.

Probable initial flight path, shown with turns at 130 kt IAS and 60° bank angle
