Air Accidents Investigation Branch

**Report on the accident to
Bell 214 ST G-BKFN
in the North Sea 14 miles
North East of Fraserburgh, Scotland
on 15 May 1986**

Aircraft Accident Report No 9/87

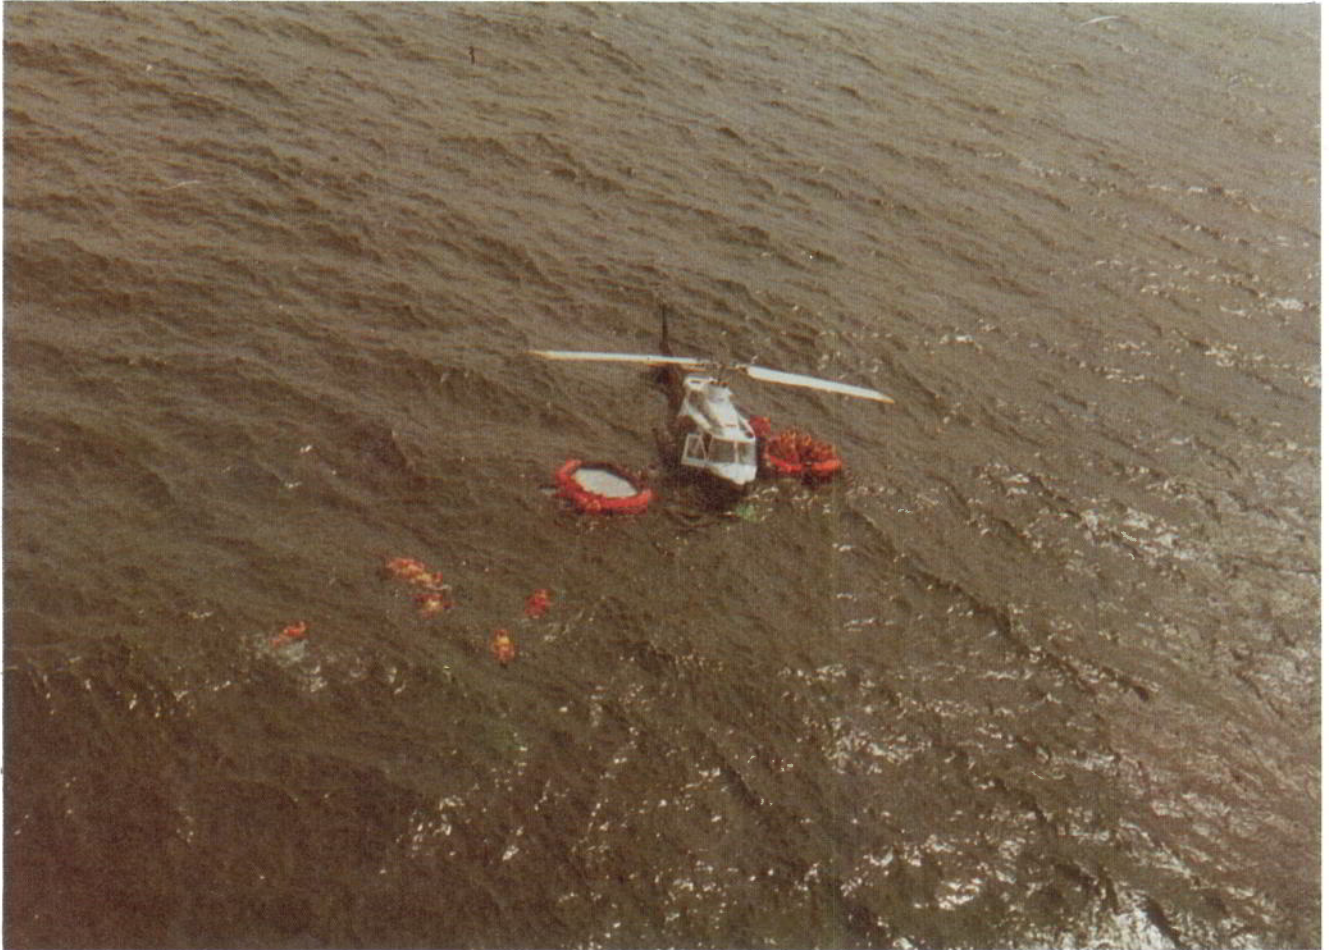
**BELL 214ST G-BKFN SHORTLY AFTER DITCHING
14 NAUTICAL MILES NORTH EAST OF FRASERBURGH**
