## Grob G115A, G-RAFA

<b>AAIB Bulletin No:</b> 8/2004	<b>Ref:</b> EW/C2003/09/07	<b>Category:</b> 1.3
<b>INCIDENT</b>		
<b>Aircraft Type and Registration:</b>	Grob G115A, G-RAFA	
<b>No &amp; Type of Engines:</b>	1 Lycoming O-235-H2C piston engine	
<b>Year of Manufacture:</b>	1989	
<b>Date &amp; Time (UTC):</b>	13 September 2003 at 1757 hrs	
<b>Location:</b>	Near RAF Wyton, Cambridge	
<b>Type of Flight:</b>	Training	
<b>Persons on Board:</b>	Crew - 2	Passengers - None
<b>Injuries:</b>	Crew - None	Passengers - N/A
<b>Nature of Damage:</b>	None	
<b>Commander's Licence:</b>	Commercial Pilot's Licence	
<b>Commander's Age:</b>	46 years	
<b>Commander's Flying Experience:</b>	1,280 hours (of which 120 were on type)	
	Last 90 days - 92 hours	
	Last 28 days - 24 hours	
<b>Information Source:</b>	Aircraft Accident Report Form submitted by the pilot and further AAIB enquiries

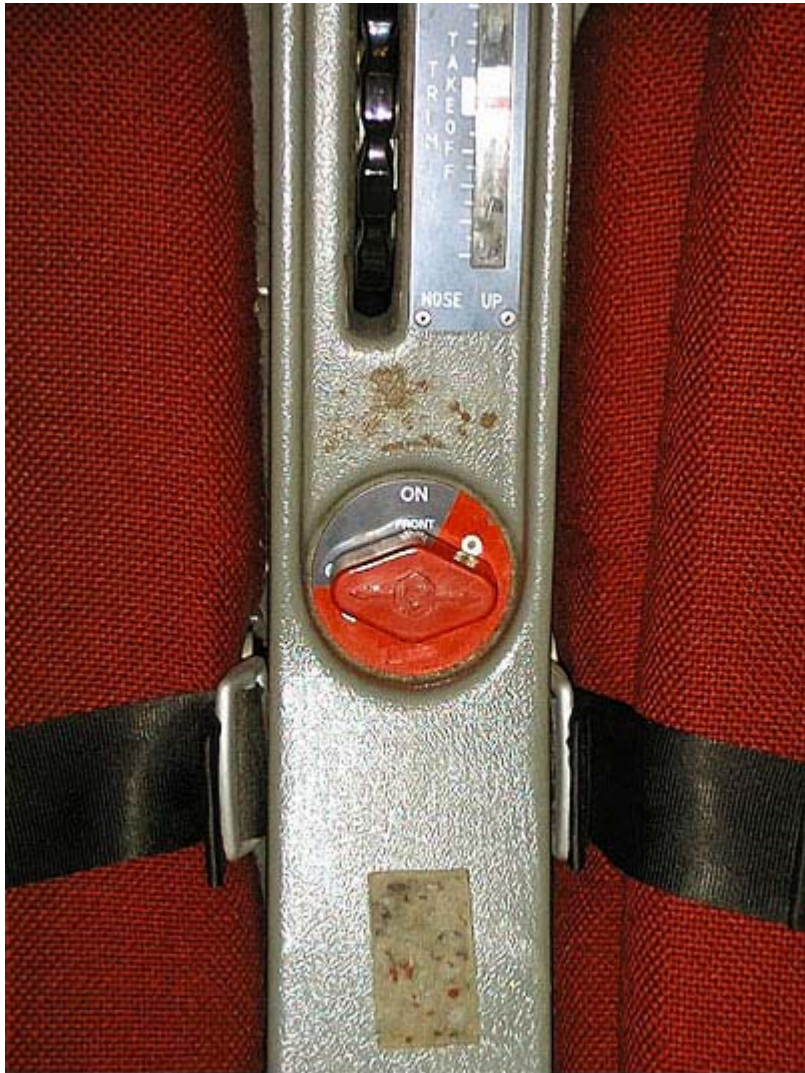
**Figure 2: Fuel ON/OFF cock in G-RAFA**

Early versions of the Grob 115 have a single fuel tank contained in the fuselage. A single fuel cock exists in these models on the centre console between the pilots. The cock has two positions: either fuel 'ON' or fuel 'OFF' (see Figure 2).

Figure 2 - Fuel ON/OFF cock in G-RAFA  
(Note position relative to elevator trim wheel)

The aircraft involved in this incident was a Grob 115A model but the student had also flown with the RAF in the Grob Tutor. It is likely that prior to starting the BEFORE TAKE-OFF power assurance checks, the student instinctively changed the position of the selector immediately behind the elevator trim wheel, as he was used to doing on the Tutor. Since the tank selector and fuel cock share the same position on the respective aircraft models, in so doing he would actually have turned the fuel cock to

the 'OFF' position. Despite the fuel cock being shut, sufficient fuel remained available to the engine for the aircraft to have taken off before the supply downstream of the cock became exhausted.

Comparison of G-RAFA's fuel cock markings with information in the Flight Manual (Figure 1) revealed differences and omissions in the colour scheme and markings. These alterations may have made it more difficult for either pilot to realise the fuel cock was in the incorrect position before takeoff.

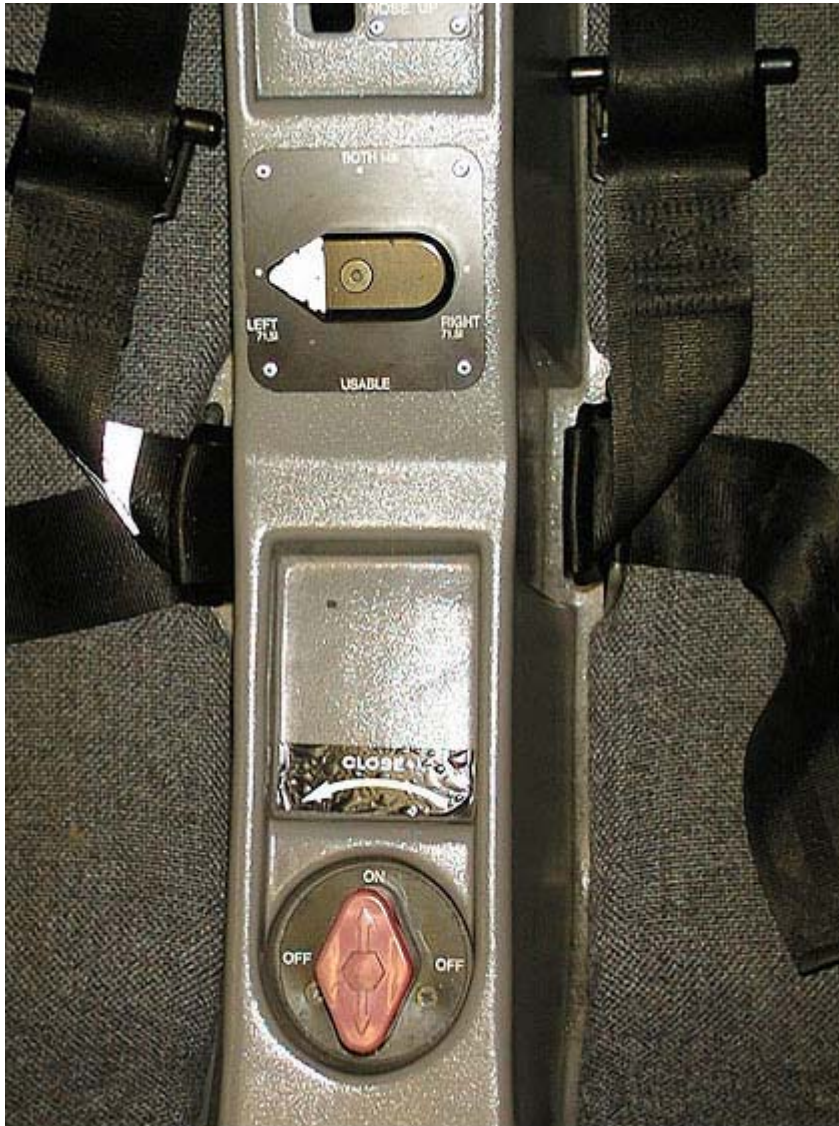
**Figure 3: Fuel tank selector and ON/OFF cock locations in later models**

In later models of the Grob 115 the single fuselage fuel tank is replaced by a tank in each wing. A fuel tank selector is incorporated in these models allowing selection of either tank independently or both tanks together. This selector is positioned on the centre console aft of the elevator trim wheel in the same position as the ON/OFF cock in the early models. The displaced ON/OFF cock was repositioned to the rear of the centre console (see Figure 3).

Figure 3 - Fuel tank selector and ON/OFF cock locations in later models

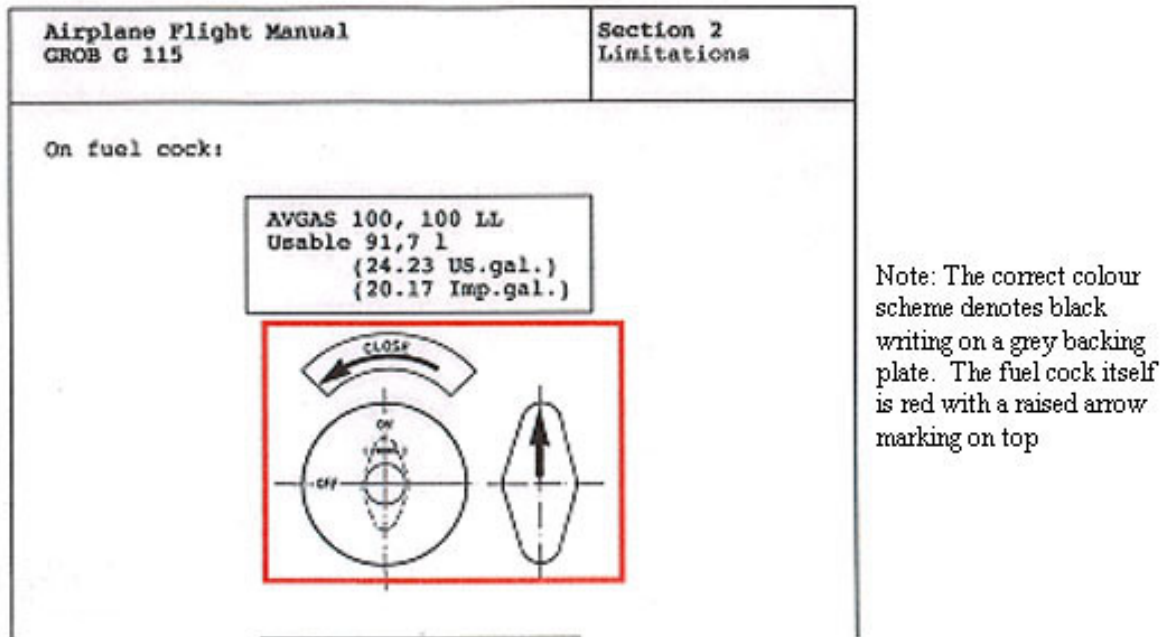
**Figure 1: Flight Manual Illustration of Fuel Cock Markings**

**Figure 1 - Flight Manual Illustration of Fuel Cock Markings**
