ACCIDENT

Aircraft Type and Registration:	Piper PA-32-301 Saratoga, G-BMDC	
No & Type of Engines:	1 Lycoming IO-540-K1G5 piston engine	
Year of Manufacture:	1980	
Date & Time (UTC):	16 September 2007 at 1609 hrs	
Location:	Shotteswell, near Banbury, Oxfordshire	
Type of Flight:	Private	
Persons on Board:	Crew - 1	Passengers - None
Injuries:	Crew - 1 (Fatal)	Passengers - N/A
Nature of Damage:	Damaged beyond economic repair	
Commander's Licence:	Private Pilot's Licence	
Commander's Age:	58 years	
Commander's Flying Experience:	Approximately 200 hours (of which 4 were on type) Last 90 days - N/K hours Last 28 days - N/K hours	
Information Source:	AAIB Field Investigation

Synopsis

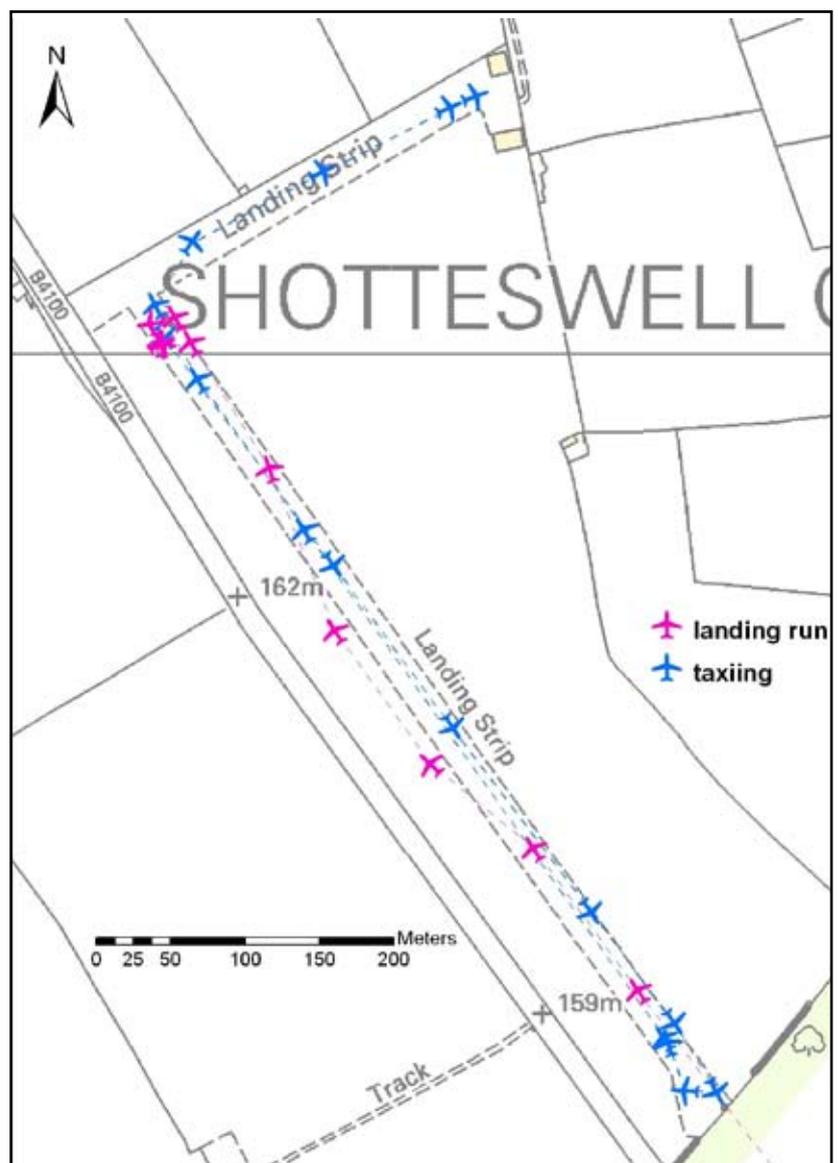
Figure 1

was apparent to observers on the ground that the pilot had to contend with a crosswind from the left. The GPS data indicated that during the touchdown the aircraft veered to the left, possibly off the runway, before returning to the prepared runway surface (see Figure 1). After landing, G-BMDC remained at the end and to the left of Runway 33 for two and a half minutes before backtracking along Runway 33 to the threshold, where

Landing and subsequent taxiing at Shotteswell airstrip prior to accident flight

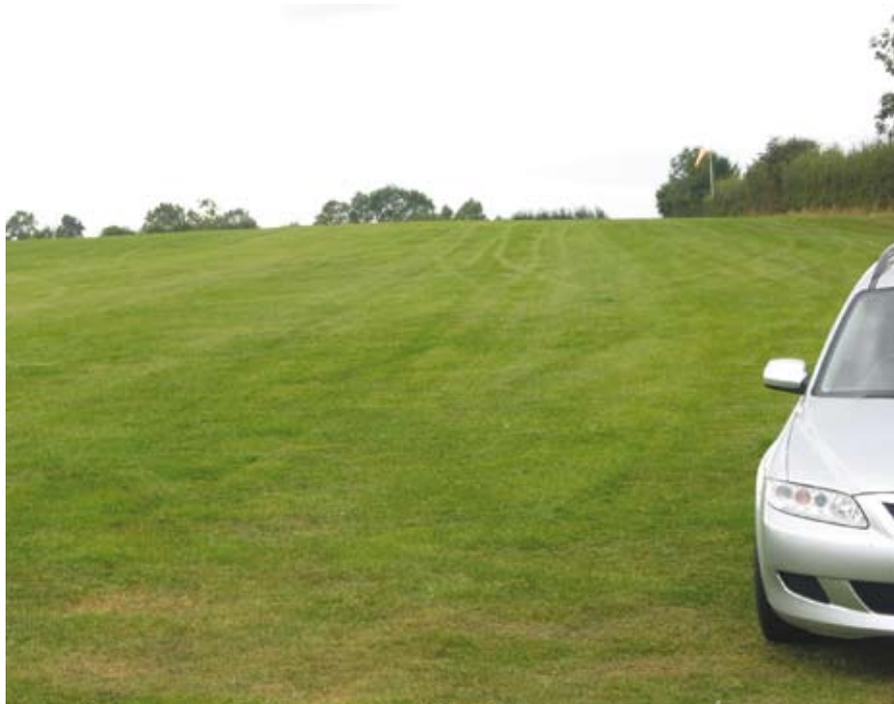
Figure 2

A survey of the airfield immediately after the accident indicated that the useable length of Runway 25 was 302 metres, with a 1.6% upslope; this distance did not include the grass area in front of the hangar which was not considered useable by an aircraft of the size of G-BMDC. Including the grass area in front of the hangar resulted in an approximate 'hedge-to-hedge' distance of 330 metres. At the western end of the runway was a hedge which was approximately 18 to 22 ft tall. Immediately on the other side of that was a single carriageway road, the B4100, on the far side of which stood trees that were approximately 30 to 40 ft in height. See Figures 2 and 3.

Runway 25 from the threshold

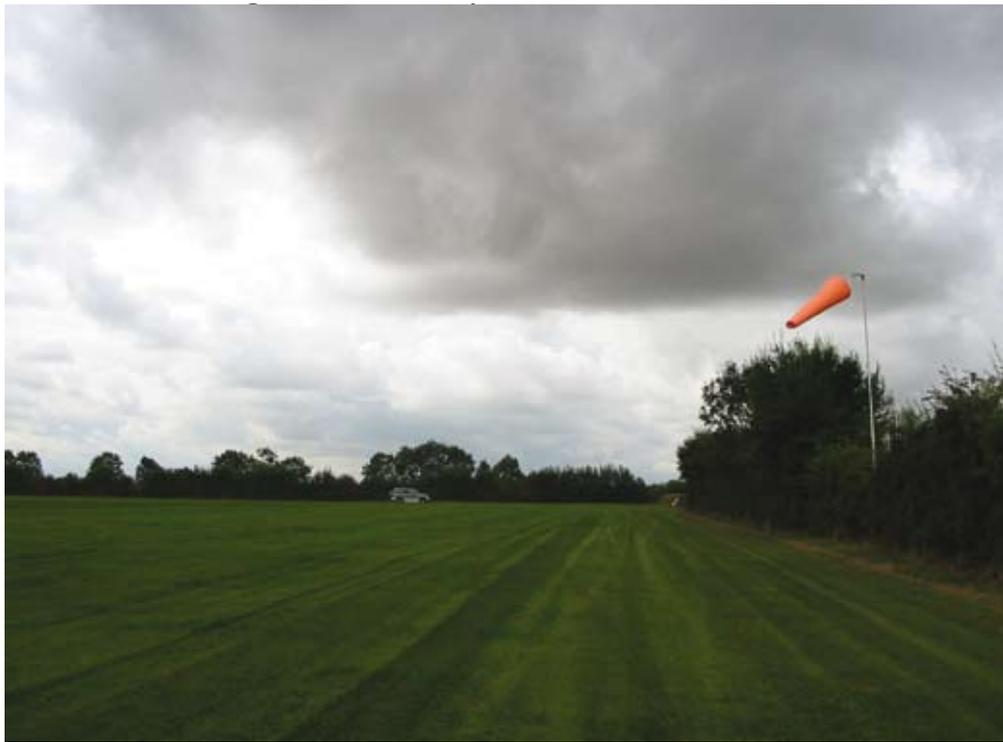
Figure 3

Approximately halfway along Runway 25

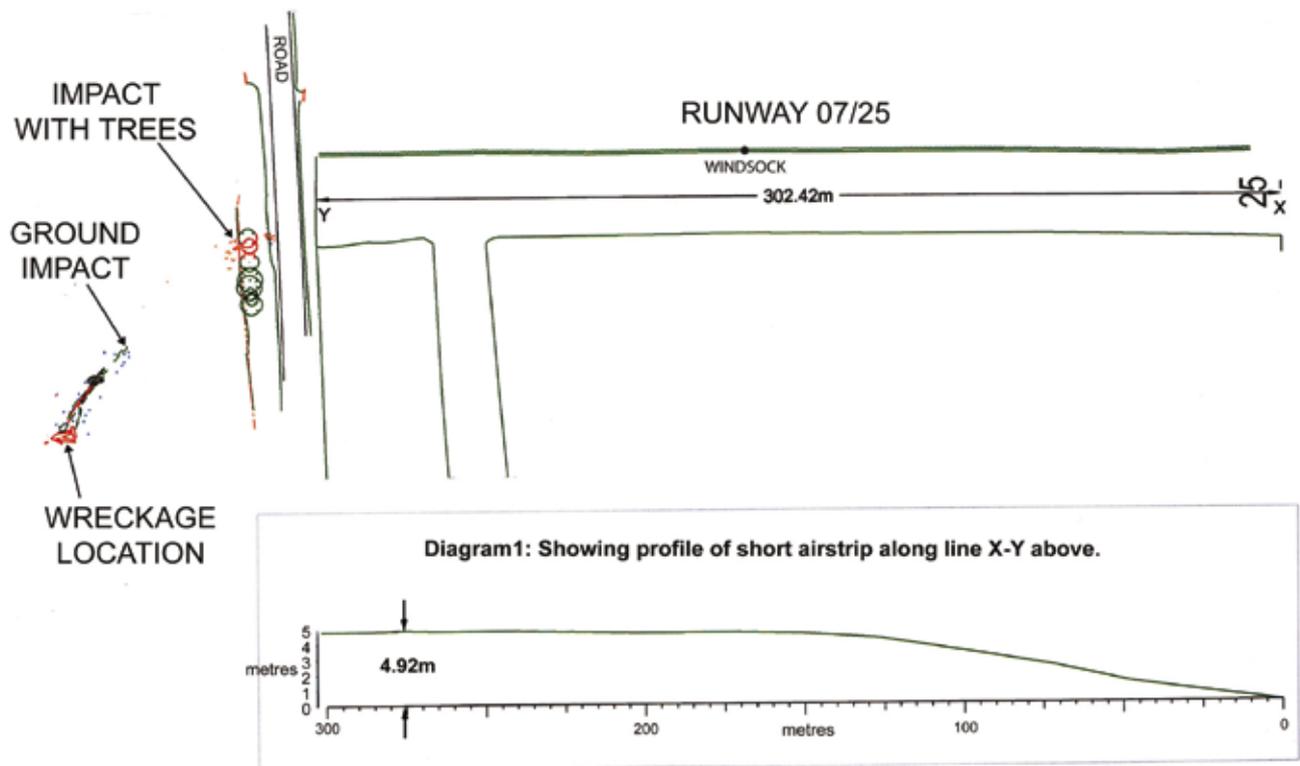
Figure 4

The aircraft wreckage was found lying inverted in a field beyond the end of Runway 25. The ground scars and wreckage distribution were consistent with the aircraft having hit the ground with its left wing tip first, in a steep left bank, before impacting on its nose and cartwheeling to the right. Both wing spars failed during the impact sequence. There was evidence that the aircraft's left wing had struck trees that were approximately 30 metres from the end of Runway 25, as depicted in Figure 4. The aircraft's left wing tip strobe light housing was found at the base of these trees which were approximately 30 to 40 ft high.

Runway length and profile with relative impact and wreckage locations.
(Note that the x and y axes in the vertical profile have different scales;
the total upslope gradient is 1.6%.)

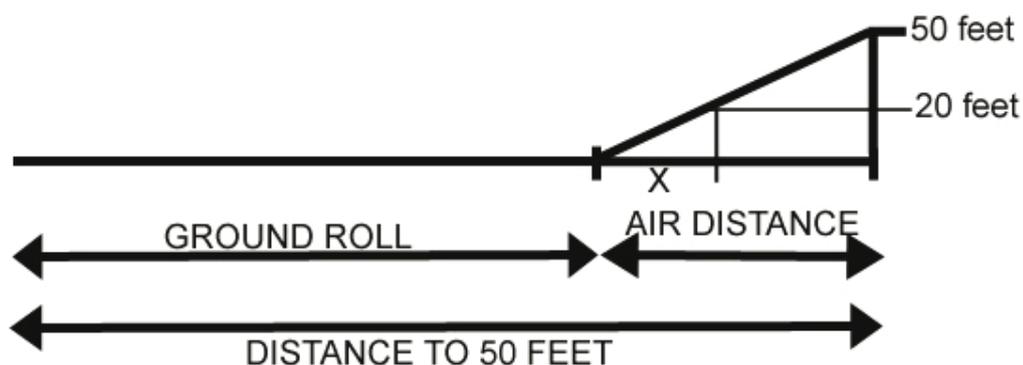
The POH did not provide a method for calculating takeoff distance required to a height of 20 feet, so the geometric method depicted in Figure 5 was used.

Method used to estimate the takeoff distance to a height of 20 feet³

The calculated takeoff distance from Runway 25 to a height of 20 feet was 340 metres (flaps up), before applying the 1.33 safety factor. This was 38 metres greater than the 302 metres of runway length available. With the 1.33 safety factor the distance required rose to 452 metres. Had the pilot used flaps 25 then the achievable takeoff distance to a height of 20 feet was 268 metres, before applying the 1.33 safety factor. This was 34 metres less than the runway length available. However, this figure makes no allowance for imperfect pilot technique, aircraft and engine wear, or less than favourable conditions. Therefore, applying the 1.33 safety factor provides a more realistic takeoff performance figure of 357 metres to a height of 20 feet with flaps 25. This was 55 metres more than the runway length available, which indicates that a successful takeoff from this runway was unlikely, even with flaps 25 set. This was, however, less than the 400 metres quoted in the pilot's out-of-date chart from the flight guide that he had used. This excessive
