ACCIDENT

Aircraft Type and Registration:	Piper PA-32-301 Saratoga, G-BMDC	
No & Type of Engines:	1 Lycoming IO-540-K1G5 piston engine	
Year of Manufacture:	1980	
Date & Time (UTC):	16 September 2007 at 1609 hrs	
Location:	Shotteswell, near Banbury, Oxfordshire	
Type of Flight:	Private	
Persons on Board:	Crew - 1	Passengers - None
Injuries:	Crew - 1 (Fatal)	Passengers - N/A
Nature of Damage:	Damaged beyond economic repair	
Commander's Licence:	Private Pilot's Licence	
Commander's Age:	58 years	
Commander's Flying Experience:	Approximately 200 hours (of which 4 were on type) Last 90 days - N/K hours Last 28 days - N/K hours	
Information Source:	AAIB Field Investigation

Synopsis

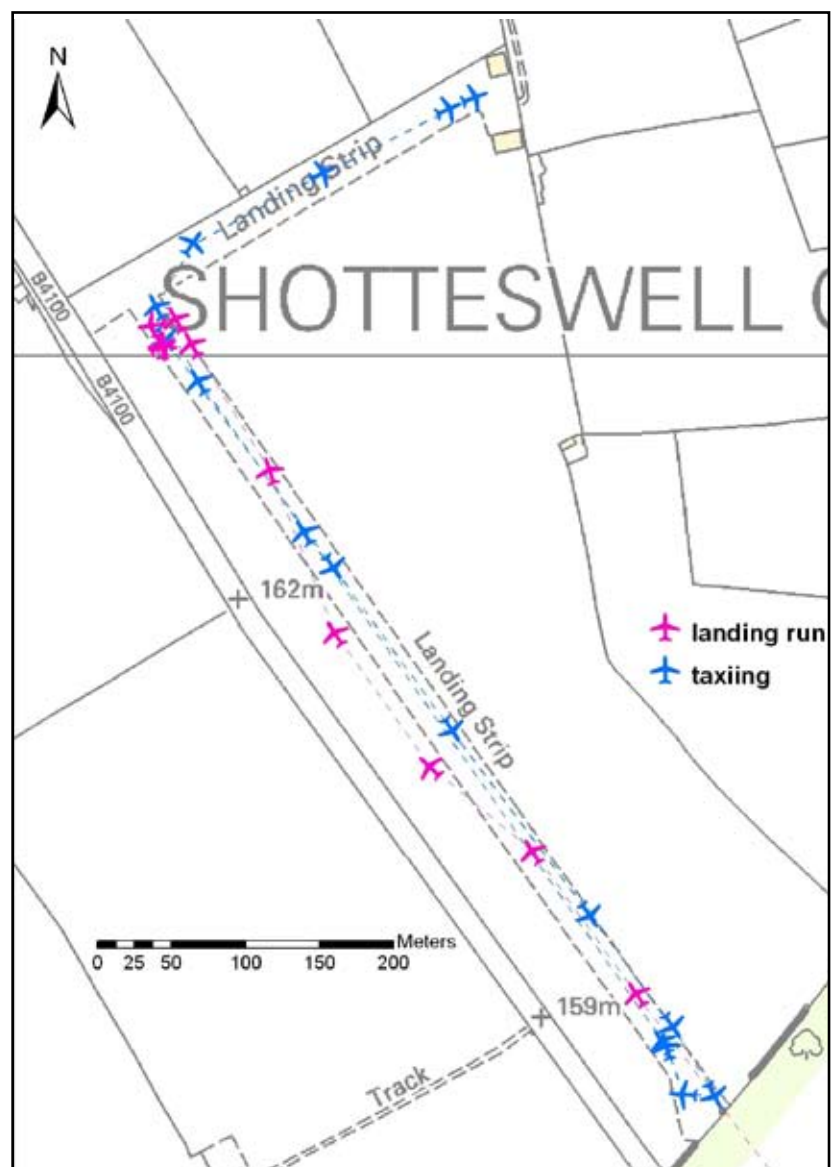
Figure 1

was apparent to observers on the ground that the pilot had to contend with a crosswind from the left. The GPS data indicated that during the touchdown the aircraft veered to the left, possibly off the runway, before returning to the prepared runway surface (see Figure 1). After landing, G-BMDC remained at the end and to the left of Runway 33 for two and a half minutes before backtracking along Runway 33 to the threshold, where

Landing and subsequent taxiing at Shotteswell airstrip prior to accident flight

it remained for three and a half minutes. It then taxied back along the runway and down the shorter Runway 25 to its threshold. The aircraft was last recorded at that position, by the GPS unit, at 1608:36 hrs.

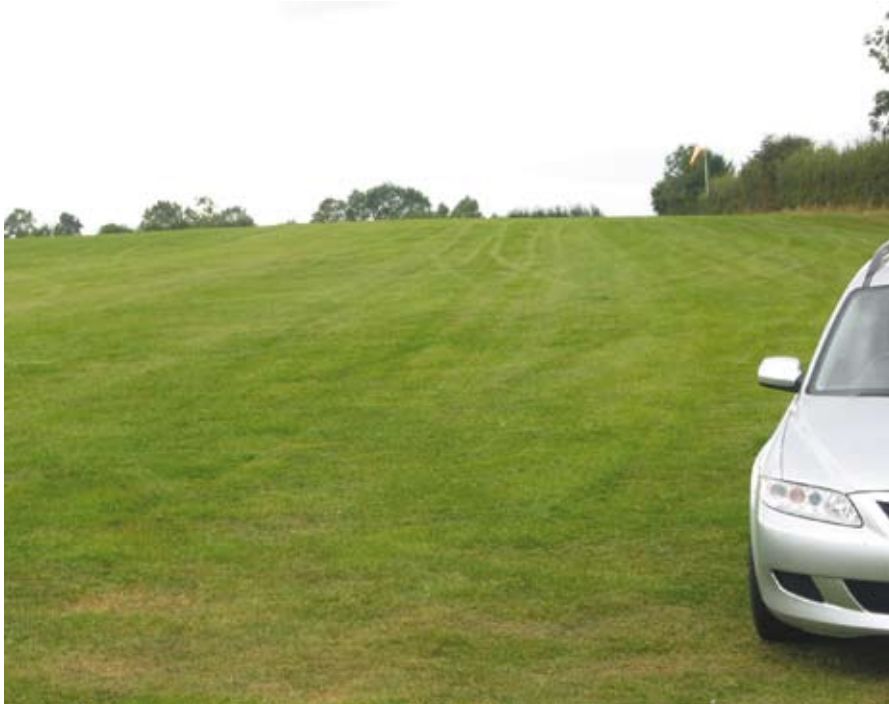
Figure 2

A survey of the airfield immediately after the accident indicated that the useable length of Runway 25 was 302 metres, with a 1.6% upslope; this distance did not include the grass area in front of the hangar which was not considered useable by an aircraft of the size of G-BMDC. Including the grass area in front of the hangar resulted in an approximate 'hedge-to-hedge' distance of 330 metres. At the western end of the runway was a hedge which was approximately 18 to 22 ft tall. Immediately on the other side of that was a single carriageway road, the B4100, on the far side of which stood trees that were approximately 30 to 40 ft in height. See Figures 2 and 3.

Runway 25 from the threshold

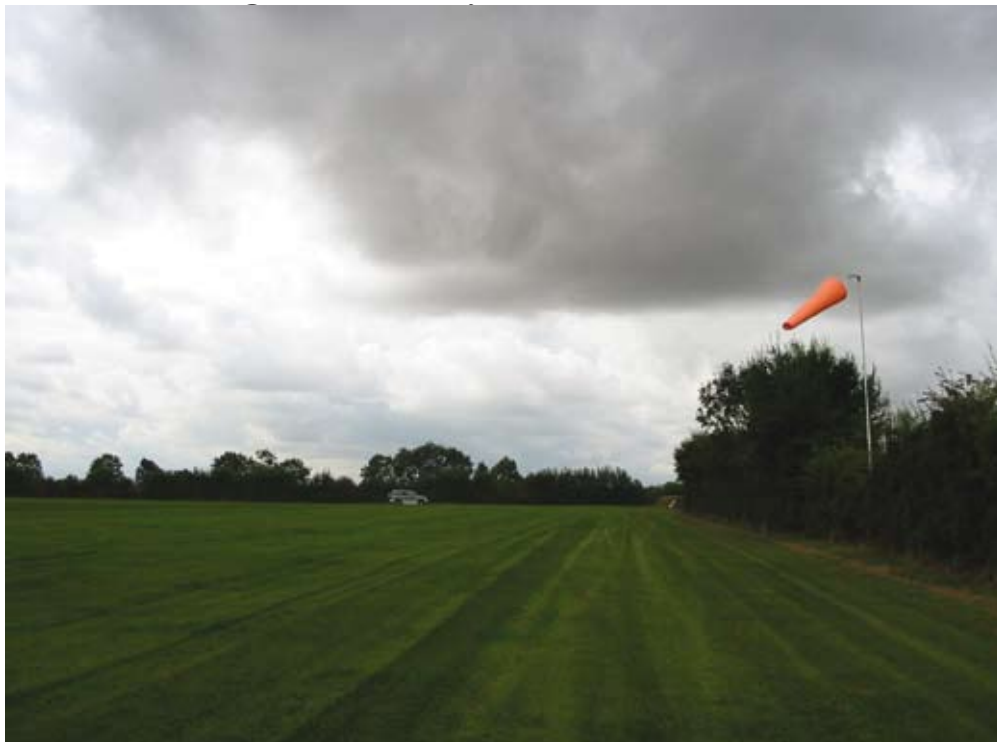
Figure 3

Approximately halfway along Runway 25
