ACCIDENT

Aircraft Type and Registration:	Piper PA-32-301 Saratoga, G-BMDC	
No & Type of Engines:	1 Lycoming IO-540-K1G5 piston engine	
Year of Manufacture:	1980	
Date & Time (UTC):	16 September 2007 at 1609 hrs	
Location:	Shotteswell, near Banbury, Oxfordshire	
Type of Flight:	Private	
Persons on Board:	Crew - 1	Passengers - None
Injuries:	Crew - 1 (Fatal)	Passengers - N/A
Nature of Damage:	Damaged beyond economic repair	
Commander's Licence:	Private Pilot's Licence	
Commander's Age:	58 years	
Commander's Flying Experience:	Approximately 200 hours (of which 4 were on type) Last 90 days - N/K hours Last 28 days - N/K hours	
Information Source:	AAIB Field Investigation

Synopsis

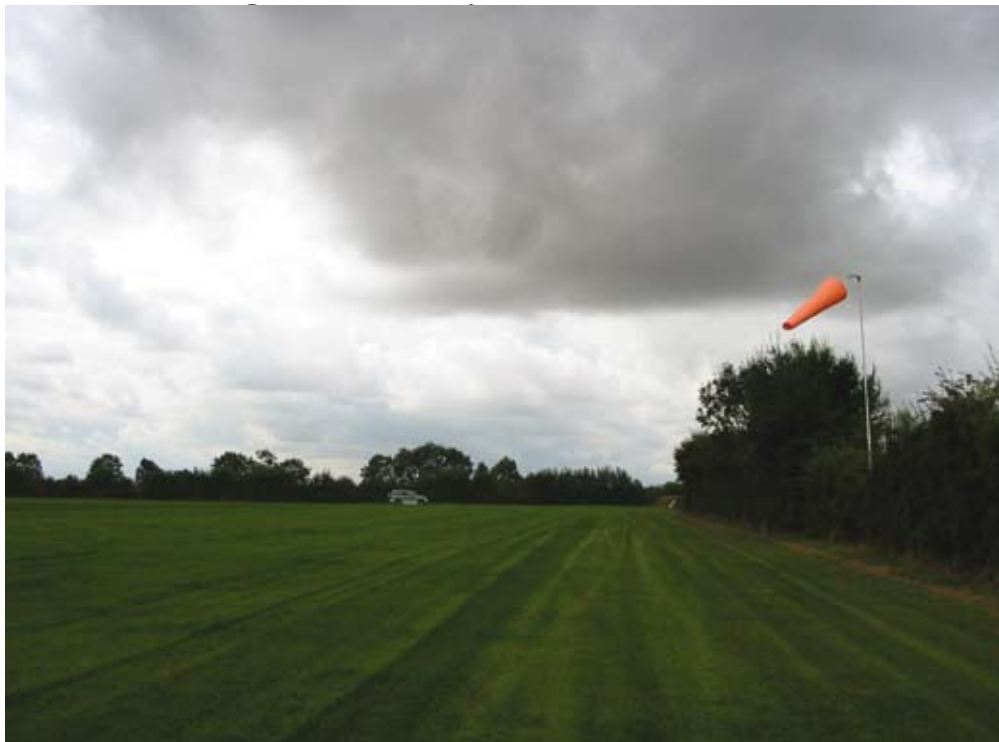
Figure 3

A survey of the airfield immediately after the accident indicated that the useable length of Runway 25 was 302 metres, with a 1.6% upslope; this distance did not include the grass area in front of the hangar which was not considered useable by an aircraft of the size of G-BMDC. Including the grass area in front of the hangar resulted in an approximate 'hedge-to-hedge' distance of 330 metres. At the western end of the runway was a hedge which was approximately 18 to 22 ft tall. Immediately on the other side of that was a single carriageway road, the B4100, on the far side of which stood trees that were approximately 30 to 40 ft in height. See Figures 2 and 3.

Approximately halfway along Runway 25

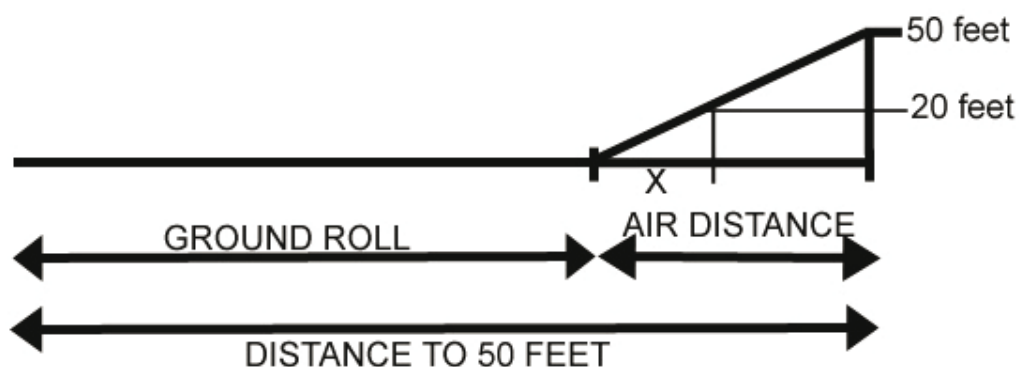
The POH did not provide a method for calculating takeoff distance required to a height of 20 feet, so the geometric method depicted in Figure 5 was used.

Method used to estimate the takeoff distance to a height of 20 feet³

³ AIR DISTANCE = (DISTANCE TO 50 FEET) – (GROUND ROLL).

$X = 20 * (\text{AIR DISTANCE}) / 50$. The takeoff distance to 20 feet is equal to (GROUND ROLL) + X.
