ACCIDENT

Aircraft Type and Registration:	Piper PA-32-301 Saratoga, G-BMDC	
No & Type of Engines:	1 Lycoming IO-540-K1G5 piston engine	
Year of Manufacture:	1980	
Date & Time (UTC):	16 September 2007 at 1609 hrs	
Location:	Shotteswell, near Banbury, Oxfordshire	
Type of Flight:	Private	
Persons on Board:	Crew - 1	Passengers - None
Injuries:	Crew - 1 (Fatal)	Passengers - N/A
Nature of Damage:	Damaged beyond economic repair	
Commander's Licence:	Private Pilot's Licence	
Commander's Age:	58 years	
Commander's Flying Experience:	Approximately 200 hours (of which 4 were on type) Last 90 days - N/K hours Last 28 days - N/K hours	
Information Source:	AAIB Field Investigation

Synopsis

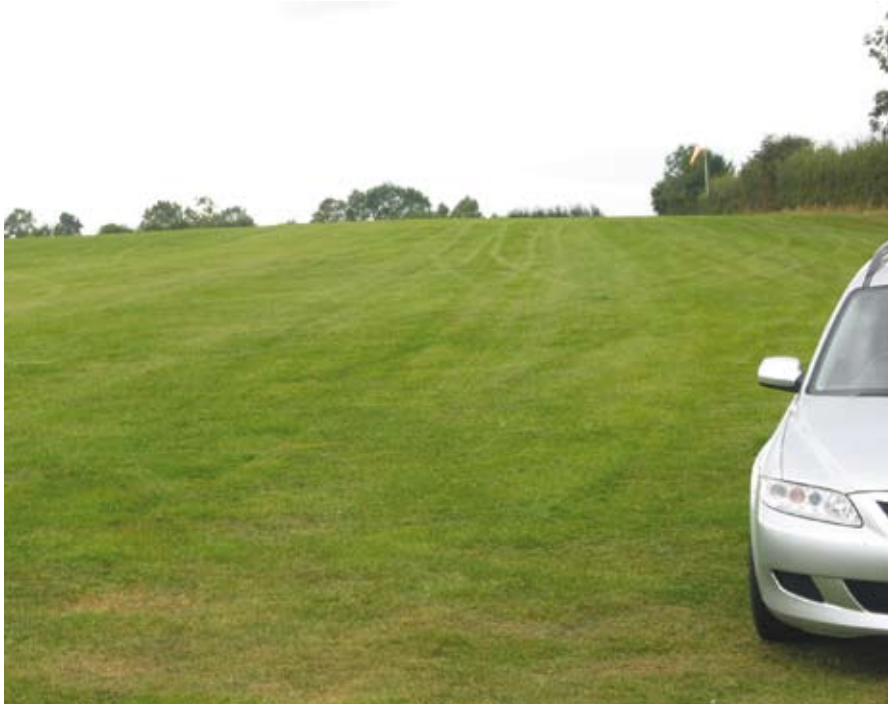
Figure 2

A survey of the airfield immediately after the accident indicated that the useable length of Runway 25 was 302 metres, with a 1.6% upslope; this distance did not include the grass area in front of the hangar which was not considered useable by an aircraft of the size of G-BMDC. Including the grass area in front of the hangar resulted in an approximate 'hedge-to-hedge' distance of 330 metres. At the western end of the runway was a hedge which was approximately 18 to 22 ft tall. Immediately on the other side of that was a single carriageway road, the B4100, on the far side of which stood trees that were approximately 30 to 40 ft in height. See Figures 2 and 3.

Runway 25 from the threshold
