**ACCIDENT**

<b>Aircraft Type and Registration:</b>	Piper PA-32-301 Saratoga, G-BMDC	
<b>No &amp; Type of Engines:</b>	1 Lycoming IO-540-K1G5 piston engine	
<b>Year of Manufacture:</b>	1980	
<b>Date &amp; Time (UTC):</b>	16 September 2007 at 1609 hrs	
<b>Location:</b>	Shotteswell, near Banbury, Oxfordshire	
<b>Type of Flight:</b>	Private	
<b>Persons on Board:</b>	Crew - 1	Passengers - None
<b>Injuries:</b>	Crew - 1 (Fatal)	Passengers - N/A
<b>Nature of Damage:</b>	Damaged beyond economic repair	
<b>Commander's Licence:</b>	Private Pilot's Licence	
<b>Commander's Age:</b>	58 years	
<b>Commander's Flying Experience:</b>	Approximately 200 hours (of which 4 were on type) Last 90 days - N/K hours Last 28 days - N/K hours	
<b>Information Source:</b>	AAIB Field Investigation

**Synopsis**

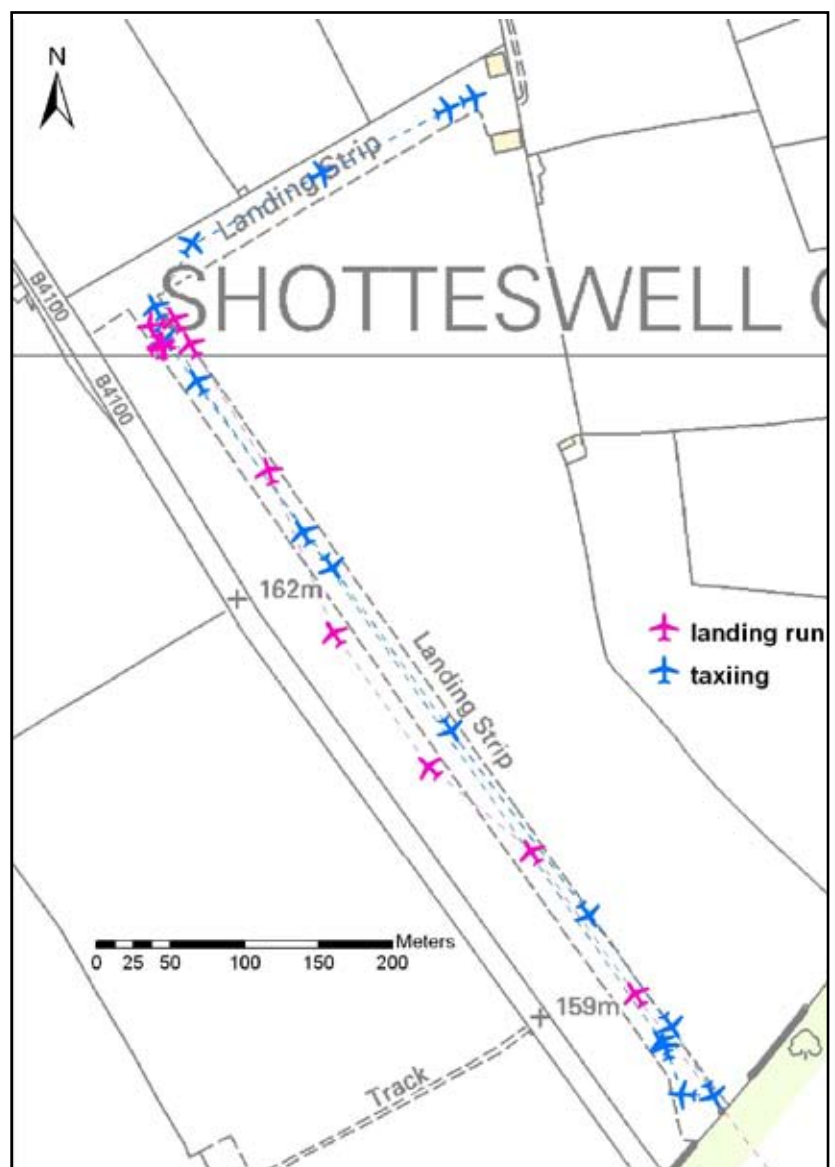
**Figure 1**

Landing and subsequent taxiing at Shotteswell airstrip prior to accident flight

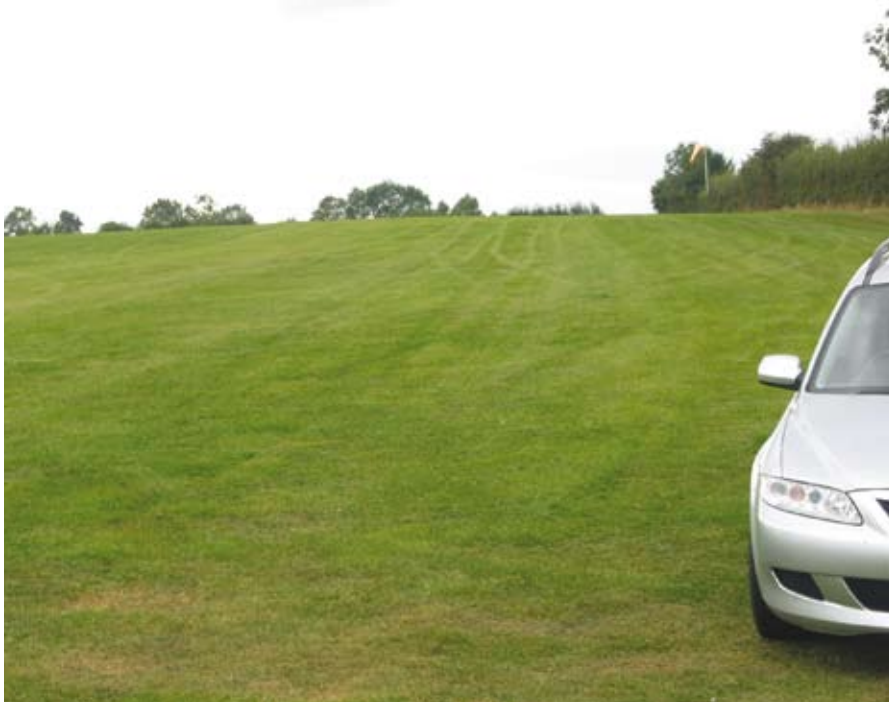
**Figure 2**

A survey of the airfield immediately after the accident indicated that the useable length of Runway 25 was 302 metres, with a 1.6% upslope; this distance did not include the grass area in front of the hangar which was not considered useable by an aircraft of the size of G-BMDC. Including the grass area in front of the hangar resulted in an approximate 'hedge-to-hedge' distance of 330 metres. At the western end of the runway was a hedge which was approximately 18 to 22 ft tall. Immediately on the other side of that was a single carriageway road, the B4100, on the far side of which stood trees that were approximately 30 to 40 ft in height. See Figures 2 and 3.

Runway 25 from the threshold

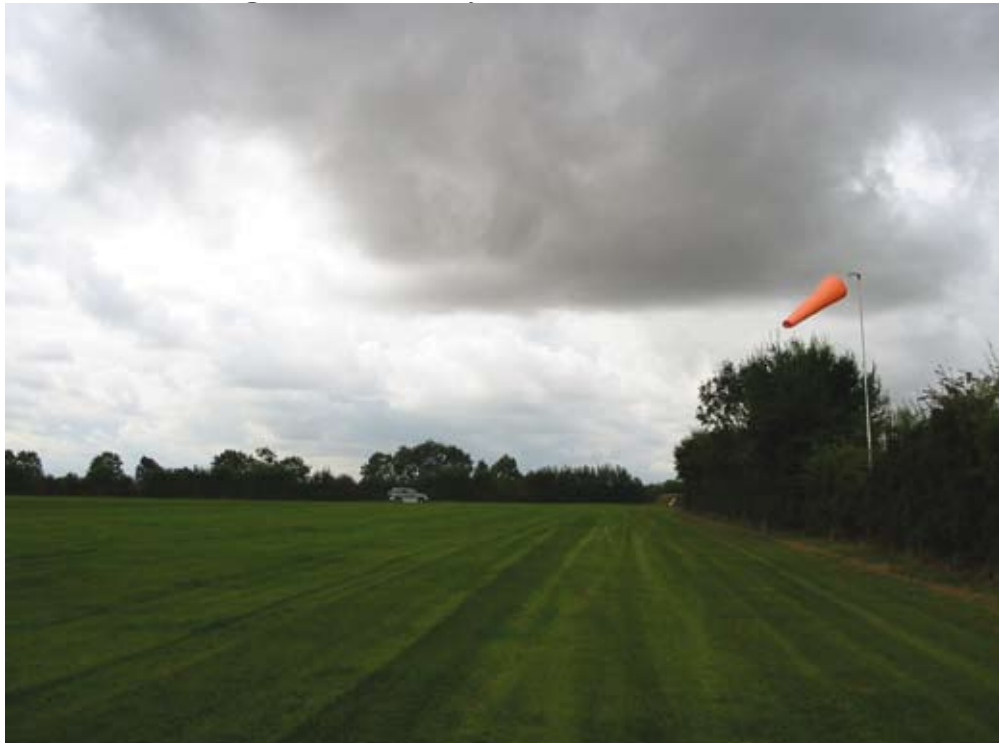
**Figure 3**

Approximately halfway along Runway 25

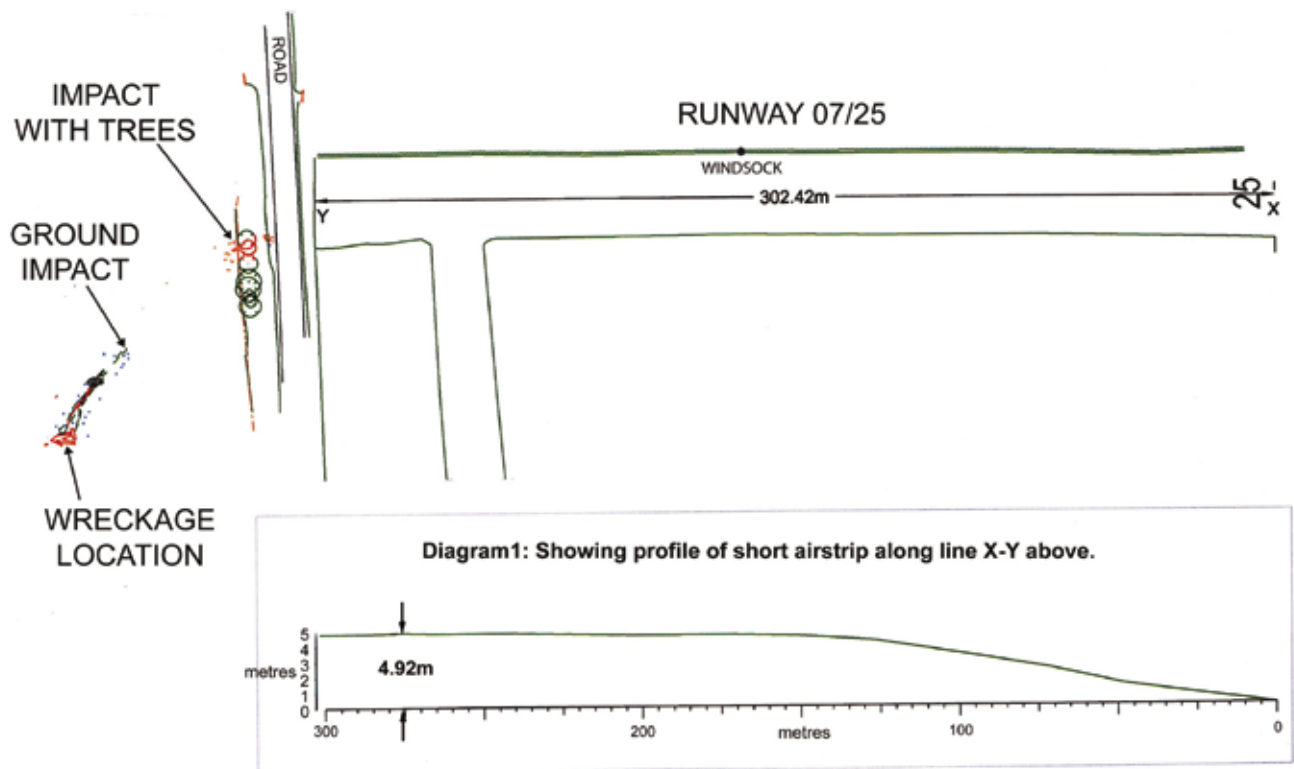
**Figure 4**

The aircraft wreckage was found lying inverted in a field beyond the end of Runway 25. The ground scars and wreckage distribution were consistent with the aircraft having hit the ground with its left wing tip first, in a steep left bank, before impacting on its nose and cartwheeling to the right. Both wing spars failed during the impact sequence. There was evidence that the aircraft's left wing had struck trees that were approximately 30 metres from the end of Runway 25, as depicted in Figure 4. The aircraft's left wing tip strobe light housing was found at the base of these trees which were approximately 30 to 40 ft high.

Runway length and profile with relative impact and wreckage locations.  
(Note that the x and y axes in the vertical profile have different scales;  
the total upslope gradient is 1.6%.)

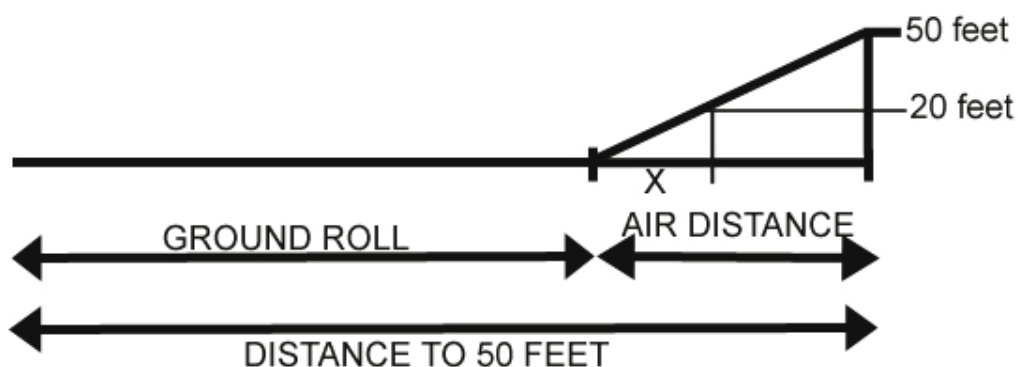
**Figure 5**

The POH did not provide a method for calculating takeoff distance required to a height of 20 feet, so the geometric method depicted in Figure 5 was used.

Method used to estimate the takeoff distance to a height of 20 feet<sup>3</sup>

The calculated takeoff distance from Runway 25 to a height of 20 feet was 340 metres (flaps up), before applying the 1.33 safety factor. This was 38 metres greater than the 302 metres of runway length available. With the 1.33 safety factor the distance required rose to 452 metres. Had the pilot used flaps 25 then the achievable takeoff distance to a height of 20 feet was 268 metres, before applying the 1.33 safety factor. This was 34 metres less than the runway length available. However, this figure makes no allowance for imperfect pilot technique, aircraft and engine wear, or less than favourable conditions. Therefore, applying the 1.33 safety factor provides a more realistic takeoff performance figure of 357 metres to a height of 20 feet with flaps 25. This was 55 metres more than the runway length available, which indicates that a successful takeoff from this runway was unlikely, even with flaps 25 set. This was, however, less than the 400 metres quoted in the pilot's out-of-date chart from the flight guide that he had used. This excessive
