ACCIDENT

Aircraft Type and Registration:	Airbus A320-214, G-OZBY	
No & Type of Engines:	2 CFM56-5B4/P turbofan engines	
Year of Manufacture:	2000 (Serial no: 1320)	
Date & Time (UTC):	10 April 2013 at 1425 hrs	
Location:	Prestwick Airport	
Type of Flight:	Training	
Persons on Board:	Crew - 14	Passengers - None
Injuries:	Crew - None	Passengers - N/A
Nature of Damage:	Damage to the nose landing gear	
Commander's Licence:	Airline Transport Pilot's Licence	
Commander's Age:	58 years	
Commander's Flying Experience:	15,085 hours (of which 2,791 were on type) Last 90 days - 41 hours Last 28 days - 6 hours	
Information Source:	AAIB Field Investigation

Synopsis

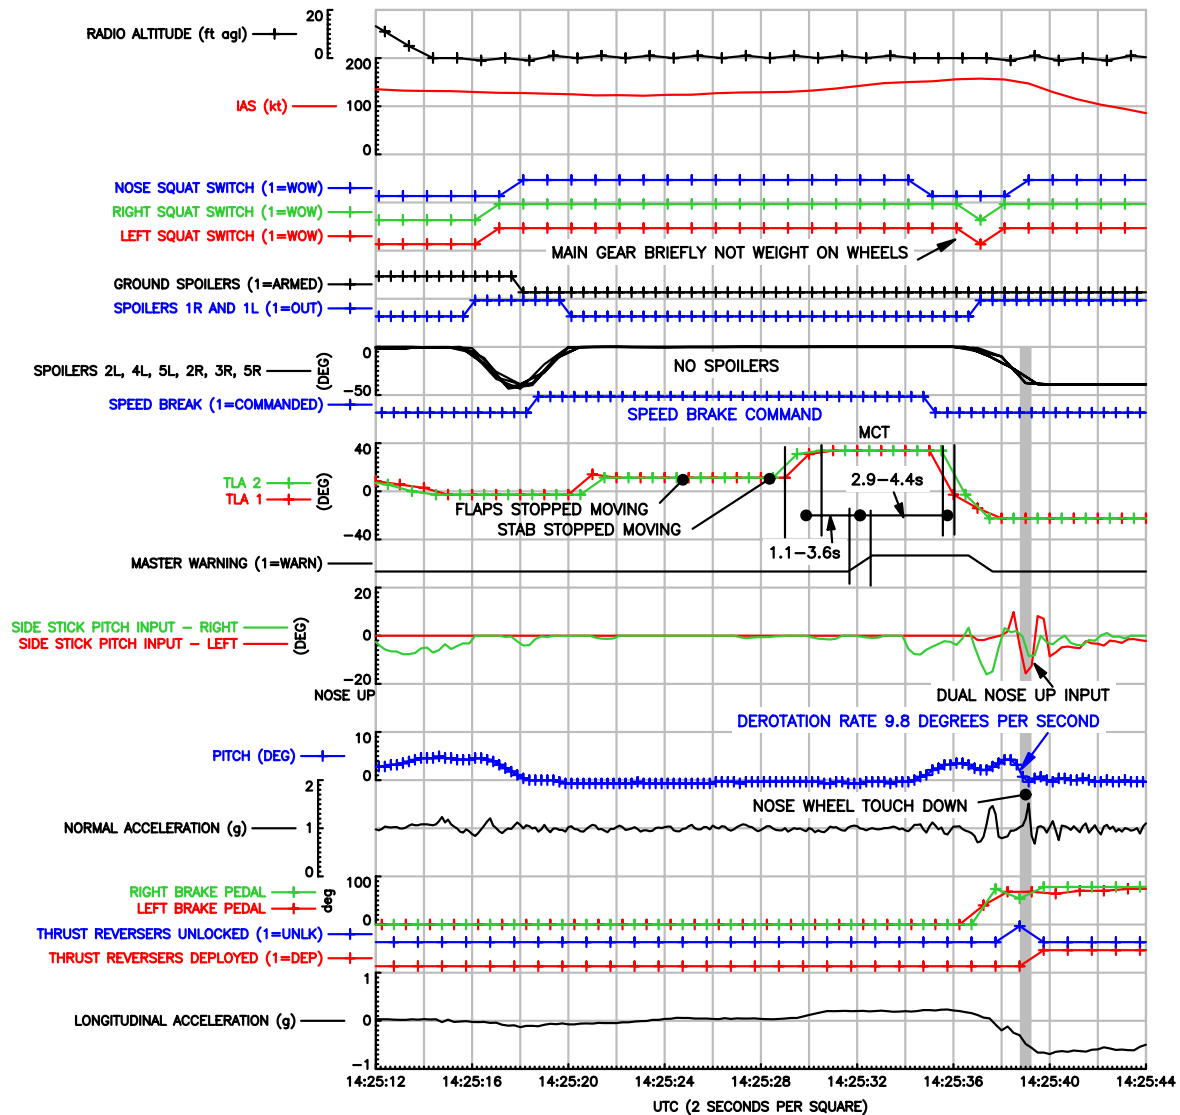
The following information is an amalgamation of the recorded data. Figure 1 shows the pertinent extracts from the recordings leading up to and including the RTO.

Prior to landing, the ground spoilers had been ARMED and, on landing, they deployed as intended. As the nose landing gear proximity switch registered weight-on-wheels, the ground spoiler system transitioned to NOT ARMED and the speed brake parameter transitioned to COMMANDED. Within the following two seconds the spoilers retracted. During this period the flaps started to move. Shortly after that, the throttle levers were advanced to a position half way to the CLB detent and the stabiliser trim started moving.

When the stabiliser trim stopped moving the throttles were moved to the MCT detent. The in-cockpit video indicates that approximately 1.8 seconds after thrust levers reached MCT, the master warning was triggered. Approximately 2.5 seconds after the onset of the warning, the speed brake command parameter reset to NOT COMMANDED. This was followed by the thrust levers being retarded to idle and then reverse thrust. Meanwhile, the pilot in the right seat had started to rotate the aircraft. With the nose landing gear in the air, the spoilers started to deploy and the brake pedals were applied. The main landing gear proximity switches indicated they were in the 'air' (landing gear uncompressed) position for one sample (the sample rate was 1 per second) and then showed weight-on-wheels, again, shortly following which the thrust reversers unlocked. The aircraft then derotated, nose-down, reaching a rate of 9.8 °/s at the same time as both side stick controls were commanding a pitch-up. A normal acceleration spike of 1.52g was recorded at the centre of gravity as the nose landing gear touched down.

Between the onset of the master warning and the first recorded movement of the thrust levers to reject the takeoff, the aircraft had accelerated from a ground speed of 131 kt to 147 kt.

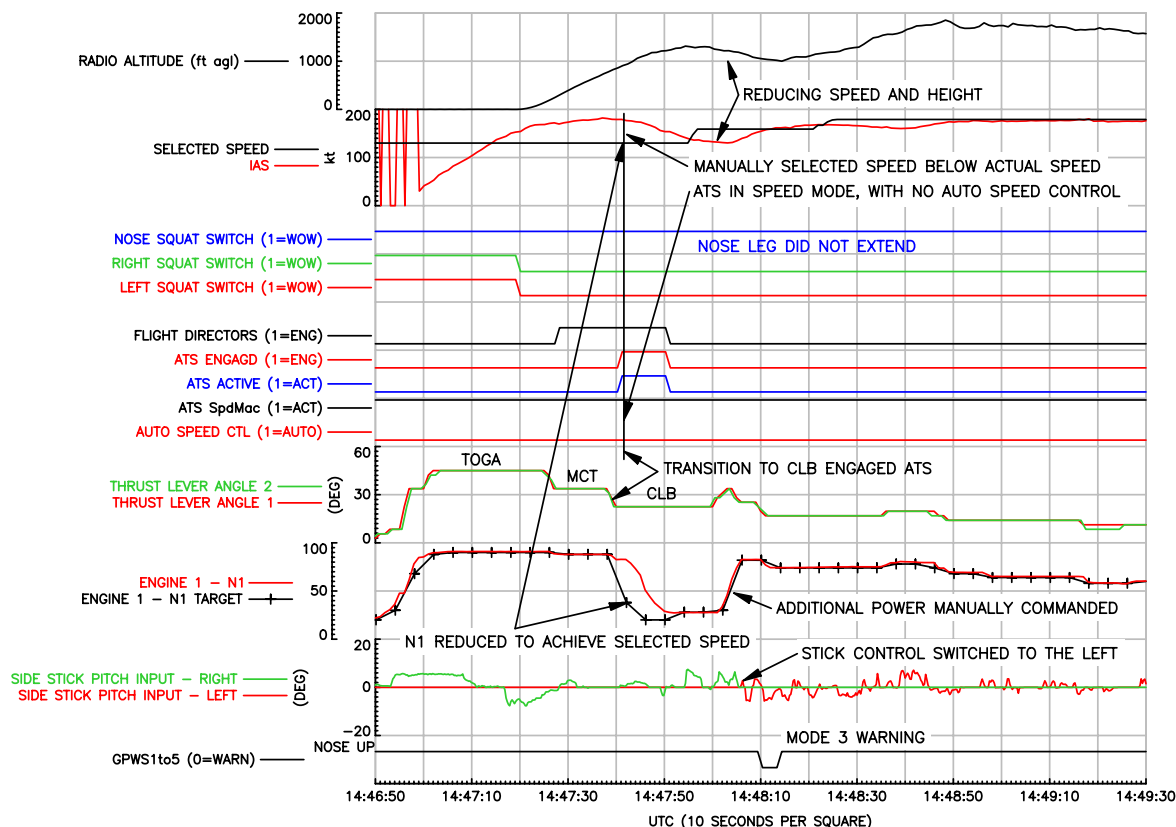
Figure 2

The subsequent flight departed at 1446 hrs. The data recorded at the start of the flight is shown in Figure 2. The nose landing gear proximity switches continued to indicate weight-on-wheels after takeoff and the flight directors were engaged at 200 ft agl. At 800 ft agl, the autothrust engaged in 'speed' mode after the thrust levers were retarded to CLB. With the aircraft speed above the selected speed of 130 kt, the engine target N_1 and, subsequently, achieved N_1 values reduced. The flight director and autothrust systems then disengaged as the aircraft passed 1,200 ft agl, with the aircraft decelerating. Five seconds later, the selected speed was increased to above the aircraft speed. A further five seconds later the thrust levers were advanced and subsequently the sidestick control inputs switched from the right to the left. Shortly afterwards, an EGPWS mode 3 (altitude loss after takeoff), warning was triggered.
