No: 4/92

Ref: EW/G91/09/21

**Aircraft Type and Registration:** Piper PA-18-180 Super Cub, G-AVOO  
**No & Type of Engines:** 1 Lycoming O-320-A3A piston engine  
**Year of Manufacture:** 1967  
**Date & Time (UTC):** 8 September 1991 at 1100 hrs  
**Location:** Dunstable Airfield, Bedfordshire  
**Type of Flight:** Private (glider towing)  
**Persons on Board:** Crew - 1                      Passengers - None  
**Injuries:** Crew - None                      Passengers - N/A  
**Nature of Damage:** Damage to tailplane trim system  
**Commander's Licence:** Private Pilot's Licence with Night rating  
**Commander's Age:** 33 years  
**Commander's Flying Experience:** 1,150 hours (of which 130 were on type)  
**Information Source:** Aircraft Accident Report Form submitted by the pilot

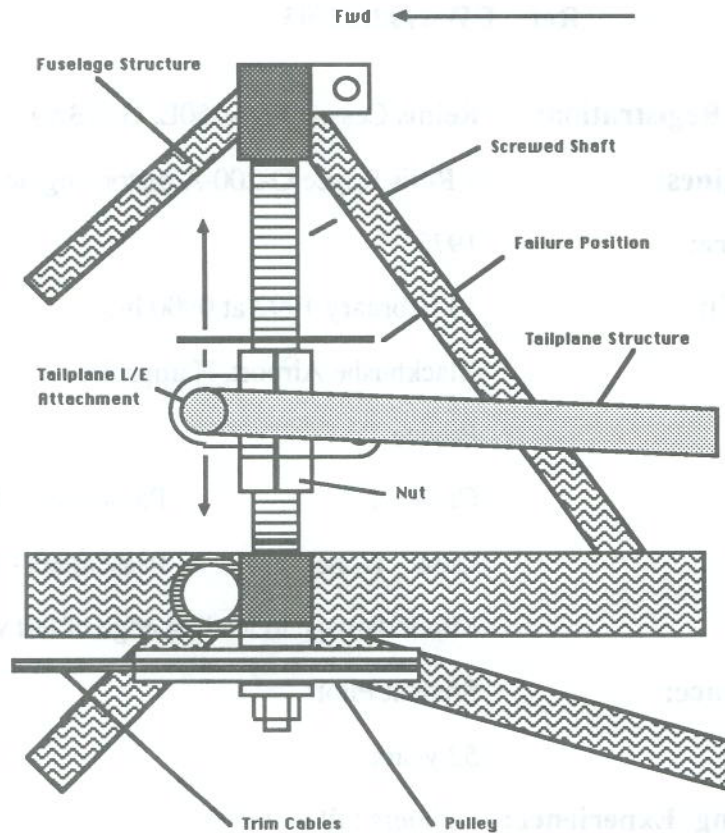
**Tailplane Trim Mechanism Installation - Schematic**

Pitch trim on this aircraft is effected by altering the incidence of the tailplane. This is accomplished by the tailplane pivoting about its trailing edge, with the leading edge attached at its centre to a nut which runs on a screw-shaft mounted vertically in the airframe. The shaft is rotated by cables from a handle in the cockpit, there being approximately 25 turns of the handle required for full travel. During aerotow operations this trim system is in almost constant use, compensating for large variations in pitching moments due to flap, power and speed changes. The aircraft is also subject to considerable vibration, particularly during the low speed, full power, climb segment of each flight.

The shaft had failed at its mid-point within a region which exhibited excessive wear on the screw thread. Evidence of fatigue cracking was present on the fracture surfaces, originating from the entire circumference of the thread root. Metallurgical examination of the screw material showed it to conform to the manufacturer's specification.
