ACCIDENT

Aircraft Type and Registration:	Reims Cessna F152, G-BMCV	
No & type of Engines:	1 Lycoming O-235-N2C piston engine	
Year of Manufacture:	1963	
Date & Time (UTC):	24 August 2006 at 1310 hrs	
Location:	Leicester Airport, Leicestershire	
Type of Flight:	Training	
Persons on Board:	Crew 1	Passengers None
Injuries:	Crew None	Passengers N/A
Nature of Damage:	Damage to propeller and right wing	
Commander's Licence:	Student pilot	
Commander's Age:	18 years	
Commander's Flying Experience:	32 hours (of which all were on type) Last 90 days - 32 hours Last 28 days - 11 hours	
Information Source:	Aircraft Accident Report Form submitted by the pilot and metallurgical examination of damaged components

Synopsis

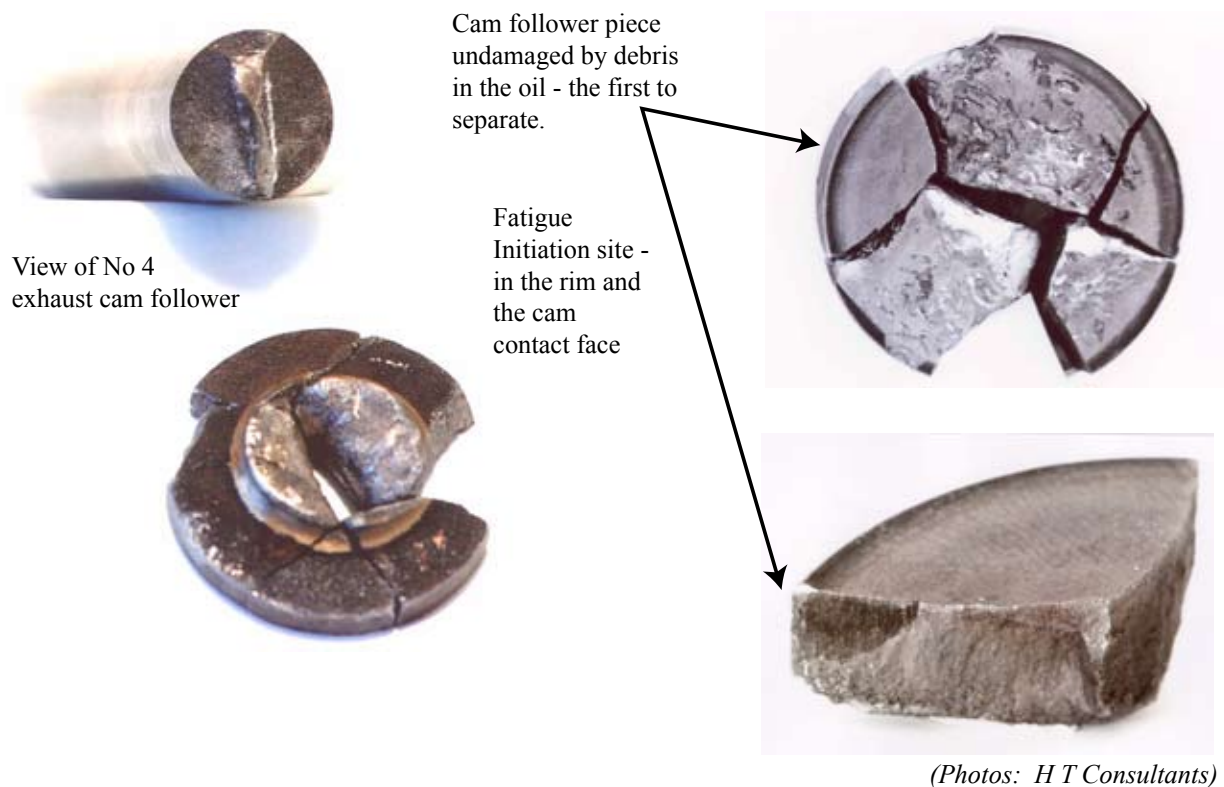
**Figure 1**

Damaged cam follower

the No 4 exhaust cam follower, the head of which had broken away from its shaft (see Figure 1) and was found in several pieces in the bottom of the oil sump. There was also consequential damage to the engine caused by the debris from the failed cam follower.

The No 4 cam follower, the camshaft and the crankcase were returned to the AAIB for metallurgical examination. The cam follower head had broken into seven pieces; many of the failures showed evidence of flexural fatigue from loads applied by the associated cam lobe. All but one of the pieces recovered had been damaged on the cam lobe contact face by circulating debris; the undamaged piece was considered to be the first to have separated. It contained a fatigue initiation site, in the junction between the rim and the cam contact face, which had progressed more slowly than the separations on the other pieces (see Figure 1).

It was concluded that the break-up of the cam follower resulted from a flexural fatigue mechanism caused by offset cyclic loading from the related camshaft lobe. No conclusion could be made about the cause of the offset loading.
