BULLETIN ADDENDUM

AAIB File:	EW/G95/09/18
Aircraft Type and Registration:	Piper PA-23-250 Aztec, G-YSFT
Date & Time (UTC):	7 August 1995 at 1400 hrs
Location:	Bournemouth (Hurn) Airport, Dorset
Information Source:	CAA Occurrence Report, Aircraft Accident Report Form submitted by the pilot and AAIB engineering investigation

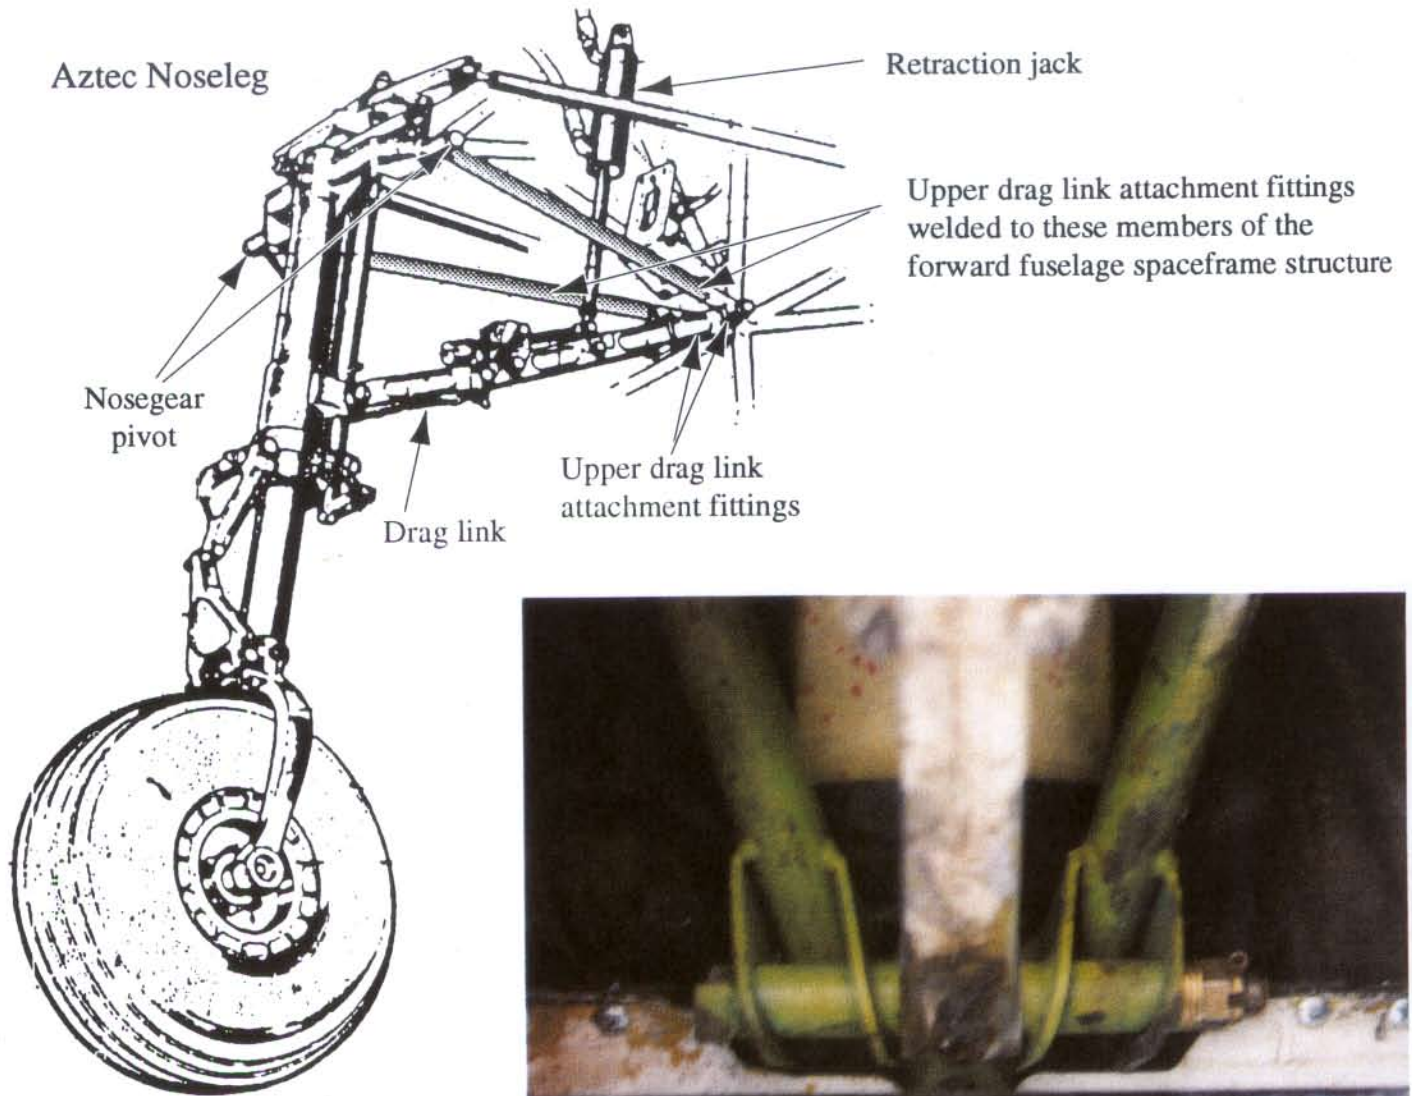
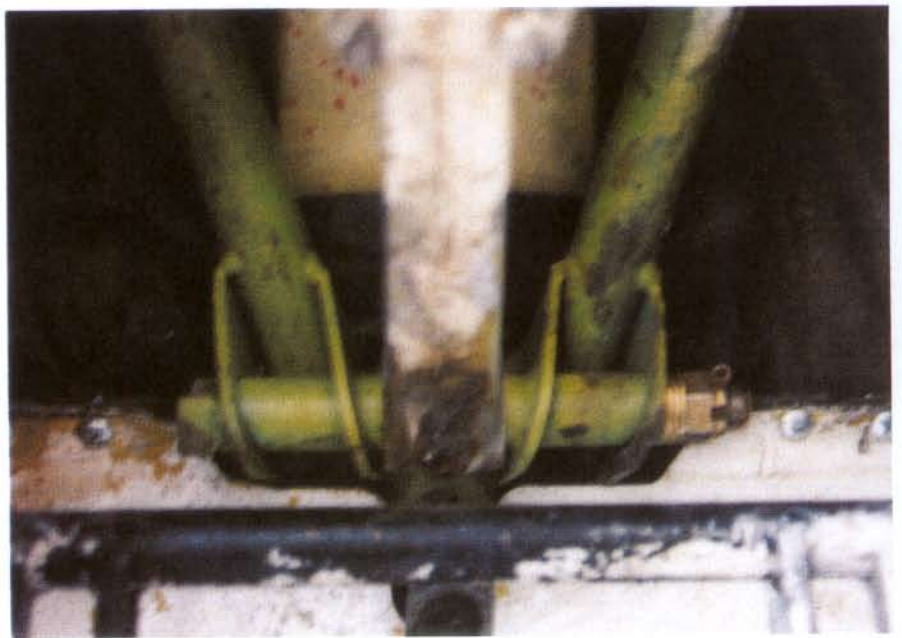
Subsequent examination by the operator's maintenance organisation revealed that the brackets restraining the upper end of the nose leg drag link (Fittings, Part Nos 17082-000 & -001) had fractured and that the leg itself had pivoted, lower end forward, until held by the wheel-well front bulkhead, which had been considerably distorted. The fragments of upper drag link attachment bracket which had remained attached to the aircraft structure were, of necessity, destroyed whilst being removed to effect repairs. The fragments of the brackets which had been attached to the drag link, however, had been retained and, for interest, shown to AAIB whilst the second failure was being investigated.

View, looking aft and upwards, of upper drag link attachment fittings

95-41: The CAA should liaise with the aircraft manufacturer with a view to the formulation of a Service Bulletin to alert operators of PA-23-250, Aztec, aircraft to the potential failure of the nose gear upper drag link attachment fittings (Part Nos 17082-000 & -001) and require periodic inspection of these fittings.

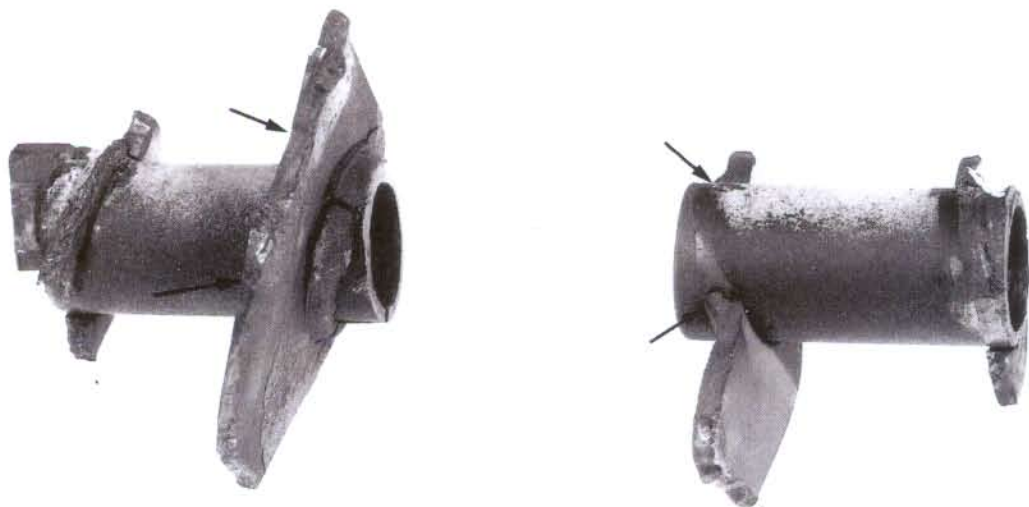
Subsequent metallurgical examination revealed that both brackets had suffered extensive fatigue cracking until too weak to sustain normal loads. The bracket on one side had failed as a result of almost purely tensile fatigue through the hole accommodating the drag stay upper pivot bolt whereas the other had largely suffered bending fatigue, at or close to the weld attaching the bracket to the fuselage structure (see diagram and photographs).

This aircraft has been used extensively in the training role in recent years which probably resulted in the landing gear being exposed to more extension/retraction cycles than the majority of this type. The brackets which failed are not readily inspectable for cracking, being awkward to view, and as a result of this failure, the operator has made inspection of these fittings a highlighted item at 450 hour scheduled inspections. There are no Piper Service Bulletins covering this area which encourage particular attention to these brackets.

Failed fittings - Arrows point to fatigue origins
