List of Aircraft Accidents Reported by CIB in 1977

Avions Pierre Robin HR 200/100 G-BCCO
Report on the accident south-east of Sywell
Aerodrome, Northamptonshire, 27 March 1976

Accidents Investigation Branch
Aircraft Accident Report No. 3/77
(EW/C555)

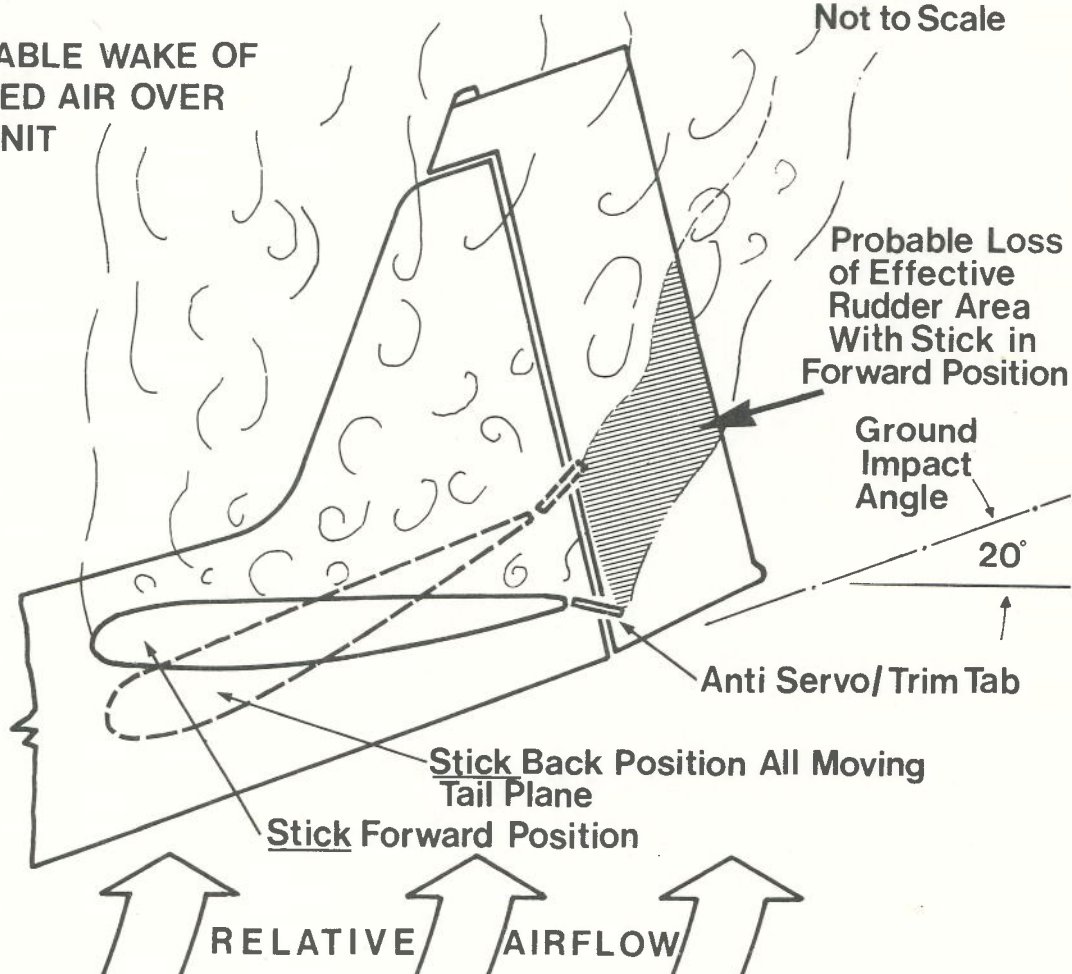
Appendix
Not to Scale

The special problem is that during a spin, much of the rudder is usually in the stalled wake of the horizontal tail and sometimes the wing, over which the dynamic pressure is low, or abnormal airflow conditions exist.

①. PROBABLE WAKE OF STALLED AIR OVER TAIL UNIT

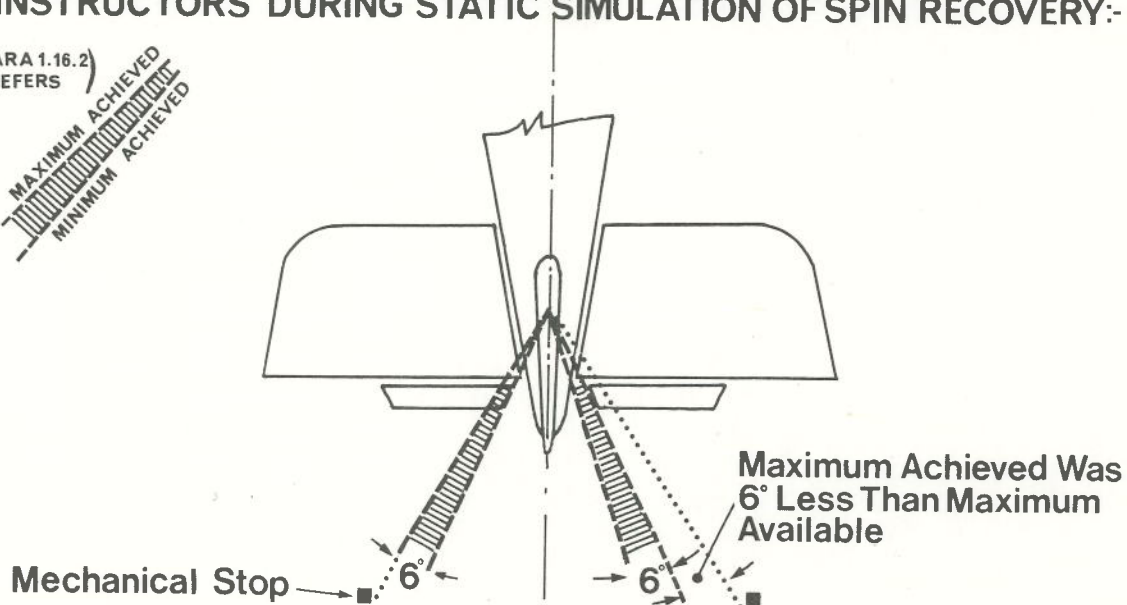
Ten simulated recoveries were made and in each case the pilot considered that he had applied full opposite rudder. However in only one case, did the rudder reach its stop. In the remainder of simulated recoveries, the distance of the rudder from its stop varied

from $\frac{1}{8}$ to $\frac{1}{2}$ inch (3 to 12 mm). As each $\frac{1}{8}$ inch represents approximately 3 degrees of rudder movement, a $\frac{1}{2}$ inch represents 40 per cent of the total rudder travel. (See Appendix).

②. RANGE OF MAXIMUM RUDDER MOVEMENT ACHIEVED BY TWO INSTRUCTORS DURING STATIC SIMULATION OF SPIN RECOVERY:-

(PARA 1.16.2
REFERS)

MAXIMUM ACHIEVED
MINIMUM ACHIEVED
