ACCIDENT

Aircraft Type and Registration:	Piper PA-38-112, G-BNVD	
No & Type of Engines:	1 Lycoming O-235-L2C piston engine	
Year of Manufacture:	1978	
Date & Time (UTC):	9 December 2006 at 1110 hrs	
Location:	Durham Tees Valley Airport	
Type of Flight:	Training	
Persons on Board:	Crew - 2	Passengers - None
Injuries:	Crew - None	Passengers - N/A
Nature of Damage:	Left wing and main landing gear damaged beyond repair	
Commander's Licence:	Airline Transport Pilot's Licence	
Commander's Age:	63 years	
Commander's Flying Experience:	22,300 hours (of which 140 were on type) Last 90 days - 110 hours Last 28 days - 25 hours	
Information Source:	AAIB Field Investigation

Synopsis

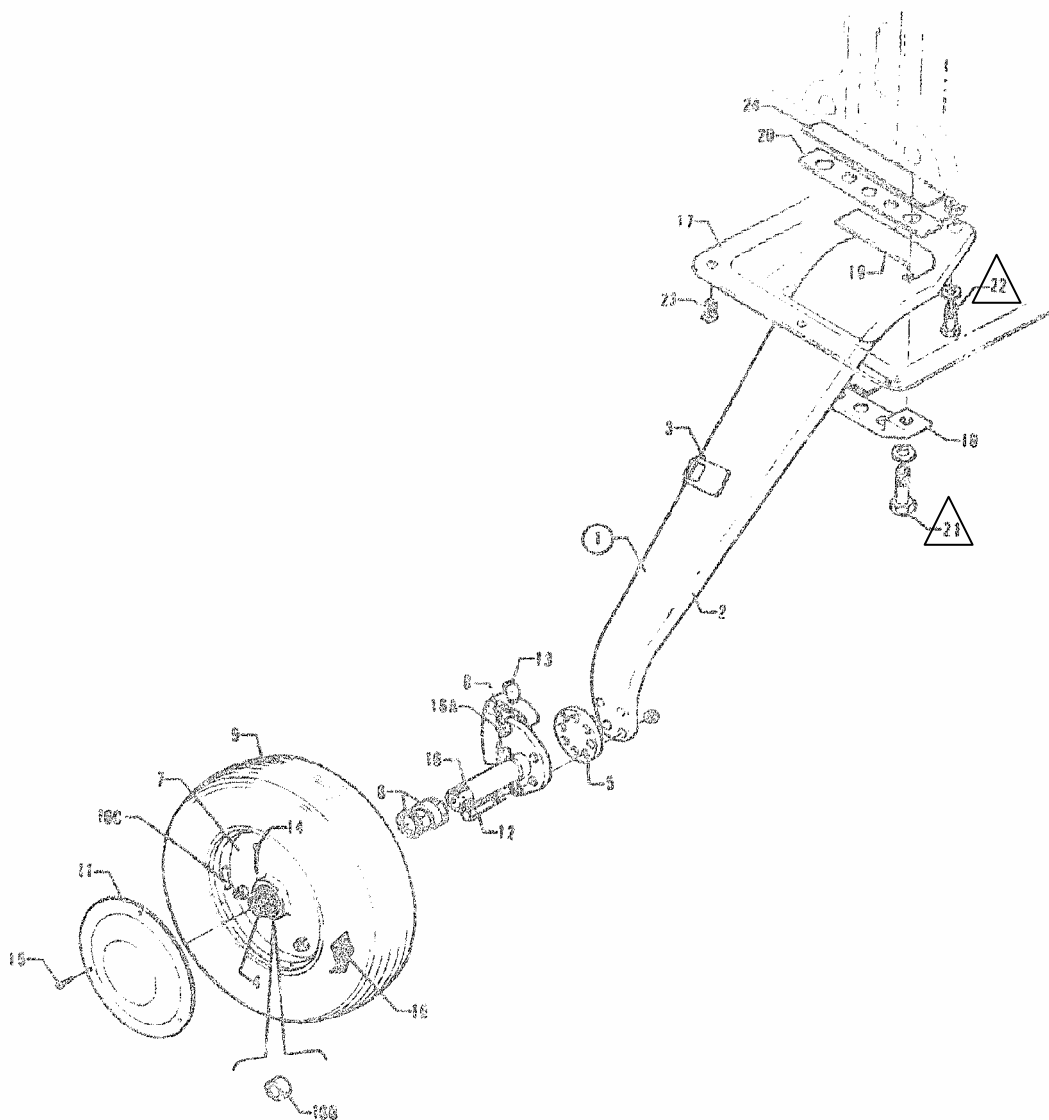
Figure 1

Examination of the detached left main landing gear indicated that one of the three bolts (Figure 1, item 22), part number 401 511, that attach the landing gear to the aircraft, was missing. The other two bolts (Figure 1, items 21), part number 401 462, were attached to the landing gear with locking wire and exhibited very good

evidence of having been pulled out of their barrel nuts as the landing gear was in the process of detaching from the aircraft. A search of the runway touchdown area located the missing bolt, which, upon examination, showed that it had unscrewed and dropped out of the barrel nut located in the wing. There was no wire locking or lock washer and none were specified in the aircraft's Maintenance Manual.

It is recommended that the Civil Aviation Authority reconcile the anomaly of the aircraft manufacturer's requirement to check the torque of the main landing gear attachment bolts on Piper PA-38 aircraft every 100 hours against the LAMS requirement to check the security of landing gear attachment bolts every 150 hours.

It is recommended that the Federal Aviation Administration require that Piper Aircraft introduce a form of locking on the main landing gear attachment bolt, part number 401 511, fitted to PA-38 series aircraft.
