ACCIDENT

Aircraft Type and Registration:	1) Boeing 777-240(LR), AP-BGY 2) DHC-8-402 Dash 8, G-JEDR
No & Type of Engines:	1) 2 General Electric GE90-110B turbofan engines 2) 2 Pratt & Whitney Canada PW150A turboprop engines
Year of Manufacture:	1) 2005 2) 2003
Date & Time (UTC):	15 February 2007 at 1220 hrs
Location:	Manchester Airport
Type of Flight:	1) Commercial Air Transport (Passenger) 2) Commercial Air Transport (Passenger)
Persons on Board:	1) Crew - 12 Passengers - 144 2) Crew - 6 Passengers - 37
Injuries:	1) Crew - None Passengers - None 2) Crew - None Passengers -None
Nature of Damage:	1) Minor scratches on right wingtip 2) Damage to the rudder
Commander's Licence:	1) Airline Transport Pilot's Licence 2) Airline Transport Pilot's Licence
Commander's Age:	1) N/K 2) 46 years
Commander's Flying Experience:	1) 14,000 hours (of which 180 were on type) Last 90 days - N/K Last 28 days - N/K 2) 9,873 hours (of which 2,000 were on type) Last 90 days - 150 hours Last 28 days - 50 hours

Synopsis

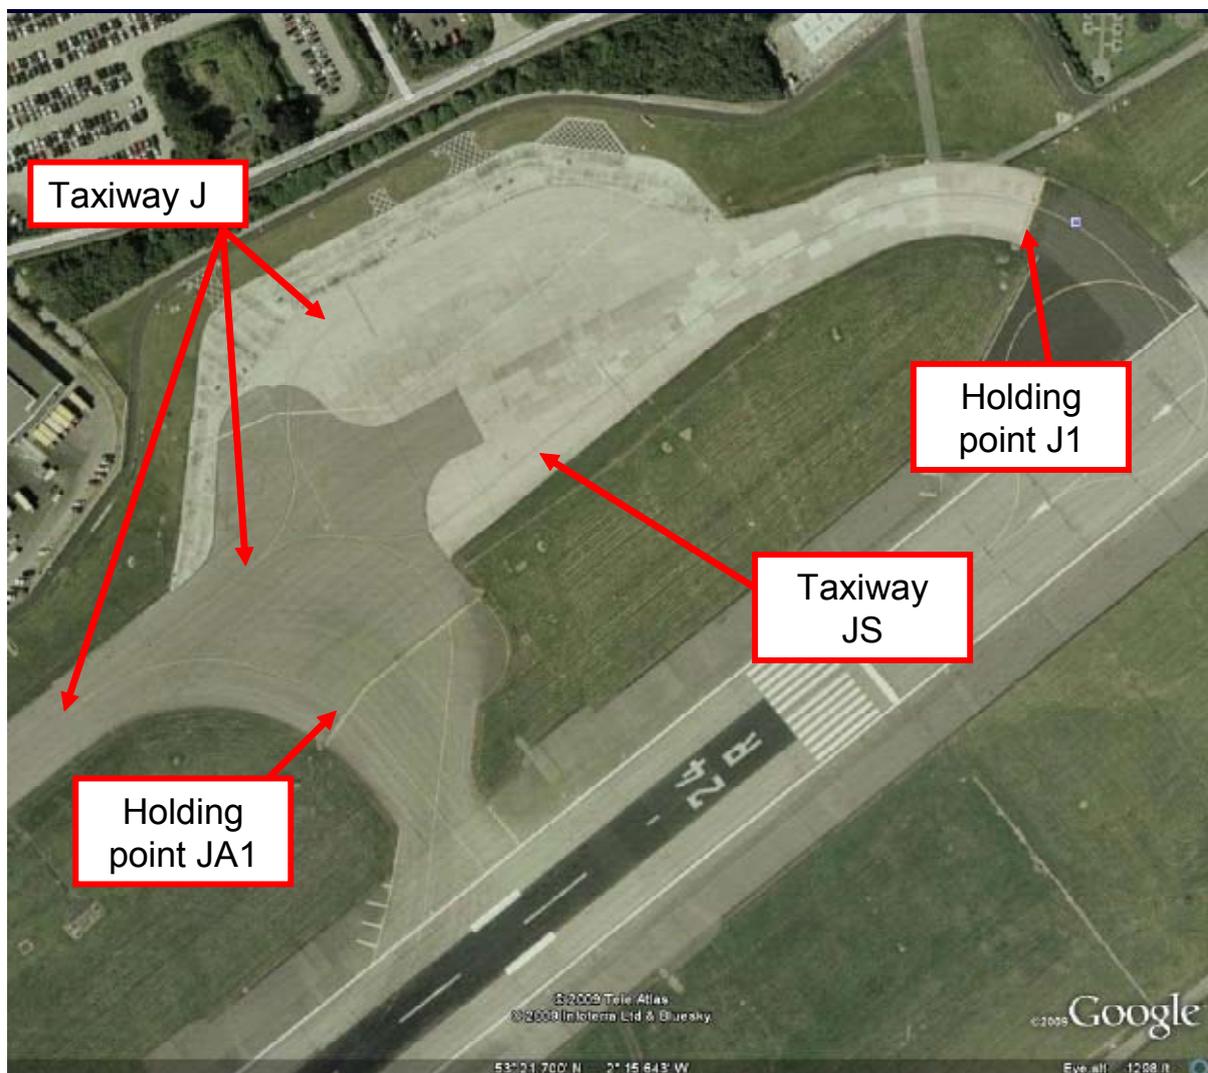
Figure 1

Complying with an instruction from the Ground Movement Control (GMC) controller, the commander of G-JEDR taxied his aircraft to Holding Position JA1 (see Figure 1) and stopped the aircraft “on the line” at about 1216 hrs. The flight crew prepared for an immediate departure and waited for clearance to enter the runway. They were aware that the Boeing 777, AP-BGY, was taxiing along Taxiway Juliet and would pass behind them.

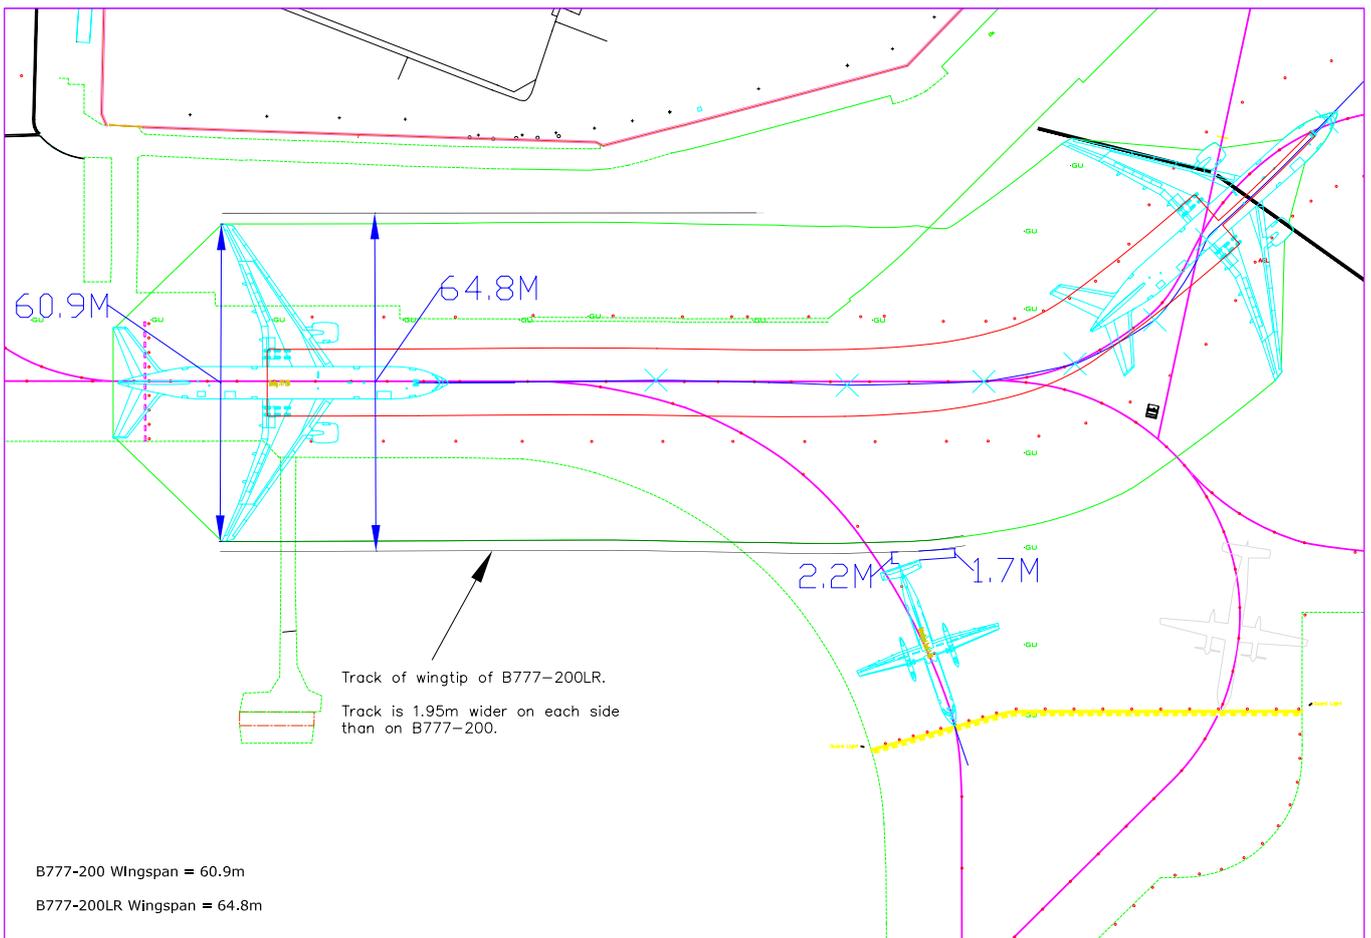
Figure 2

the impact. However, the clearances between the two aircraft were simulated using a computer generated map, based on accurate survey data, on which scale representations of various aircraft types could be displayed (see Figure 2). This indicated that there would be a clearance of 2.0 m between the rudder of a DHC-8-400 (parked with its nose precisely at the stop line at holding point JA1 and on the taxiway centreline) and the right wingtip of a Boeing 777-200LR taxiing behind it along the centreline of Taxiway J. The gap between the wingtip of the B777 and the higher trailing edge of the DHC-8’s left elevator would be less, at 1.4 m.

Whilst the crew of G-JEDR reported that they had stopped “on the line” at the holding position, analysis showed that if the aircraft had been stopped with its nose precisely above the relevant marking, and that AP-BGY had been following the taxiway centreline, the two aircraft would not have collided. Therefore, it is logical to conclude that G-JEDR had stopped a few metres short of the holding position, which was consistent with allowing the crew a view of the stop bar, as is normal aviation practice.

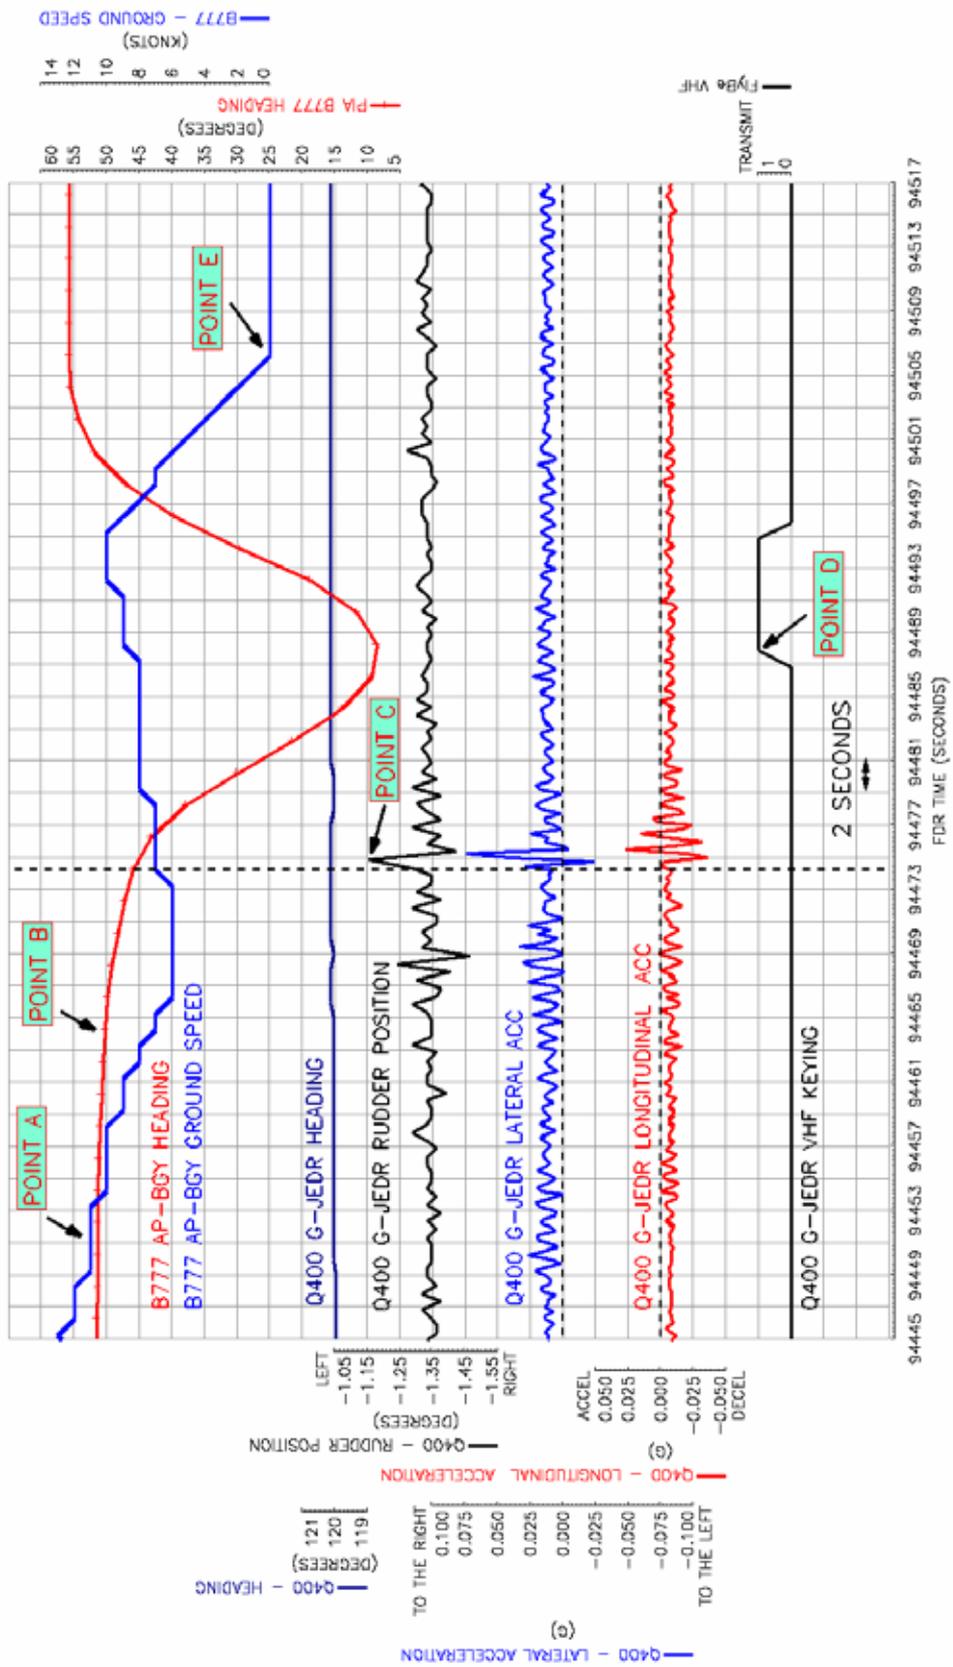
Figure 3

Both aircraft were equipped with a Flight Data Recorder (FDR) and a Cockpit Voice Recorder (CVR), capable of recording a minimum of 25 hours of data and 120 minutes of audio respectively. Parameters recorded by AP-BGY included its heading and ground speed. A plot of the salient FDR parameters from both aircraft is provided in Figure 3.

When AP-BGY was about 100 metres from G-JEDR, it gradually decelerated (Figure 3, POINT A). There was some conversation between its flight crew about the position of G-JEDR, reflecting a concern that there would be little separation between the aircraft as they passed. As it closed to about 60 metres from G-JEDR, AP-BGY started to make a gradual turn to the left, with its ground speed reducing to about 6 kt (Figure 3, POINT B). As the turn continued, the collision occurred. There was a small oscillation of G-JEDR's rudder during the impact (Figure 3, POINT C), with associated lateral

and longitudinal accelerations being recorded. There was no associated recording of an impact on AP-BGY and its flight crew made no mention of one. The flight crew in G-JEDR briefly discussed whether they had been struck, before they contacted ATC to advise "[CALLSIGN] I THINK THE AIRCRAFT BEHIND US HAS JUST CAUGHT THE BACK OF OUR WING...OUR TAIL RATHER" (Figure 3, POINT D). ATC responded by advising that they had noticed it as well and advised AP-BGY to hold position, which it did (Figure 3, POINT E).
